# HUTT VALLEY OUTFALL PIPE REPAIR

*S.J. Hutchison*  
*MWH New Zealand Ltd*

A key feature of the Hutt Valley wastewater system is an 18.3 kilometre land based outfall pipeline. A pump control malfunction in March 2009 resulted in five joint failures and the start of a major repair and investigation lasting four months. The traditional response involved open excavation and casting reinforced concrete blocks around the leaking joints.

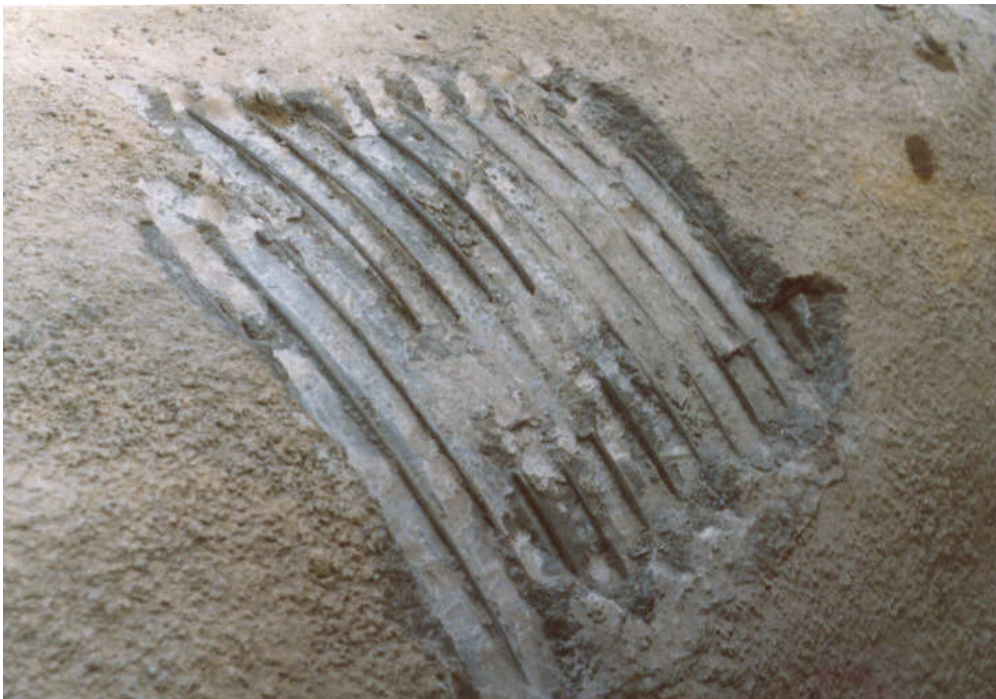
Catastrophic failures occurred in two pipes in one of two short tunnels in the southern end of the pipeline in 1978. These failures were mainly due to severe corrosion of the prestressing wire, although internal corrosion was also a factor and accidental over-pressurisation may have occurred. The corrosion of the prestressing wires was caused by contact of saline groundwater dripping onto the pipes in the tunnel. In 1995 the annular space of these tunnels was filled with concrete to remove the risk of further wall failure in the tunnels.

This failure raised the concern over possible, albeit slower, corrosion of the prestressing wire due to groundwater conditions. Condition survey work in 1989 and 2003 has found areas of prestressing wire corrosion in five of 44 inspected pipes, however only one of these was significant. One of the pipes inspected also had extensive delamination of the protective shotcrete that was a separate concern.

*Photograph 1: View of exposed and corroded prestressing wire*

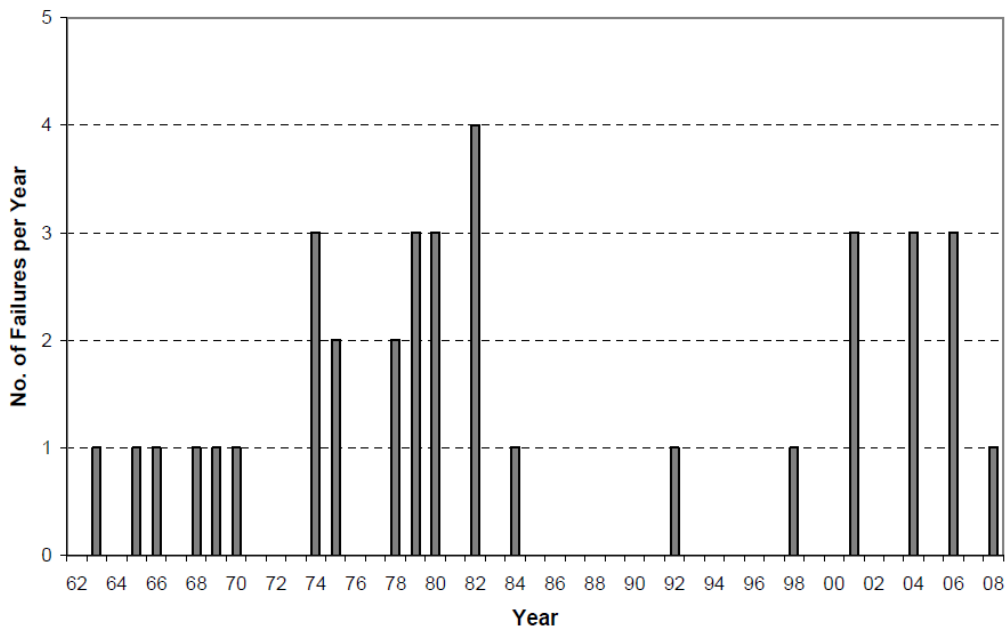
Prior to 2009 there had been 36 joint failures in the 47 years of operation of the pipe. The frequency had varied, with an obvious reduction in failures from 1982 due to new pumps and a new computer control system in 1981, however since 2001 there had been a slight increase in frequency. There are several contributing factors to these joint failures, including pipe settlement, unsatisfactory installation tolerances, internal pressure fluctuations, ingress of tree roots and loss of integrity of the rubber rung due to stress relaxation and general degradation with age.

Figure 4: Pipe joint failure histogram from 1962 commissioning to April 2008

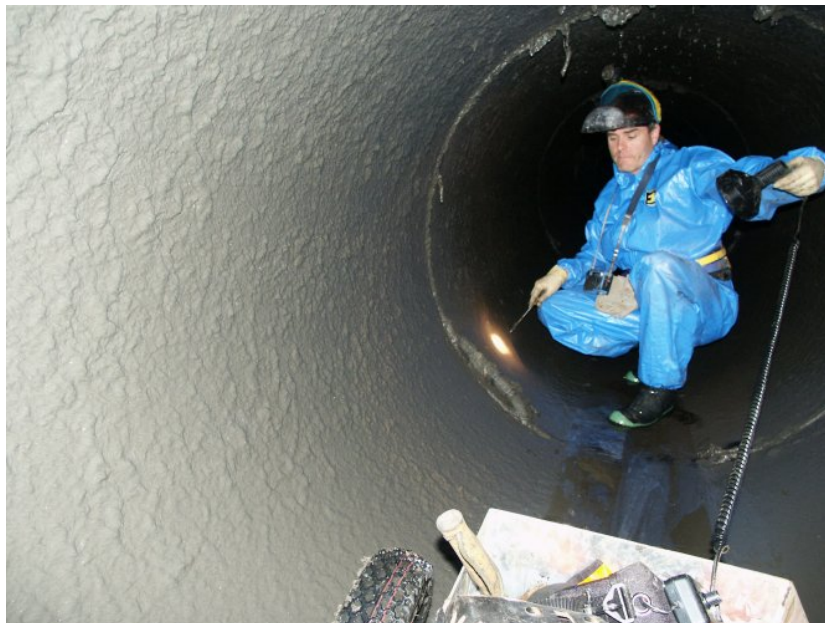
Photograph 2: Internal condition inspection 2004

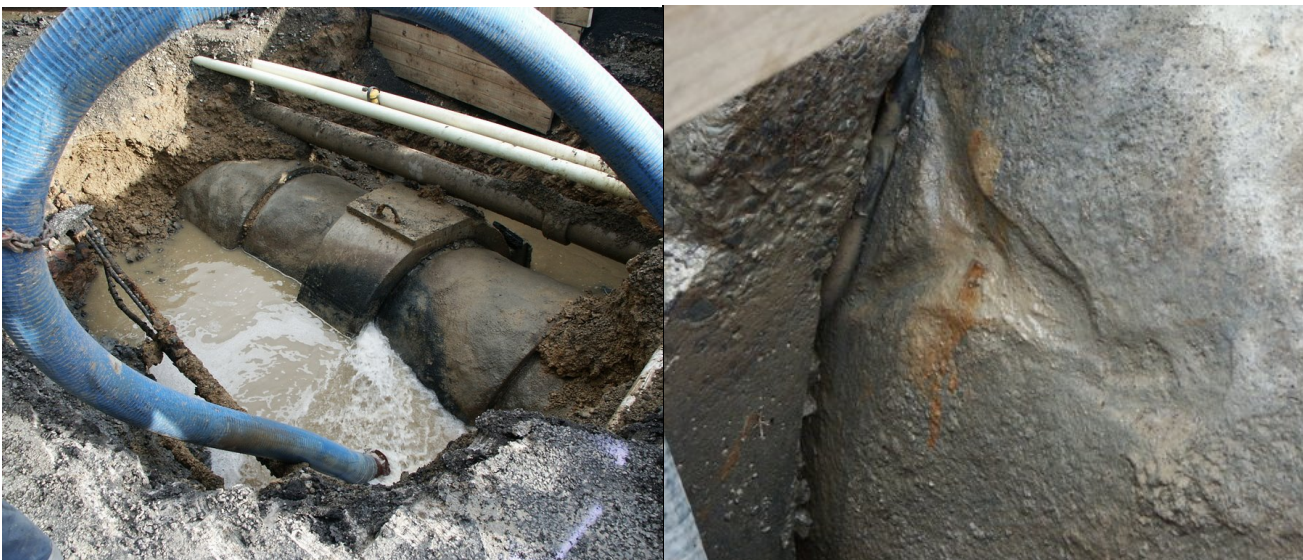
On the morning of 26 March an equipment failure at the Main Pump Station at the Seaview treatment plant lead to over-speeding of the duty pump. Although the back up over-pressure protective switch automatically activated and stopped the pumps the pressure pulse resulted in five leaks being evident as flowing through the road surface. The decision was made to shut down the main pumps and divert treated effluent to the Waiwhetu Stream while repairs were affected.

Two of the leaks were to the side of the gravel access track to Pencarrow and the other three leaks were in the carriageway of the narrow two lane road to Eastbourne. An experienced local contractor was engaged to excavate the pipeline at the leak locations and carry out repairs. Initial excavations were undertaken at four of the sites however there was insufficient room at the fifth site to excavate and maintain one lane of traffic.

*Photograph 3: General view of the leak site and close up of scoured pipe and dislodged rubber ring*

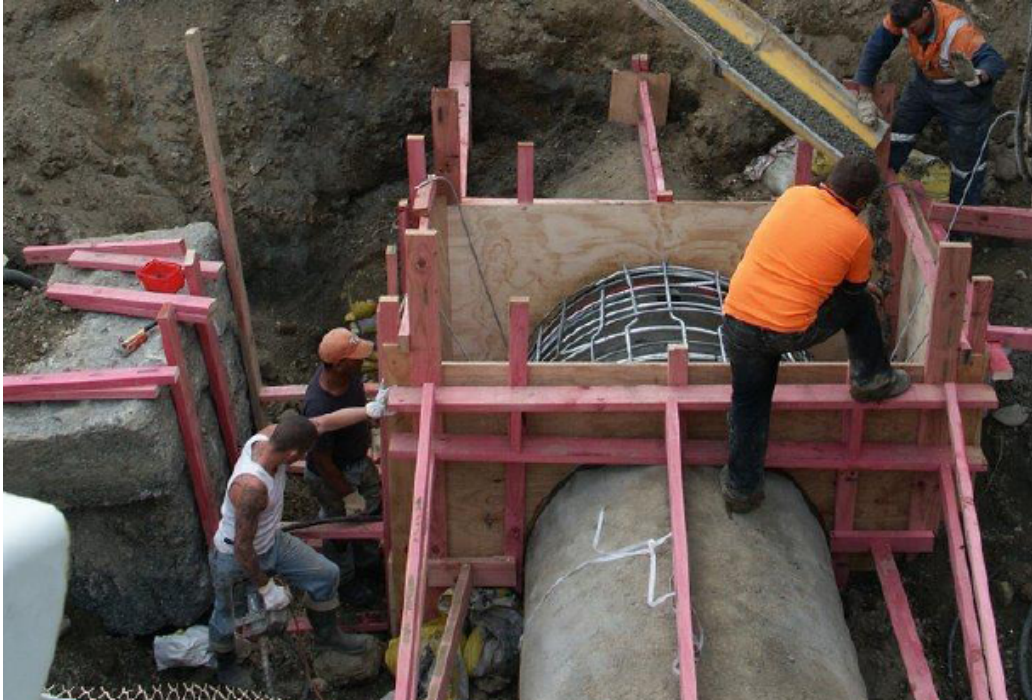
One disadvantage with this method of repair is that concrete bandages convert the previously flexible joint to a rigid joint. One repair from 1974 had cracked at the pipe barrel in 2006, requiring the original bandage to be broken out and replaced. Nevertheless, this methodology was a tried and proven technique for repairing a joint failure to enable the pipeline to continue operation.

The standard repair methodology developed over the years of operation was the construction of a reinforced concrete bandage to encase the joint. This was generally undertaken with the pipeline off-line and depressurised, however some successful repairs had been undertaken in recent years with the pipe on-line and the source of the leak diverted to minimize pressure.

*Photograph 4: Concrete bandage being poured at the first joint leak repair*

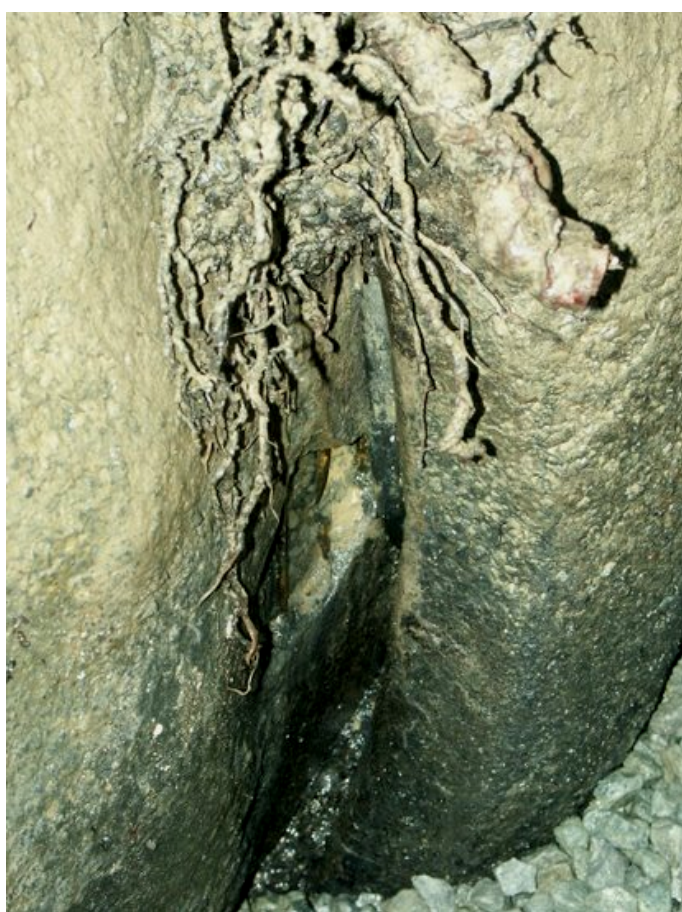
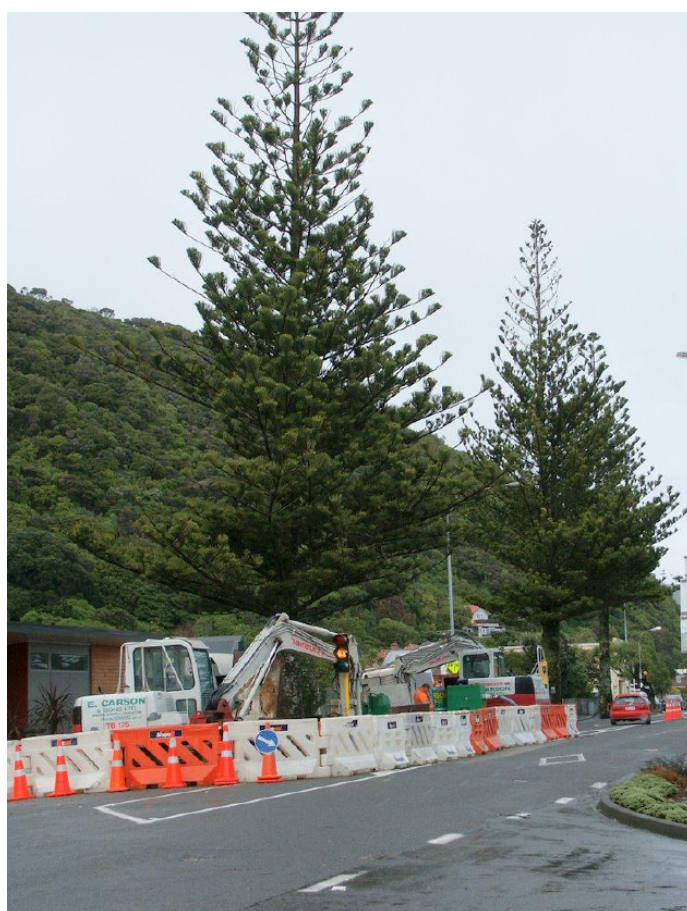
An internal inspection at the leak area revealed horizontal longitudinal cracks in three adjacent pipelines. A rubber ring from one of the pipes had dislodged and it appeared that the leak was coming through the joint, rather than the cracks. The pipeline was excavated to confirm whether the damage extended through the pipe wall. Once again the shotcrete cover near the joint leak was scoured away and in this location one of the prestressing wires had even been scoured through, suggesting that the leak had been present for a long time.

*Photograph 5: Detail of joint leak and root intrusion and general view of area*

Measurement of the pipes showed that the central damaged had deformed 20mm to be oval. The pattern of longitudinal cracking, combined with the presence of roots from the Norfolk Pine suggested that horizontal compression from the tree had caused the cracking.

The Norfolk Pine that had caused the damage to the pipe was noted in the District Plan as a Protected Tree. Several repair methodologies were considered, and it was decided to cut open the section of pipe that had been excavated for inspection and slip line with steel sections. A 900mm inspection manhole was fabricated onto one of the steel sections, to allow easier access of equipment in future.

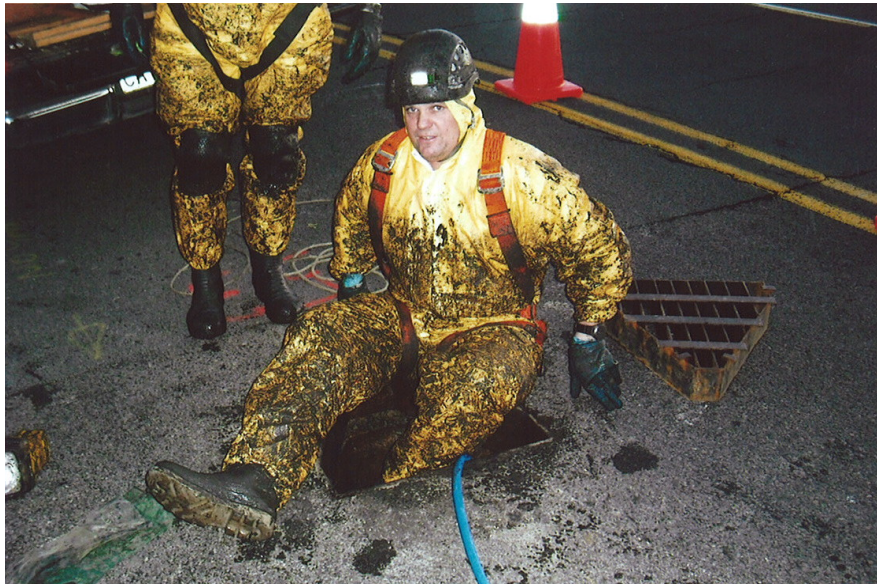
hazards associated with man entry to the confined space. E Carson & Sons were commissioned to undertake a manual inspection of the pipeline to look for any further evidence of pipe damage or leaks. This inspection took several days and 40 possible joint faults were identified. Soft areas of concrete were also identified at the two original concrete lined steel “closing sections” and these were investigated and repaired. One additional cracked pipe was identified, and this was also repaired.

*Photograph 6: Internal inspection team members*

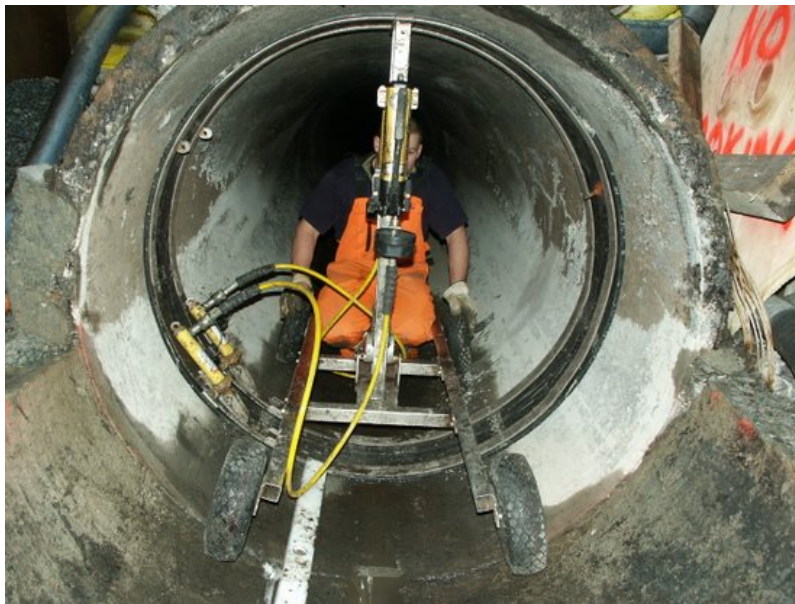
The forty possible leaks were tested first, and most of these were found to hold the prescribed test pressure. A further 100 joints were then tested as a survey of the general pipeline condition. One of these joints was found to not hold pressure.

Pressure testing rigs had been used during the original construction of the pipeline when each joint had been individually tested. In order to make the process efficient a rig was constructed based around the AMEX seal. This rig had to be manufactured to be dismantled and reassembled through the rectangular manhole openings in the pipeline. The manholes have a clear opening of 300 x 400mm only, and are located 300 metres apart on average.

*Photograph 8: Trialling of the joint testing rig at repair site*

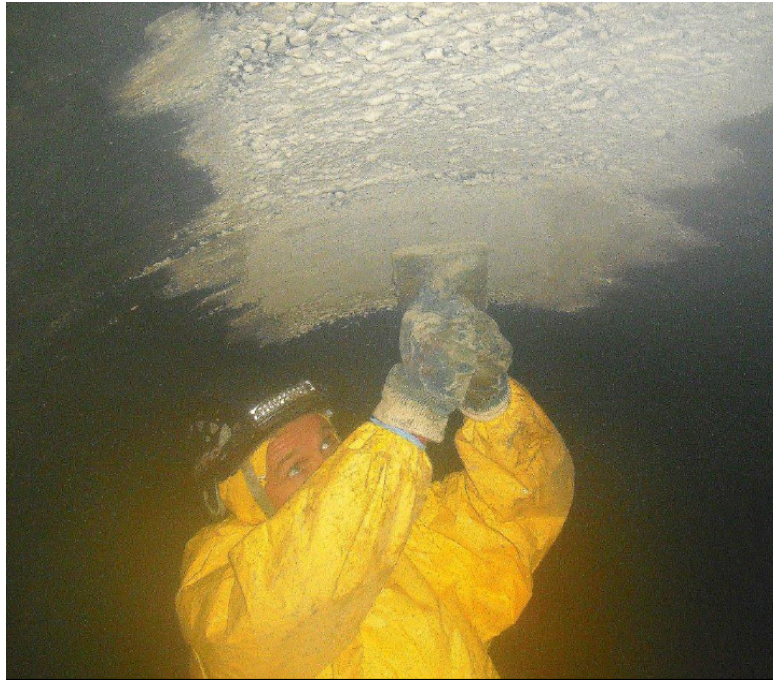
The second repair was on the southern section of the pipeline where historic corrosion of the pipe soffit had occurred. In order to ensure the AMEX bandage would seal fully the corrosion had to be locally repaired using a cementitious epoxy mortar. The product used took several days to cure in the ambient conditions, however the pipeline was returned to service on 14 September.

*Photograph 9: Repair of pipe soffit prior to placing internal AMEX seal*
