Remuera branch 1 & 2 rehabilitation 2009

MPG Lubbock, Principal Engineer, AECOM New Zealand Ltd

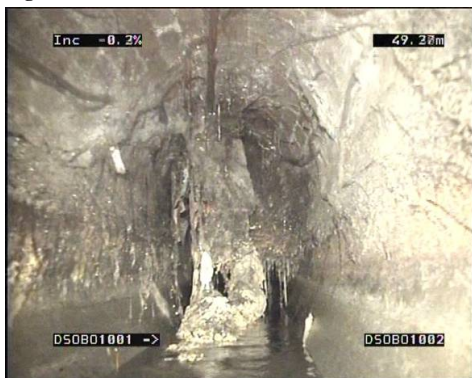
The main reason for the urgency to get these two branches lined was the detection of large root intrusions in both branches, as shown in figures 11 and 12, and the need to eliminate the risk of blockage or structural failure in the sewer that these defects implied.

Figure 11 Root intrusions Branch 1

Both the root intrusions visible in these photographs were removed by man entry. It was considered that the use of mechanical root removal devices such as chain flails or high pressure water blasting would create a risk of further damage to the brickwork of the sewer.

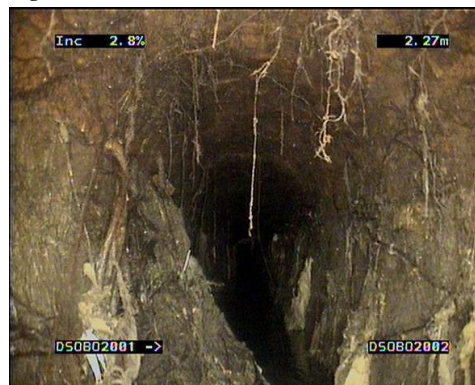
Figure 12 Root intrusions Branch 2

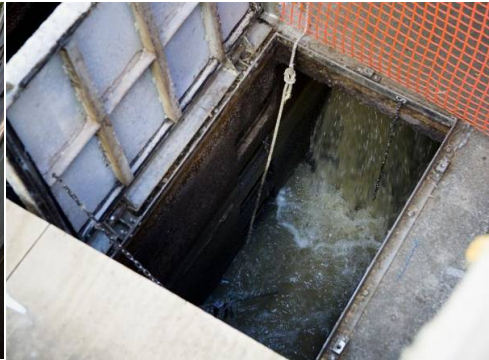
Figure 23 shows how little freeboard was available at the grit chamber, and therefore, how little the flow would have to rise before spilling. With only about ½ hour storage available at peak dry weather flow (PDWF) in the event of pump failure, it was imperative that the pumps should be manned and monitored whenever works were in progress.

Figure 23 Flow entering grit chamber

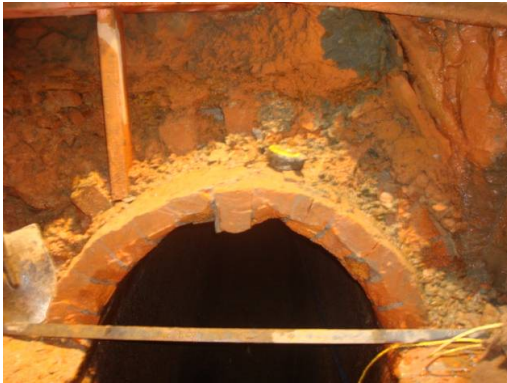
Figure 41 Branch 1 sewer at shaft base, before lining

The liner ends were cut off and then finishing work in the manholes was carried out. Figures 41 to 43 show the process of reconstructing the base of the shaft as it is taken from its initial state to the finished state. Figure 44 shows a view of MH04 after lining. In fig 42, the internal surface of the finished liner is visible. This surface is the same coated surface that started off on the outside of the liner before it was inverted during the insertion process.

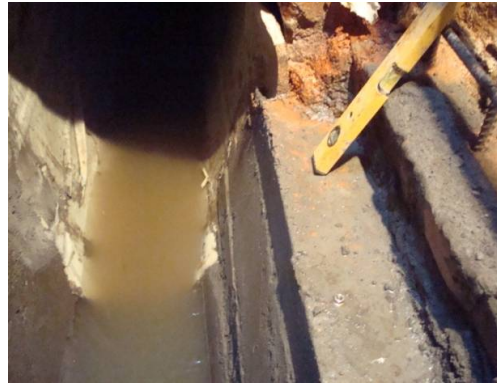
Figure 42 Shaft base reinstatement after lining
