The Fernhill Rising Main Bursts – What Went Wrong and What Was Done About It?

ABSTRACT

Rising main, burst, uPVC , burst control valve, transient pressure analysis

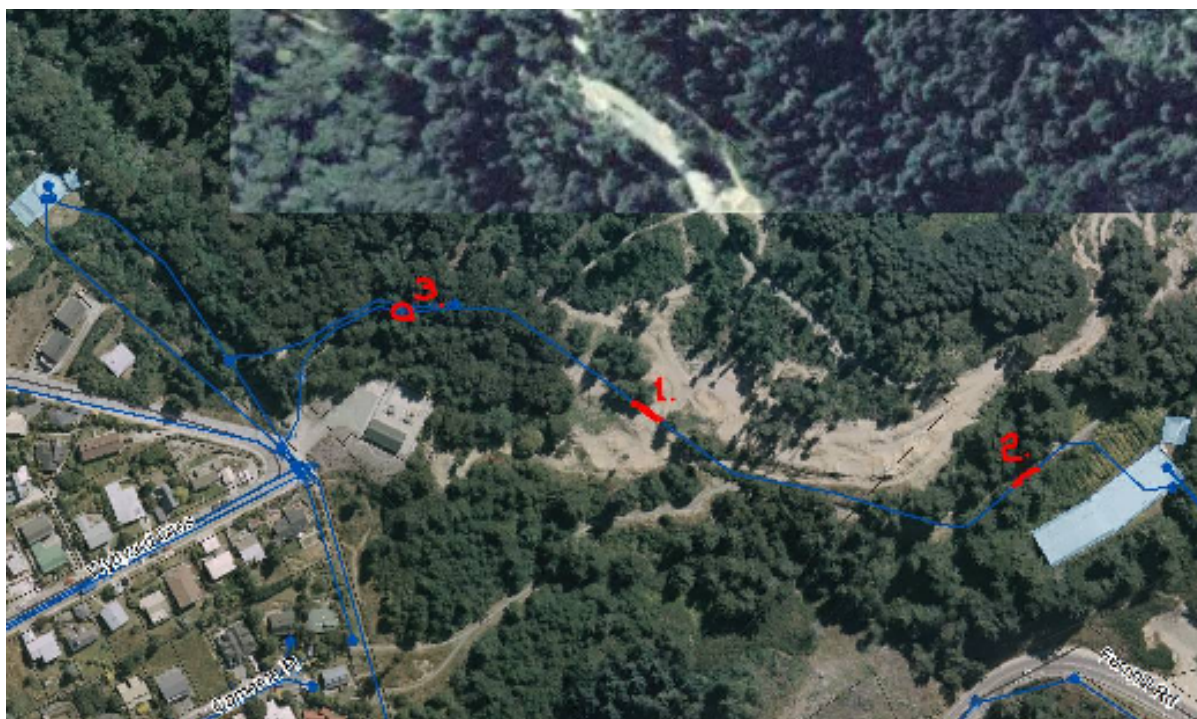
Figure 2: Locations of rising main bursts

Three failures of RM2 occurred in a five week period in July and August 2009. The locations of these failures are shown in Figure 2. These three bursts are discussed individually below. Anecdotal evidence indicates that this rising main had previously burst in February 2008 (prior to UW taking over operation of the system), at a location close to the second burst.

Significantly, however, the minimum pipe pressure (dashed blue line) caused by the transient event is below the pipe profile (solid black line), in particular immediately upstream of the first automatic air valve where negative pressures exceed -10 m. This is an indication that air/water column separation may occur in this section of RM2, potentially resulting in pipe burst or collapse. This correlates with operational experience recently where a number of bursts in this main have occurred at approximate chainages of 69, 230 and 373 metres from the WPS, as shown in Figure 2.

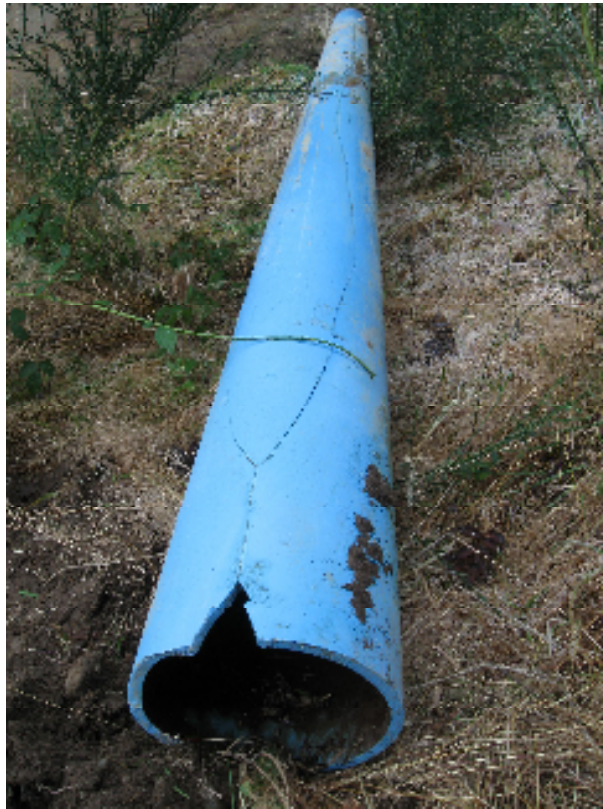
Figure 3: Section of damaged pipe, 1st burst

This burst was the result of a catastrophic failure of a 6 m section of uPVC pipe (Figure 3) and resulted in significant scouring of the walking track under which the main runs, as well as damage to a nearby mountain bike track. The scouring also exposed the adjacent 150 mm steel rising main, with the result that it was not deemed possible to isolate RM2 and use RM1 for fear of damaging it during recharge.

The root cause of the burst is undetermined; however, there are two probable causes: excavation of the pipe revealed that there was a lack of bedding material used on the initial installation, and large pointed rocks were evident surrounding the pipe; and there was a lack of sufficient surge suppression on the pipe lines protecting them from the expected forces experienced during pump start and stop. Another factor which needed to be considered was that the current SCADA system lacks the ability to be interrogated rapidly for viable data in emergency situations.

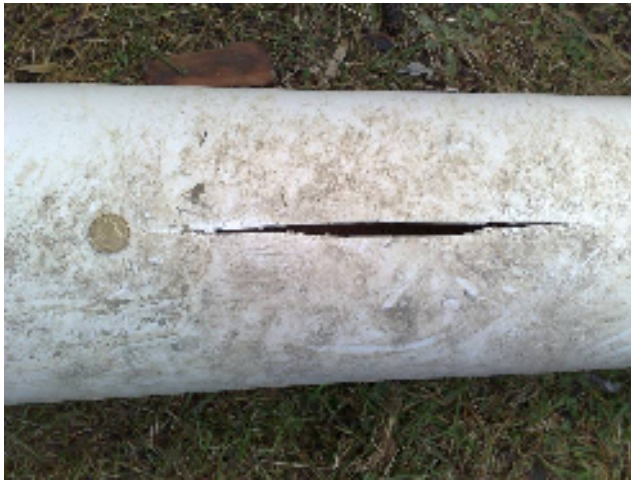
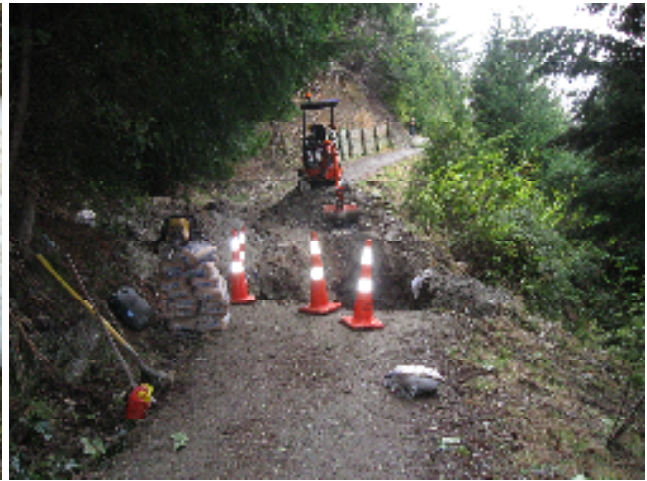
Figure 4: (a) Section of broken pipe from 2nd burst, (b) Repair of second burst underway

This burst was again due to a failure of a section of the uPVC main (Figure 4) although the section involved was white PVC compared with the piece of blue PVC in the previous burst. The reason for the failure was suspected as being a sharp protuberance of rock near the pipe failure point. The pipe in this section was laid in a channel cut from bed rock.

Repair of the main was effected on 29 July 2009 and RM2 was re-charged and returned to use at 10 pm. This time, however, RM2 was able to be isolated and RM1 put into sole use until the repairs to RM2 could be completed, with the result that water supply to the Fernhill system was only lost for 2 to 3 hours.

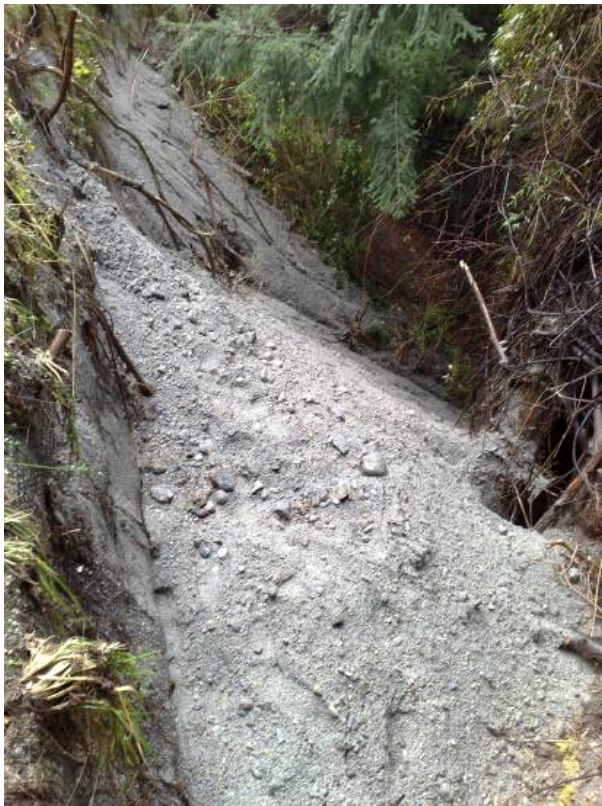
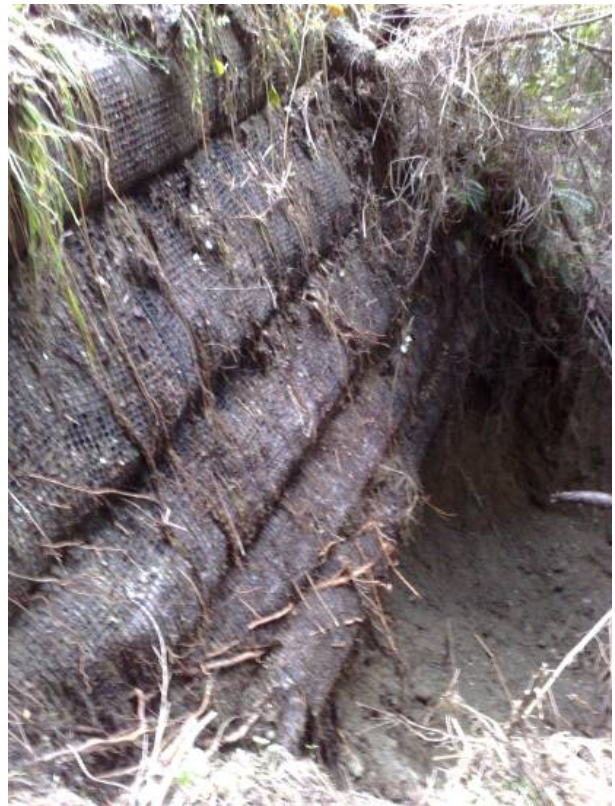
Figure 5: Scouring from from 2nd burst

The burst resulted in major scouring of an area around the Fernhill No.1 reservoir. Including the exposure of a section of the geo-textile support fabric underpinning the reservoir (Figure 5). The majority of this material was replaced by 30 July but a structural assessment of the area resulted in anchor points needing to be inserted below the reservoir to ensure stability of the shelf on which the reservoir sits. This work was only completed in early 2010.

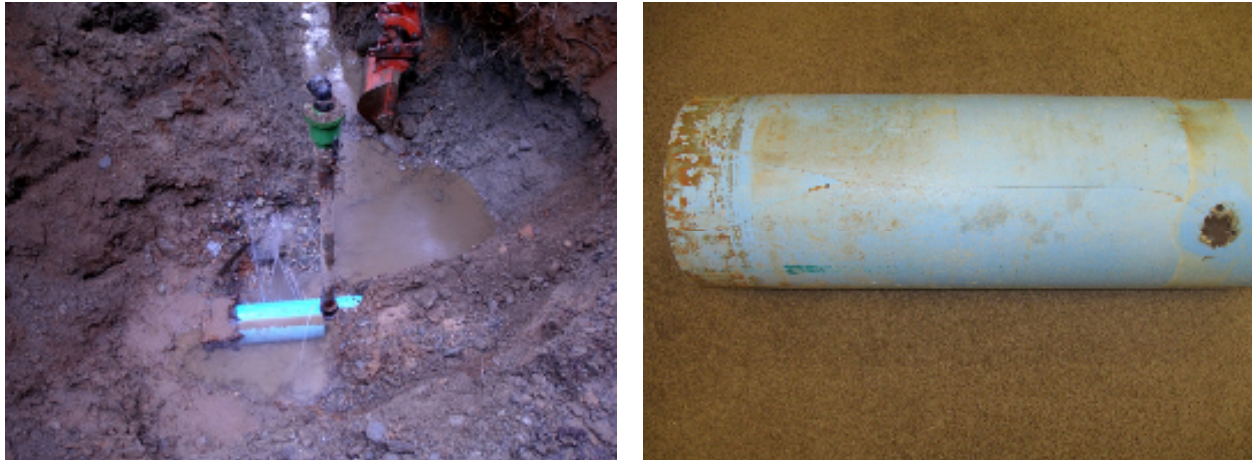
Figure 6: Section of broken pipe from 3rd burst (a) in-situ, (b) showing method of drilling tapping point

This burst was again due to the failure of a section blue uPVC pipe. However in this case the reason for the failure was more apparent. The failure occurred at the point at which a tapping band had been put on the pipe for an air valve. Removal of this section of pipe indicated that the tapping point had been chain drilled, resulting in the a number of potential weak points at which failure could occur (Figure 6).

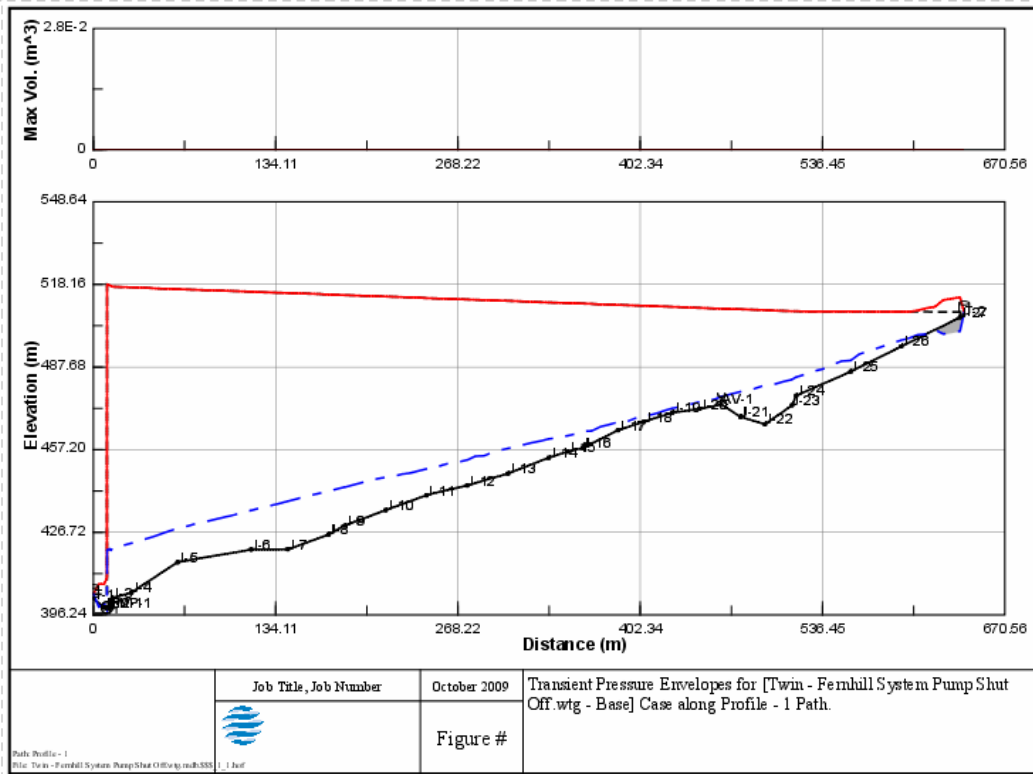
Figure 7: Surge analysis results for RM1

As can be seen in Figure 7 below, for RM1 the minimum pressure (dashed blue line) caused by the transient event is above the pipe profile (solid black line). This is good as significant negative pressures in pipework can cause air/water column separation and collapse of the pipe, particularly when negative pressures exceed -10 m.

The overpressure transient graph (red line) rarely exceeds the hydraulic grade line (dashed black line) for RM1, apart from a small peak in the section of rising main immediately prior to the Fernhill No.2 Reservoir inlet. This is unlikely to cause problems as the welded steel pipe materials used for RM1 are capable of withstanding very high pressures (up to PN 35). Therefore it is not expected that these higher surge pressures will be a cause of bursts unless the pipe is weakened by corrosion or other damage.

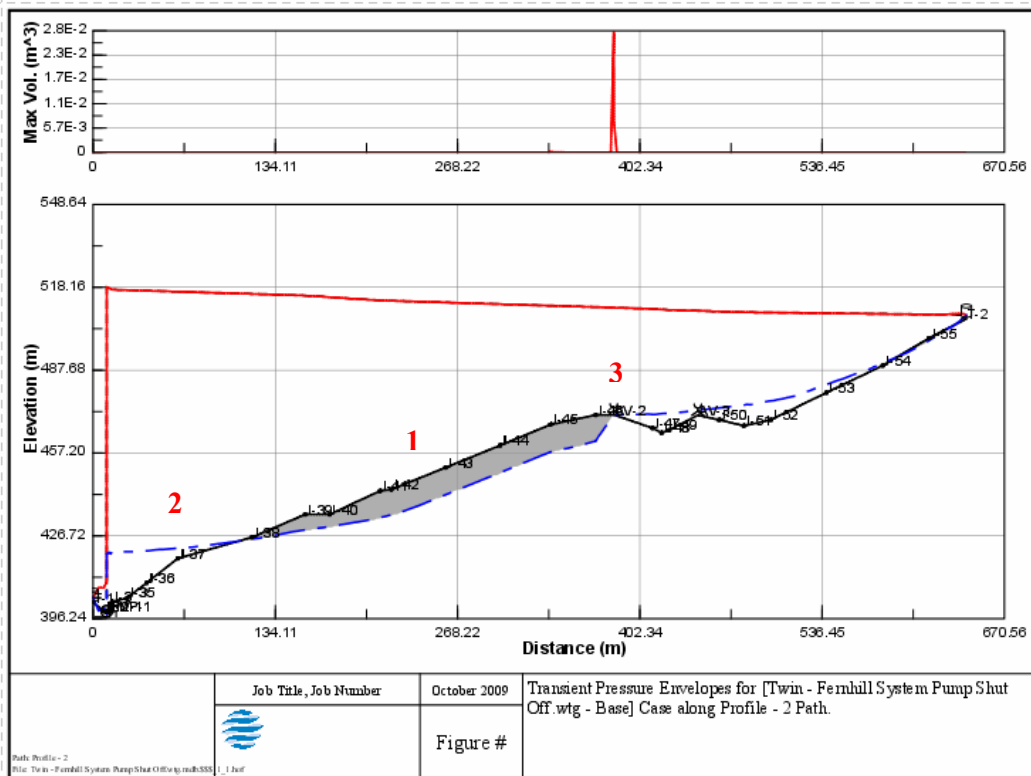
Figure 8: Surge analysis results for RM2

RM2 demonstrates significantly different results than RM1. Figure 8 shows that RM2 does not experience overpressure transient pressures (red line) higher than the hydraulic grade line (dashed black line). This is good as the operating pressures in this main are close to the pressure capacity of the uPVC class 12 pipe.

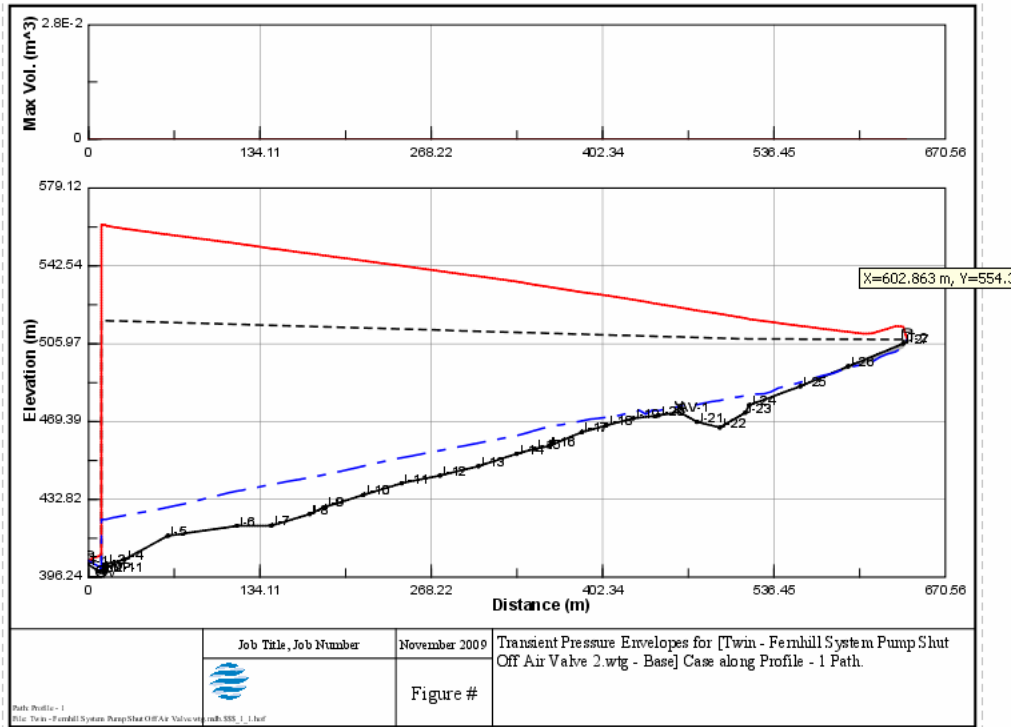
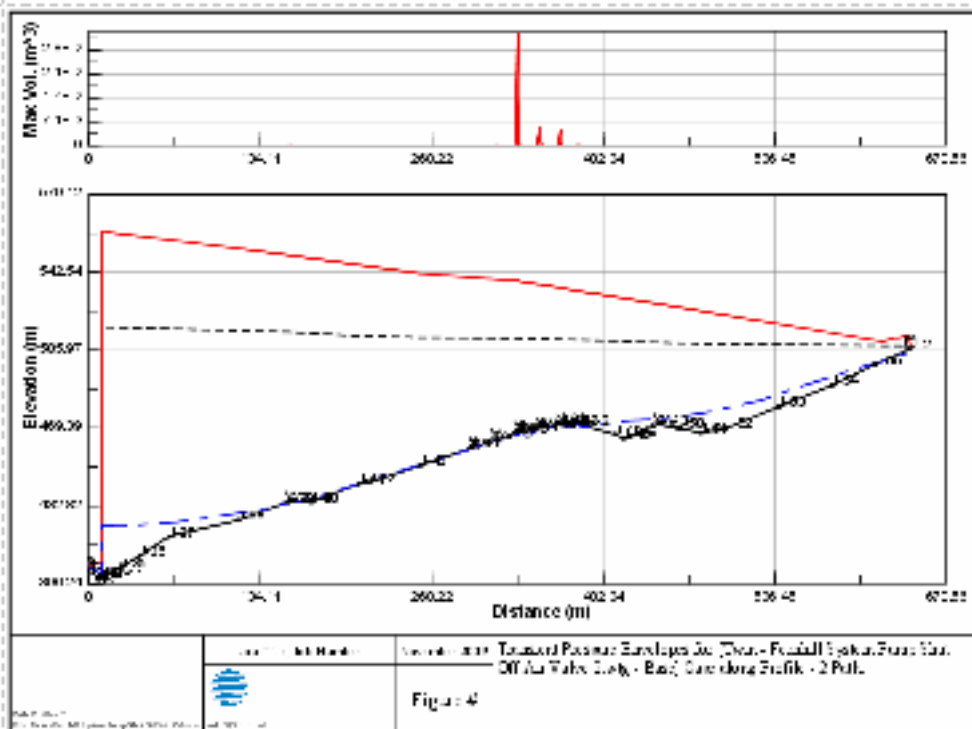
The resulting revised surge profiles with the above transient protection measures in place can be seen below in Figure 9 and Figure 10. Whilst these figures show an overpressure in the mains, this is an effect of the HAMMER modeling engine finishing the simulation and is not expected to happen in reality. The adjustment of the SAV settings will minimise this effect.

The results in Figure 9 and Figure 10 also show that there are still some slight negative pressures forming in RM2, in particular near chainage 317 and 350. Given that the HAMMER model is only an approximation, and that the material used in the construction of these sections of the rising main (uPVC class 12) is not well suited to these pressures and could be weakened by cyclic loading, it is considered a significant risk that the main in these areas could still collapse as a result of these pressures. Further mitigation measures to further reduce this risk are therefore required.

Transient protection is required for the Fernhill No.1 WPS – Fernhill No.2 Reservoir rising mains. The analysis recommended that this include the installation of approximately seven 80 mm double acting automatic air valves on RM2. The valves should be located at approximately chainage 140, 281, 299, 316, 318, 334 and 350 metres from the WPS. The air valves will prevent significant negative transient pressures in the rising main, therefore avoiding air/water column separation and potential pipe collapse.

The analysis also recommended that the SAV settings at the Fernhill No.1 WPS be checked and the valve opening time adjusted to between 2-5 minutes. This would allow sufficient time between a surge event and closure of the SAV to avoid the closure of the SAV to cause overpressure within the system.

In addition it was recommended that the pumps at the Fernhill No. 1 WPS be fitted with soft starters. This would mitigate the surge events in the system caused by pump start up and stop, therefore minimising the risk of a burst caused by surge. The soft starters should be set to allow the pump to ramp down slowly over approximately 2 minutes when powered, which should also allow the pump to spin to a stop over 5-10 seconds when power is lost to the WPS.

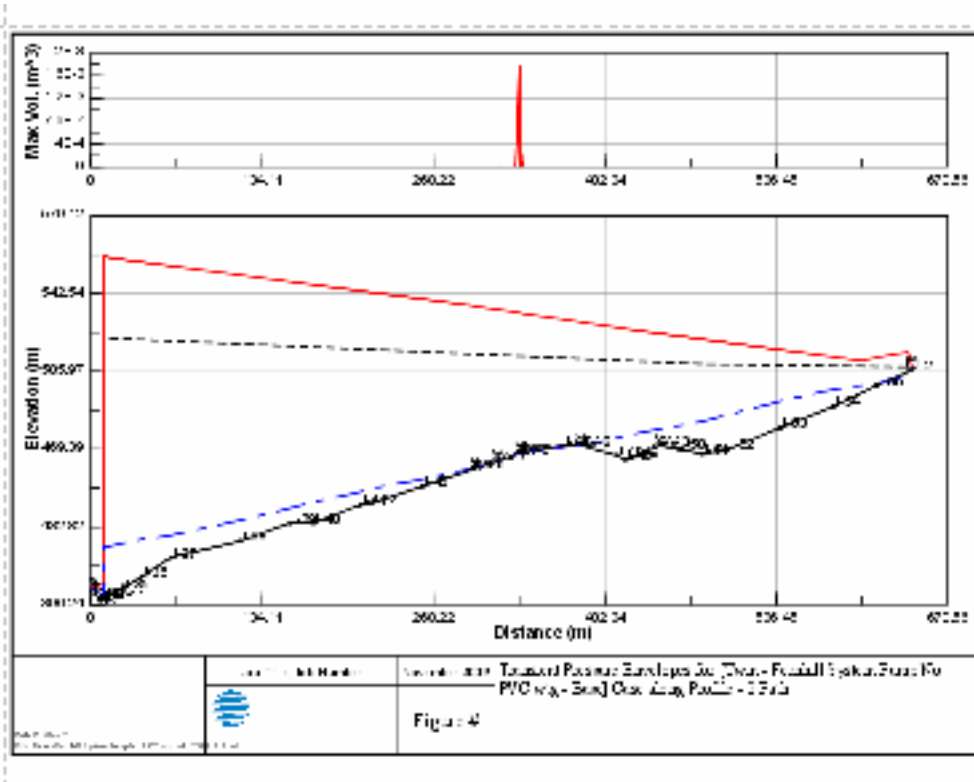
Figure 11: Surge profile for RM2 with steel pipe, 4 new air valves and soft starters.

As can be seen, this recommendation will raise the minimum transient pressure envelope along the entire pipe route, minimising the potential for negative surge pressures to form, and eliminating virtually all of the negative transient pressures. The improved ability of steel pipe to withstand these negative pressures is also important, as small inaccuracies in the HAMMER model may mean that negative pressures may still form in reality. The steel pipe material would be better suited to withstand these pressures should they form in a surge event.

The replacement of this uPVC class 12 pipe is also important in mitigating negative transient pressures and their effects. Replacement of this pipe with steel pipe, in conjunction with the installation of approximately four additional 80 mm automatic air valves at approximate chainages 281, 299, 316 and 318 metres will produce the surge profile shown in Figure 11.
