EARTHQUAKE EFFECTS ON THE KAIAPOI AND RANGIORA PVC-U PRESSURE PIPELINES

Author: John Black, Opus International Consultants

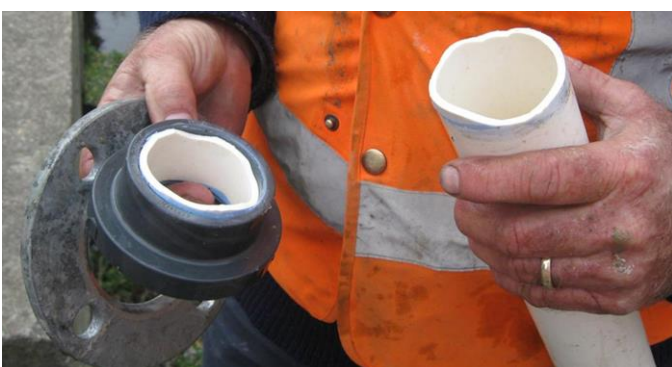
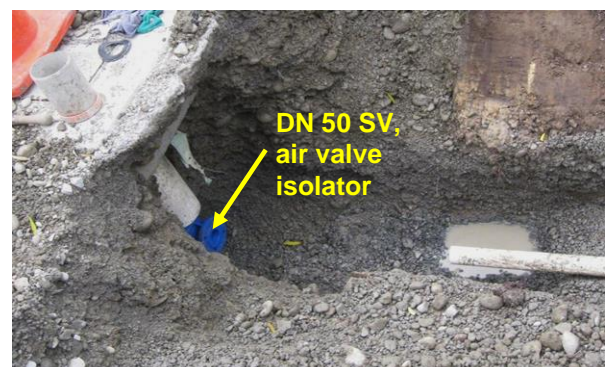
An attempt to pressurise the second section of pipeline on 9-May-2011 also indicated a leak. The leak was located at a solvent jointed stub flange on the offset pipe to the air valve at 7,700 metres, see Photograph-1. A successful test was achieved on 17-May after repairs to the fractured pipe.

Photograph-1: View of fractured pipe and stub flange and DN 50 valve – where the stub flange was connected (Opus site records)

This fracture of the DN 50 PN 12 PVC-U pipe was caused by the February 22, 2011 Christchurch earthquake.

These solvent jointed PVC air valve offset pipes were connected between two fixed points and as such there was limited flexibility. Any significant earth movement would be likely to cause fracture of the PVC-U pipe or solvent joint pull-out, however, only two of these offset pipes failed.

These failures could have been easily prevented had a compression joint been used at each end of the DN 50 PVC pipe.

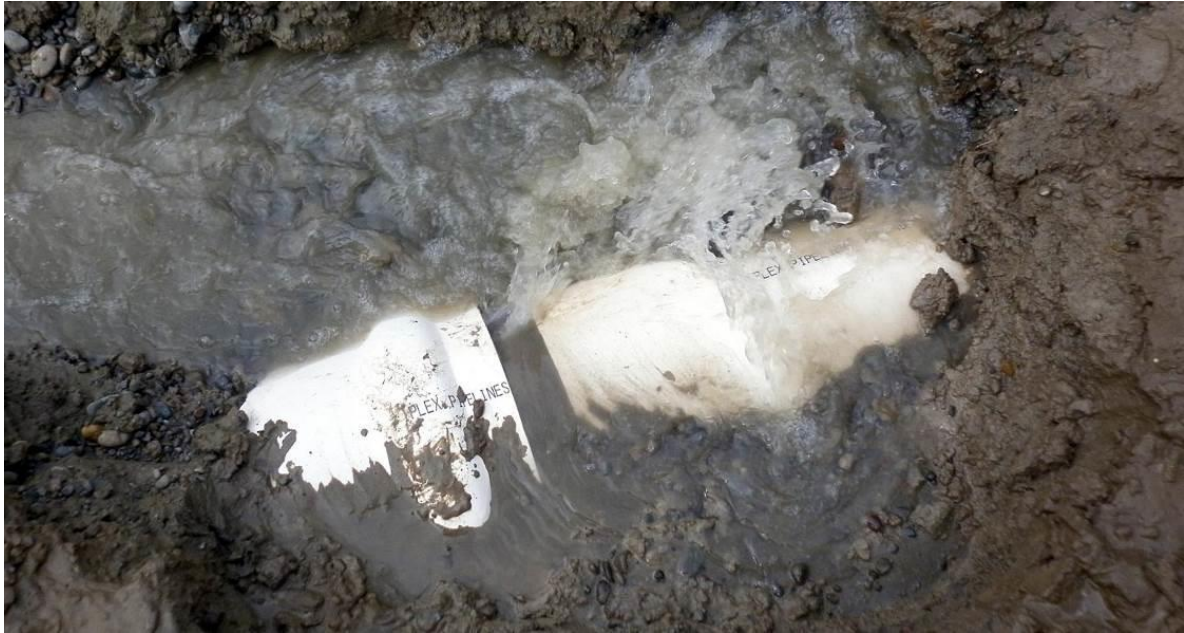
Sufficient joint pull-out occurred at one location to allow leakage (see Photograph-2). This was the only leak that occurred on this main. After the June 2011 earthquake, 90% of its length was inspected by CCTV to assess the amount of axial movement (joint pull-out) that had occurred at the pipe joints. The only un-inspected section was the flooded section of PE pipe under the river.

The CCTV survey (carried out after the leaking joint had been repaired) showed that a significant number of joints had pulled-out sufficiently (up to 130 mm) to make the risk of full disengagement unacceptable if further significant after-shocks occurred (ProjectMax report).

Photograph-2: View of the joint pull-out and leak that occurred as a result of the September 2010 earthquake (Photo - Gary Boot WDC)

For the most part, the DN 300 elastomeric ring jointed PVC pipes withstood the 2010 and 2011 earthquakes with negligible or acceptable joint pull-out. However, one joint disengaged sufficiently to leak (Photograph 2) and the joints along approximately 250 metres of the pipeline were considered to be at risk of pull-out if further earthquakes occurred (ProjectMax report). One particularly section in the vicinity of the Bowling Green was relocated further from the river. These at-risk sections were re-laid with funding from WDC's insurance.

The recommendation of the (ProjectMax) report was that a total of 250 metres of the pipeline where the joint pull-out was greater than 50 mm – 60 mm should be replaced, even though none of these joints were leaking. This recommendation was accepted by the WDC's insurers and new sections of PVC pipeline were installed with one section relocated further from the river.

Had the liquefaction and lateral spreading risks been recognised at the design stage, the susceptible areas could have been avoided, or if that was not possible, PE pipe could have been installed in those areas.

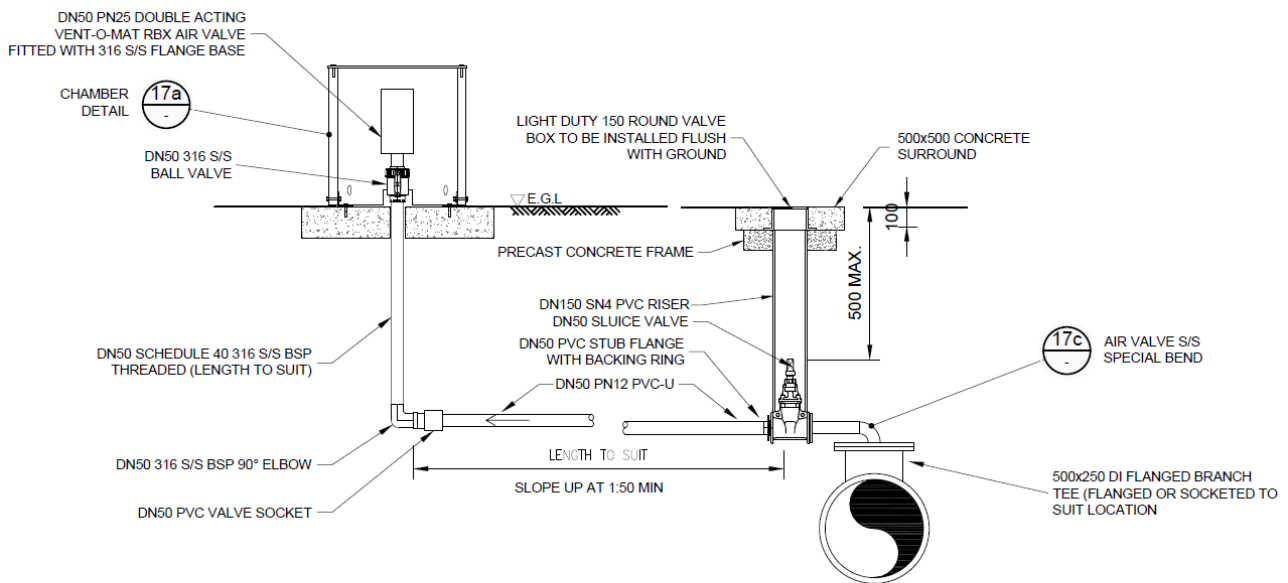
17 DN50 OFFSET AIR VALVE DETAIL (TYP.)
Scale: 1:20

Figure 1: Elevation of a typical offset air valve

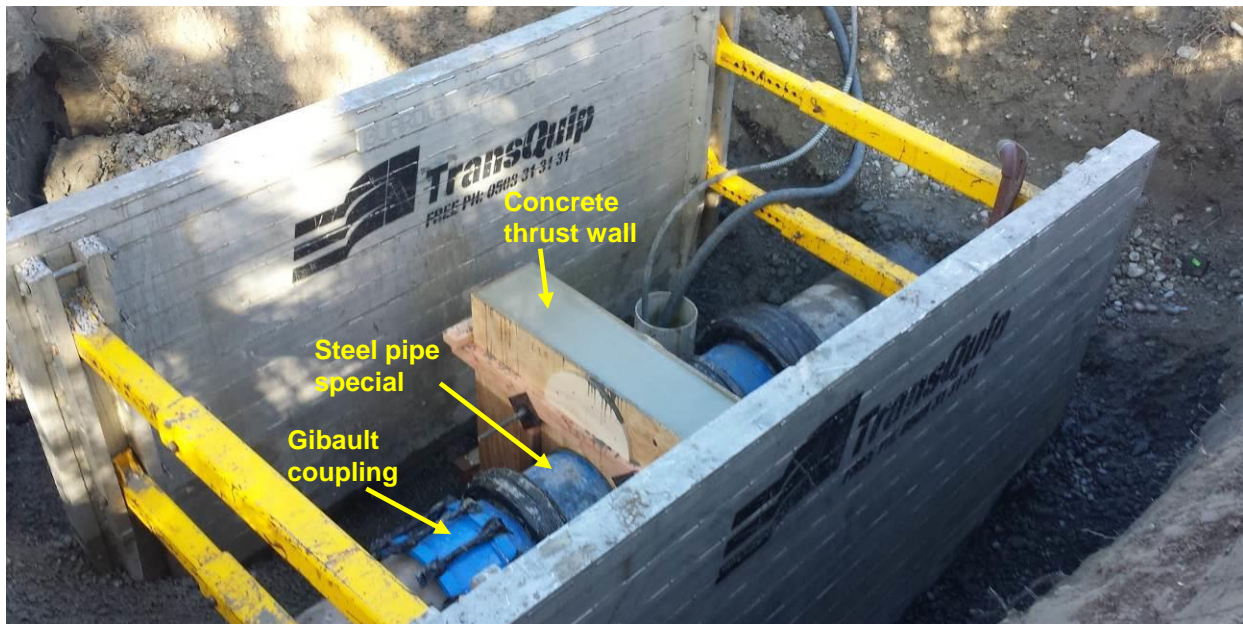
The DN 450 elastomeric ring jointed PVC pipes withstood the 2010 and 2011 earthquakes without any damage or joint leakage. The only leak that developed was at the gibault joint connection between the DN 450 PVC-U pipe and the DN 500 PE pipe that was directionally drilled under the main trunk railway line.

Photograph 3: View of The coated steel special, concrete thrust wall and gibault type coupler (Photo Rob Frizzell WDC)

The repair works included a coated steel pipe special with a puddle flange and concrete thrust wall to prevent the PE pipe from moving. Photograph 3 shows the steel special, thrust wall and the gibault type coupler used to connect the PVC pipe to the steel special.

This leak could have been prevented if an end-load bearing coupler had been used, or preferably, a thrust wall had been constructed when the pipeline was installed.
