DG43B – A PAIN IN THE ASSET

Jeremy Boxall (City Care Ltd) and Hugh Blake-Manson (City Care Ltd)

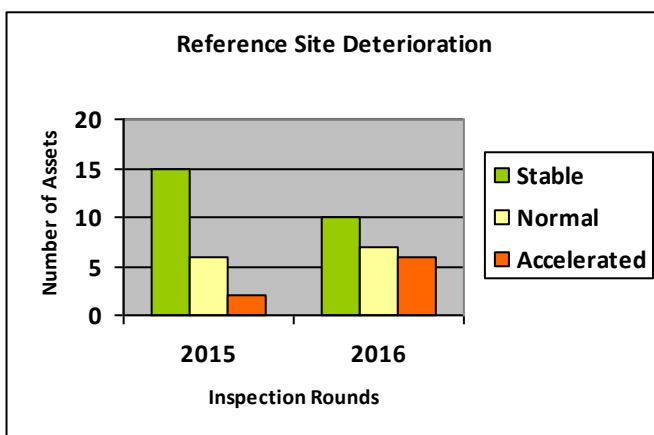
Figure 4 – Distribution of Wastewater Reference Sites across Christchurch

Some badly broken assets were over 100m in length and this analysis made it significantly easier to assess the assets on a no change or change basis. Figure 4 details the overall deterioration of the reference sites from 2011-2016. It shows that although some badly damaged assets are in stable condition, an increasing amount present accelerated deterioration.

- **Stable:** little to no change regardless of the level of damage in the asset.
- **Normal:** Attenuation of current damage throughout asset, steady development of structural defects, new defects are only minor severity
- **Accelerated:** Fast development of defects (crack to broken section), new defects can be major severity

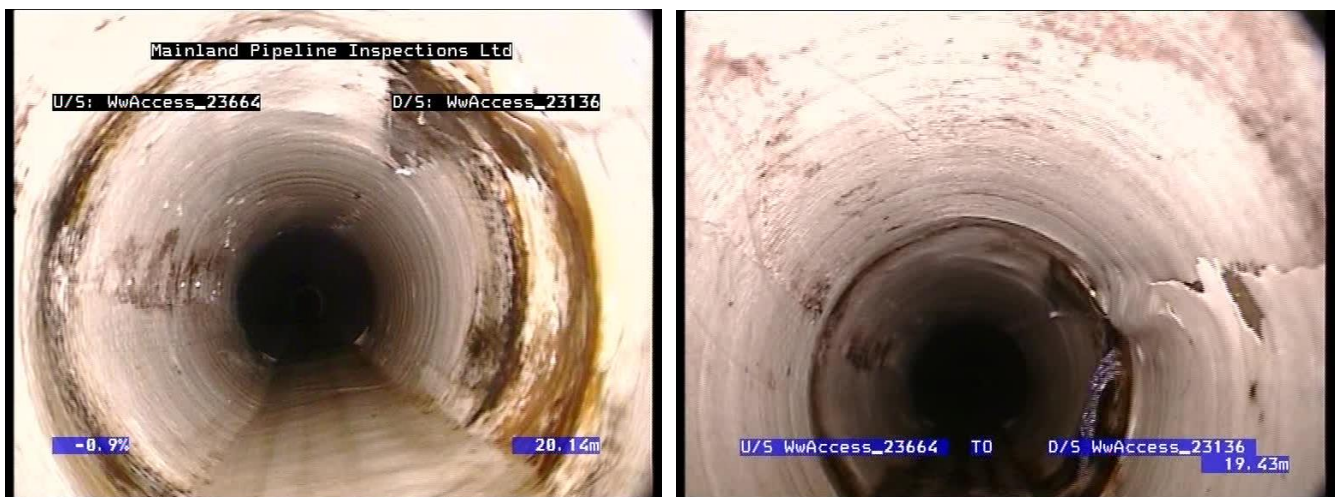
Figure 5 – 2015 CCTV Survey (left), 2016 CCTV Survey (right)

The indicators for the rate at which these developments occur can be a good prediction tool. Staining around cracks is evidence that the crack has extended through the pipe wall which often occurs just before broken sections are formed. Thick roots are evidence that they may already have been cut and can grow for several meters (small repair patches are a poor choice of repair). These failure modes would indicate that ground conditions and detailing issues are more prevalent than material deficiencies. Figure 5 is an example of a poor choice of repair as the rate of deterioration was underestimated. In the first photo a patch liner was applied to a section of pipe with large multiple cracking. The color of the liner shows major staining in the cracking behind it suggesting that broken sections had already developed through the full thickness of the pipe. The second photo on the right confirms this as the pipe behind the liner has deformed further and severe infiltration is occurring where the liner has teared.
