HASTINGS WASTEWATER OUTFALL MAXIMUM LIFE VS MINIMUM SPEND

WA Hodson (MWH Global)

ABSTRACT

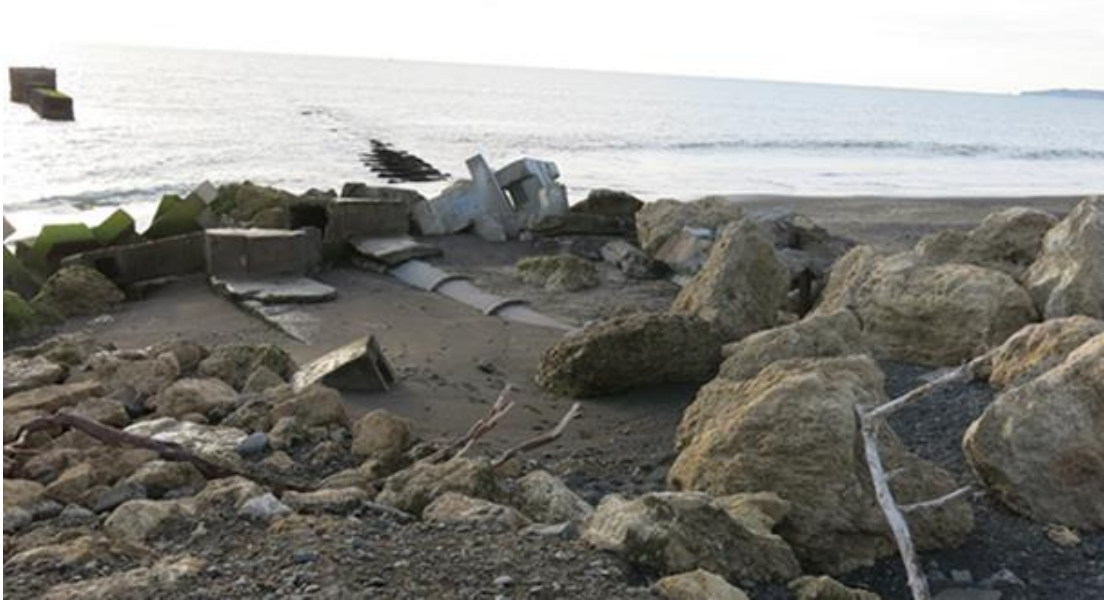
Photograph 1: Beach and Short Outfall – Damaged in recent storms

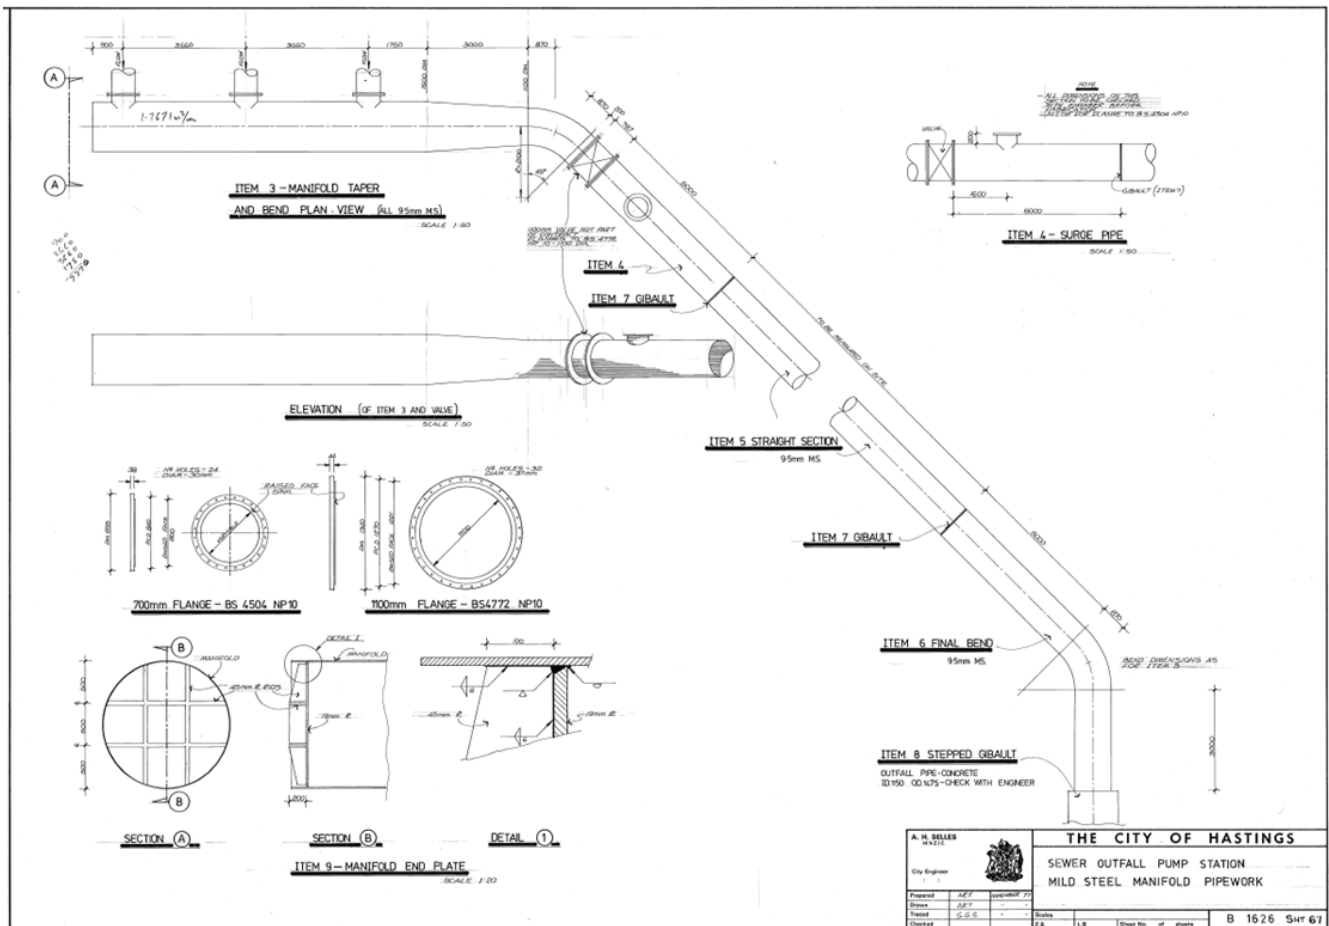
Figure 2: Manifold Pipework Detail

The manifold has required several repairs since commissioning:

- 1992 a leak in the base of the manifold required emergency repair by plugging with steel wedge, welding in place, grinding off then welding a steel plate over. Measurements of the steel using an ultrasonic thickness meter indicated that the steel thickness was between 7.4 and 8.4mm.

- b) 2005 a leak was found in the stepped gibault coupler between the steel and concrete sections. This was repaired by welding and then encasement with concrete.
- c) 2006 a leak was found in the soffit of the upstream end of the 1500mm diameter manifold and it was found that the steel at that point was very thin due to internal corrosion. The thickness, measured using ultrasonic measurement, was between 3.0 and 6.0mm in several top sections and between 8.0 and 10.0mm on the side sections.

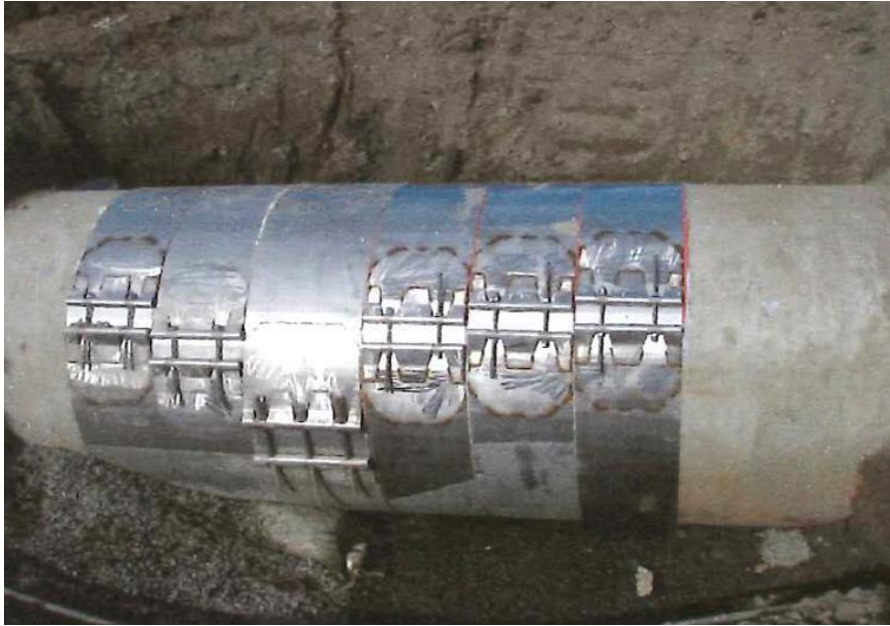
Photograph 2: Concrete Pipe Repair Bands

The land based section of the concrete pipe has also suffered some internal corrosion damage to the soffit and joints. A leak was discovered from this pipe in July 2007 from the top of the pipe at a joint. A short longitudinal crack was also found on the crown of the pipe at the 12 metre point, and when a core section was taken the thickness of the core confirmed that the soffit of the pipe was severely corroded.

Repairs to the cracked section of the pipe were carried out in 2007 by placing custom made large stainless steel straps over a linotex rubber underlay, refer to Photograph 2 below.

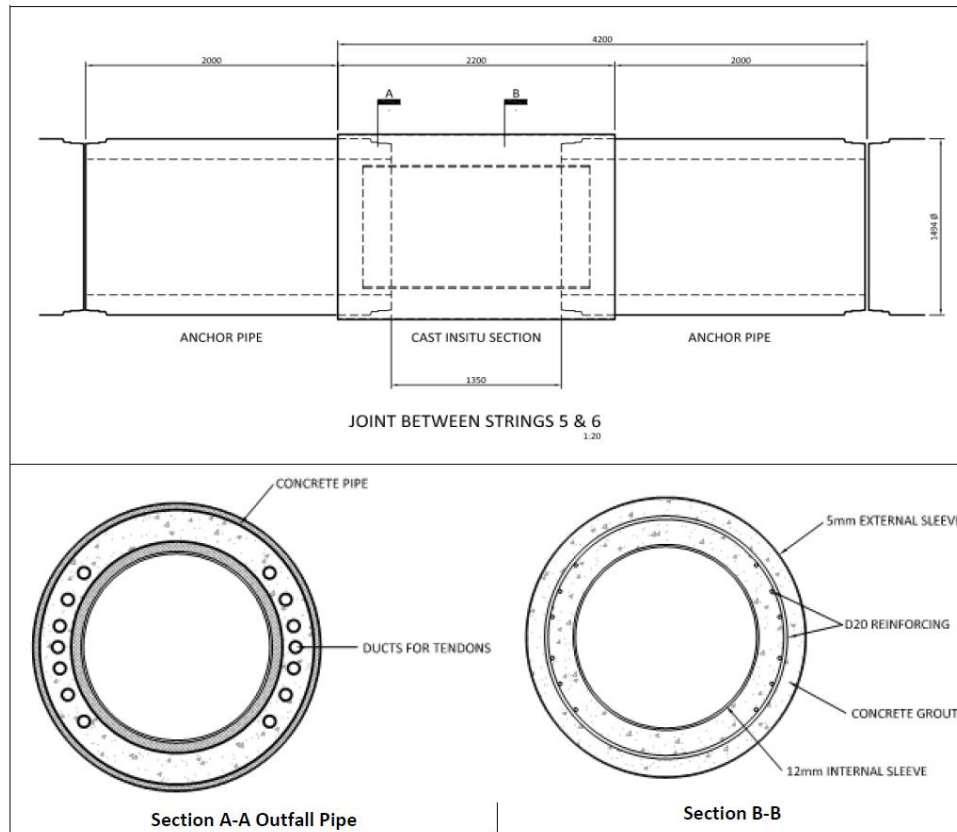
Figure 4: Joint Between Post Tensioned Pipe Strings

At least one joint (between pipe strings) has failed since the commissioning of the long outfall. This was reportedly discovered by a diver during preparations for some dye testing on the outfall. It was not confirmed which joint this was, but the repair methodology was reportedly by concrete encasement.

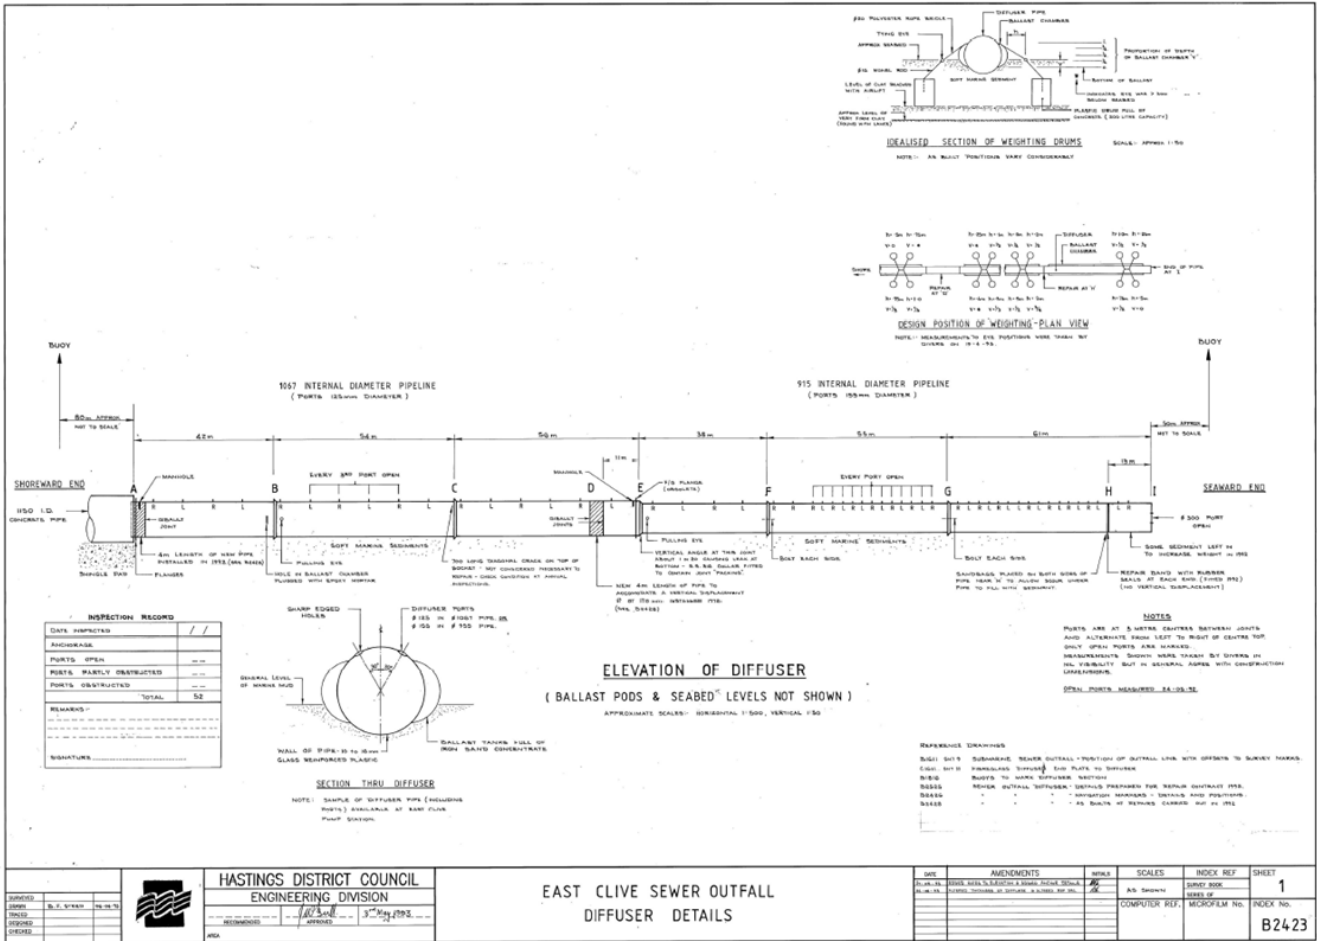
Figure 5: Fibreglass Diffuser Detail Including 1992 Repairs

Construction details from repairs made in 1992 and 1995 include repairs to two joints and repairs to two breaks in the diffuser pipe. One of the breaks had a vertical displacement of greater than 150mm.

The diffusers are condition surveyed by divers on an annual basis. The 2012 survey noted that several sections of the pipeline are showing changes to the surface texture. There was also leakage at some pipe joints, with scour that was repaired with sandbags. The report noted that it is “difficult to quantify the amount or existence of any degradation in the seabed conditions and water column visibility”, with the inspections based on touch.

The overall impression from the reports is that the diffuser section is reaching the end of its design life and the divers have noted signs of significant wear during their more recent inspections. A GPS survey has concluded that the diffuser section alignment was not in a straight line as designed. The 2012 inspection recommendation was that pipeline replacement should be considered as considerable realignment and remedial work would be required to correct the existing leakage problem.

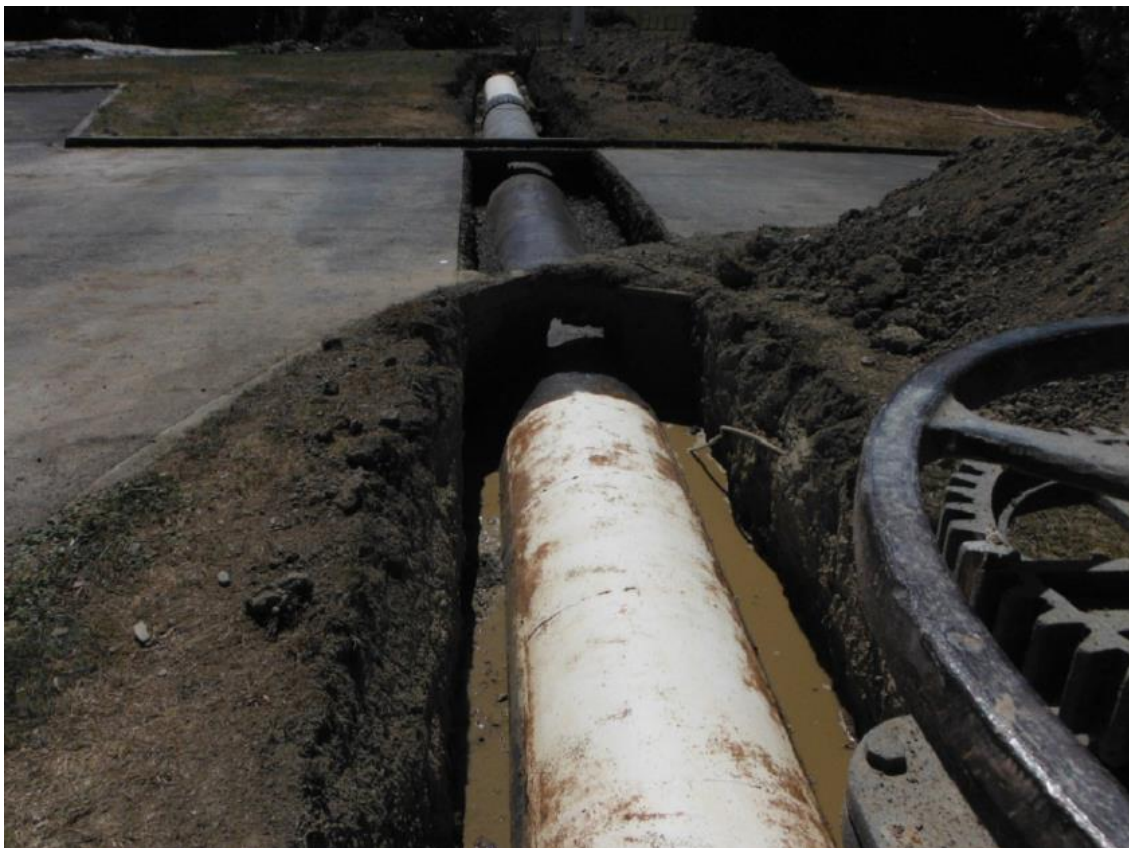
Photograph 3: Exposed Steel Pipeline

SGS were commissioned to undertake the ultrasonic thickness inspection. The survey was not able to distinguish between the 2006 installed 8mm cover steel plate and the underlying original pipe. The only conclusion that could be drawn was that the full thickness of the 2006 repairs was still intact. One of the 1 metre long repair plates on the 1500mm manifold was 10mm thickness. It is presumed that this plate was placed over the section of manifold that was cut out in the 2006 repairs. A small area around the 3" air relief stub pipe was found to have significant loss of pipe thickness, down to 3.8mm at the lowest point.

During the excavation the air relief valve by the pump station building was found to be leaking. This valve was removed and replaced. Two small leaks through the 2006 repair plates were found at the north end of the 1500mm manifold section and repaired.

Rolled steel plate held on site was welded around the air release pipe. A steel plate was also welded to the crown of the pipe under the road, where a localized area of corrosion down to 7.7mm was found. Although the remaining steel was considered satisfactory the patch was provided for added strength.

The minimal deterioration observed in the six years since the previous repairs were made suggests that with ongoing maintenance the steel manifold should have a remaining life in the order of 20 years.

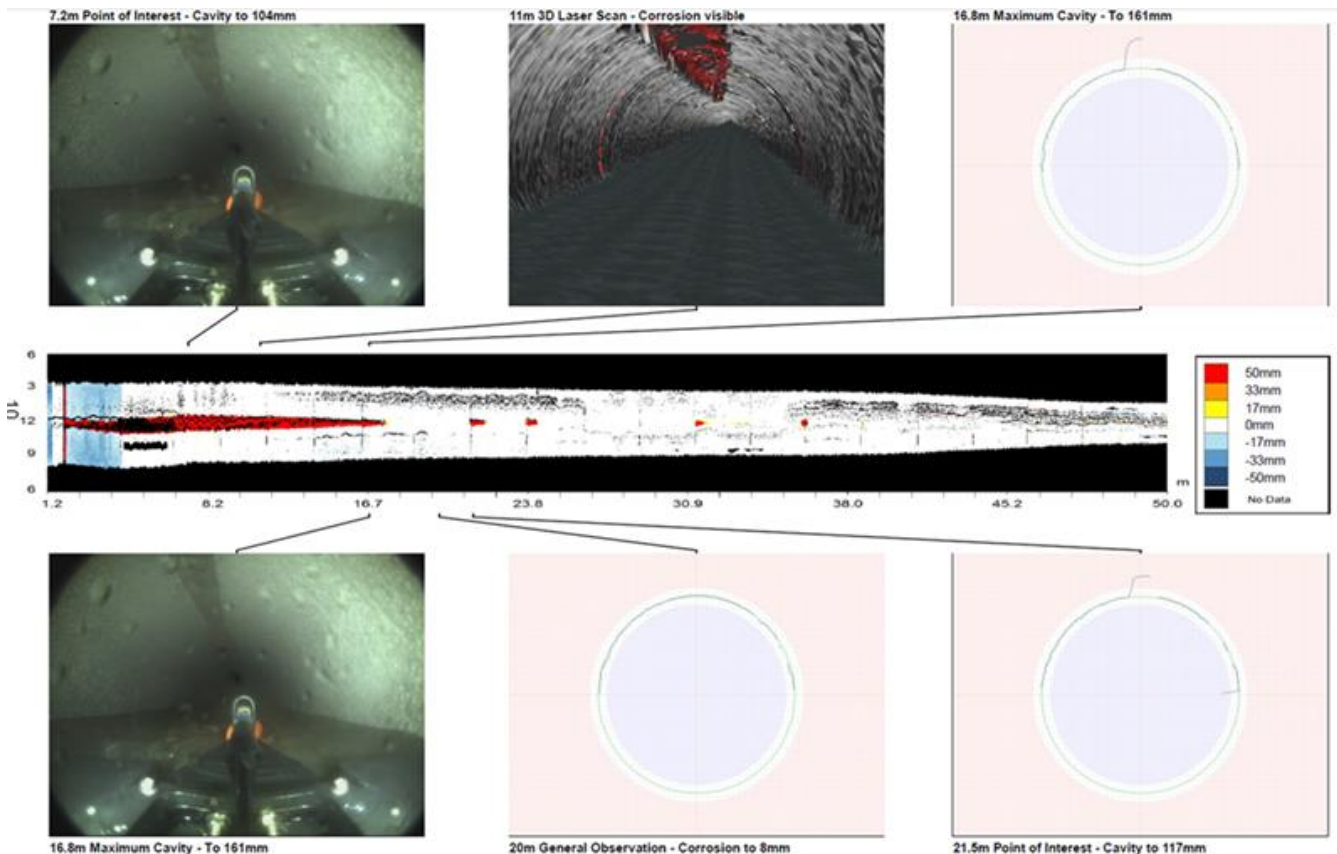
Figure 6: Extract from Laser Profiling report

A laser profile was obtained in November 2013 to a 50m distance, at which stage the water level was too high to record. An extract from the laser profile report is shown in Figure 6 below. In summary, the inspection showed the first five pipe lengths had corrosion along the entire soffit and the sixth, eighth; ninth, twelfth and fourteenth pipes had at least 50mm corrosion at the upstream end. The depth of corrosion was reported as up to 161mm in the concrete pipes which have a maximum wall thickness of 174mm and minimum wall thickness of 133mm at the joints.

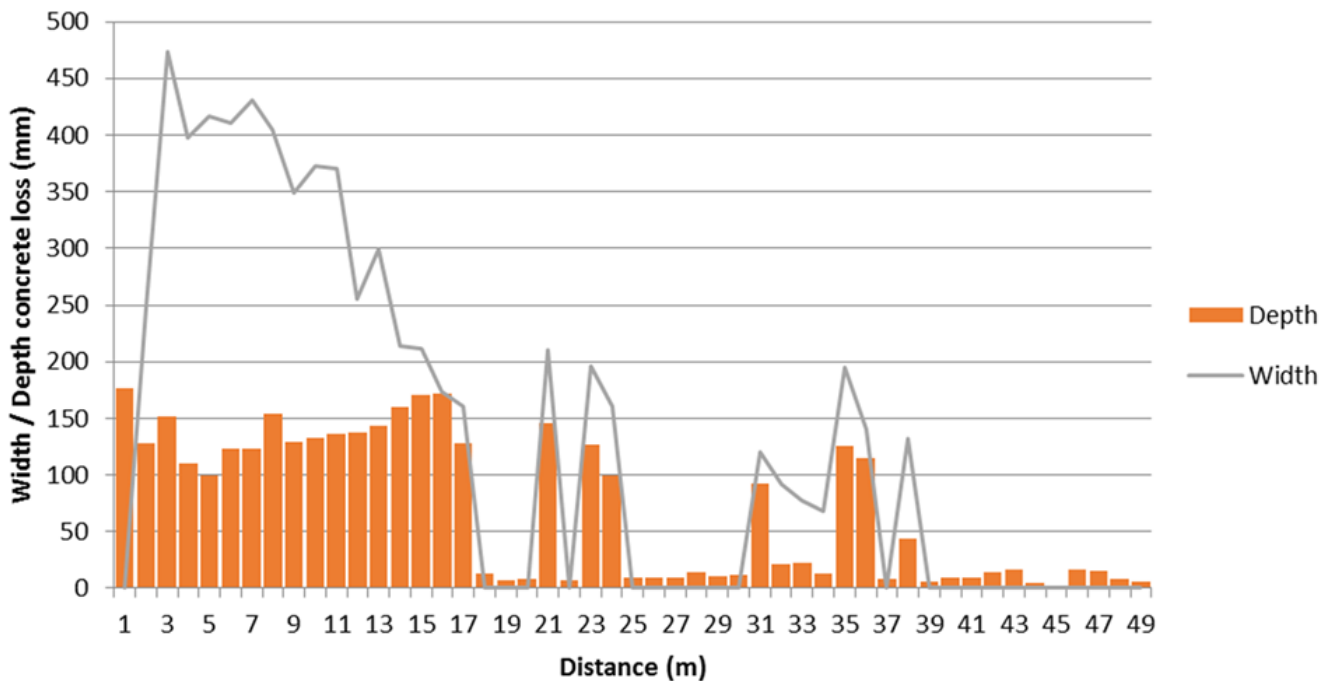
Figure 7: Width and depth of pipe wall loss (13 November 2013)

The laser profiling indicates that significant corrosion has continued to occur in the soffit of the intermittently full pipeline section since 2007. It appears that corrosion is initiated in joint areas where hydrogen sulphide can accumulate and be trapped allows for biofilm growth, creating a “corrosion slot” that continues to widen and extend along the length over time. Velocities at normal pumped rates are not high enough to limit the biofilm growth and corrosion can continue with the intermittent full pipe conditions.

Additional repairs were required urgently as additional failures could be expected with corrosion to full wall thickness for at least 20m of the pipe. Refer to Section 5 for details of the options considered and the works constructed.

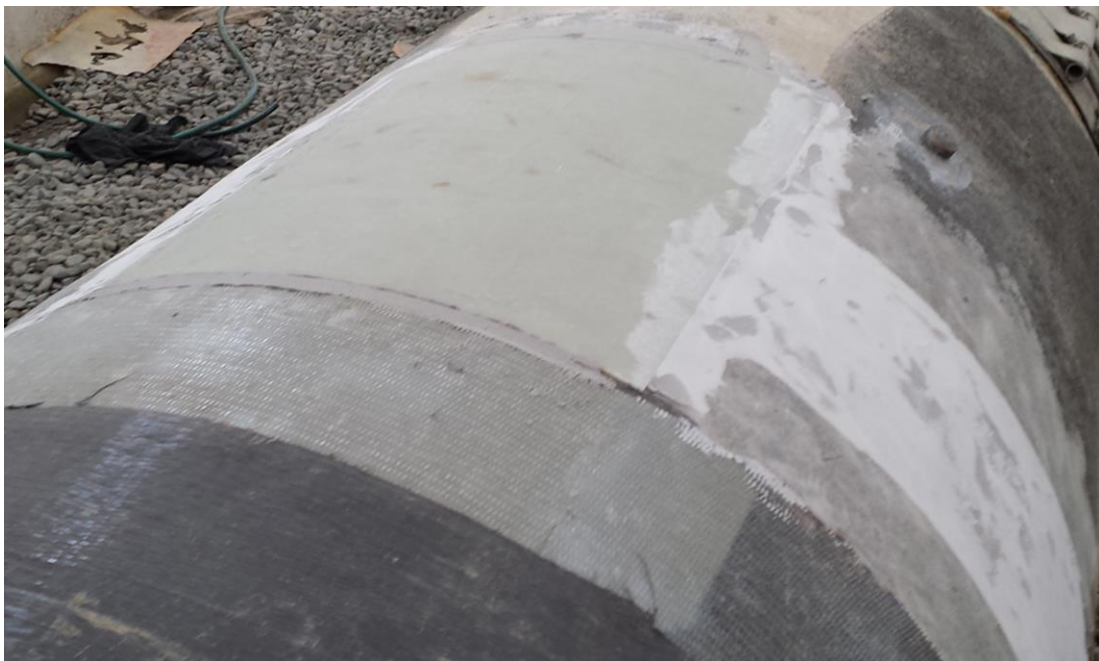
Photograph 5: GRP patch in area of “breakthrough” Corrosion at a Pipe Joint

In the area of the existing stainless steel bands, installed in 2007, there were areas of breakthrough corrosion of the concrete wall to the surface. These required additional repair stages during low level periods to install preformed GRP patches shaped to the diameter of the pipe that were adhered with Sikdur 31 CF and the bands reattached whilst the repair cured. Refer to Photograph 5 below.

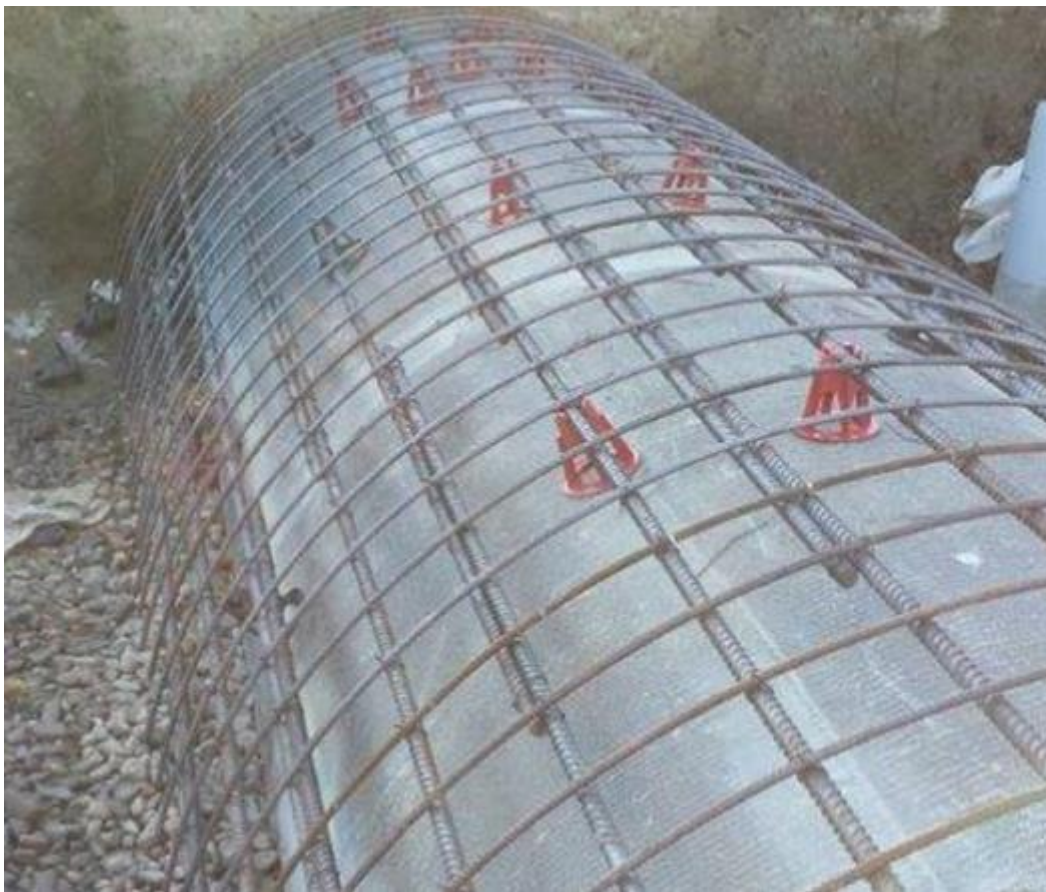
Photograph 6: Repaired pipe with FRP wrap and Steel Reinforcing Prior to Spray Concrete

The design wrap layers were then able to be installed over top to create a continuous repair over a length of approximately 40m. Refer to Photographs 6 and 7.
