# SBR RETROFIT AFTER MIDWINTER LINER RUPTURE

*Diana Kim, Craig Mountfort and Azam Khan  
Pattle Delamore Partners Limited (PDP), Auckland, New Zealand*

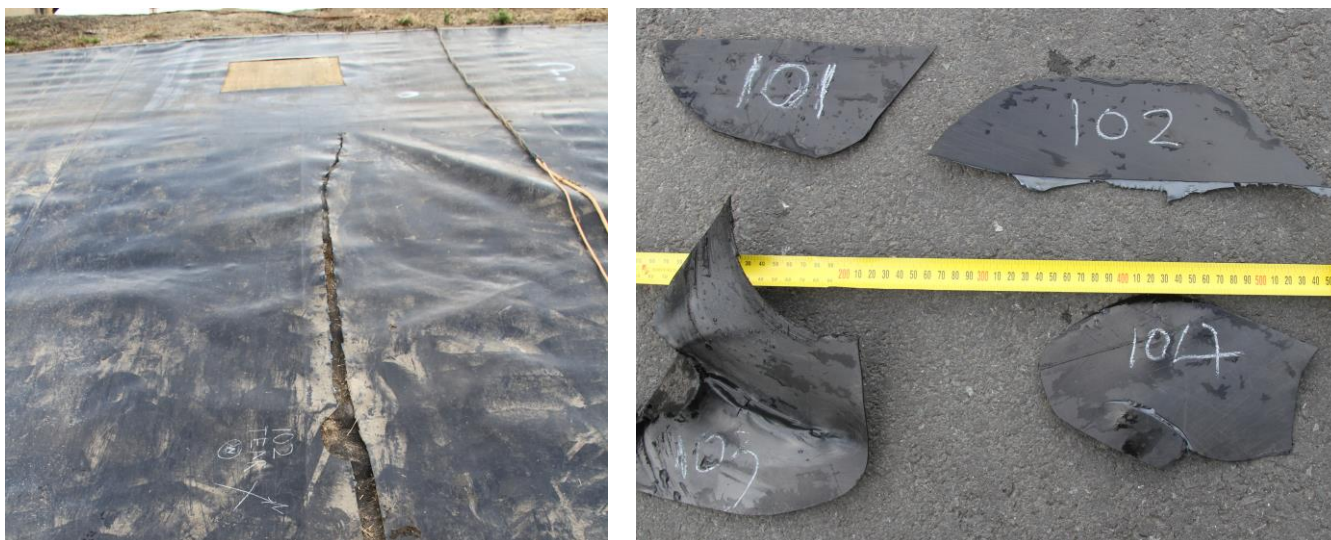
weld locations and the progression of failure continued for around 15 metres (lineal length) up the internal wall. This failure certainly raised the doubt on the reliability of the remaining seam welds.

An independent laboratory testing of the liner was initiated and two pieces of liner were cut from the SBR. One of these pieces was the exposed area above the top water level and the other piece was from an area that was always submerged. The testing was undertaken for stress crack resistance for geomembranes (ASTM D 5397), oxidative induction time (OIT) (ASTM D 3895) and high pressure oxidative induction time (HPOIT) (ASTM D 5885). While the test results showed that the liner had good stress crack resistance, the low OIT and HPOIT values (as shown in Table 1) showed that the anti-oxidant properties had been substantially depleted indicating that the HDPE membrane was at the end of its serviceable life.

It has been noted that the service life of HDPE membranes is essentially determined by the slow loss of stabilisers due to migration (Rowe *et al*, 2003). The oxidation starts only after the depletion of antioxidants and then quickly leads to brittleness of the membrane. It is generally accepted that oxidative degradation of HDPE geomembranes is not a relevant factor with regard to normal geotechnical applications, in which service lives of around 30–50 years are expected and repair work is possible (Mueller & Jakob, 2003). However, the OIT values for the exposed above top water line sample was very low, showing that a large amount of sunlight related oxidation had occurred over the years and that antioxidants were almost completely consumed. This could have resulted in the liner being brittle and unreliable for continued service after repair.

The liner tear and the area of liner utilised for testing is shown in Photograph 1. The mechanical damage could be seen in the sections cut from the liner. Given that the stress crack resistance was still high, the tear shows the enormous amount of stresses put on the liner where a mechanical score line was present that propagated the failure.

*Photographs 1 & 2: Liner showing tear line, detailed damage of various areas and testing area*

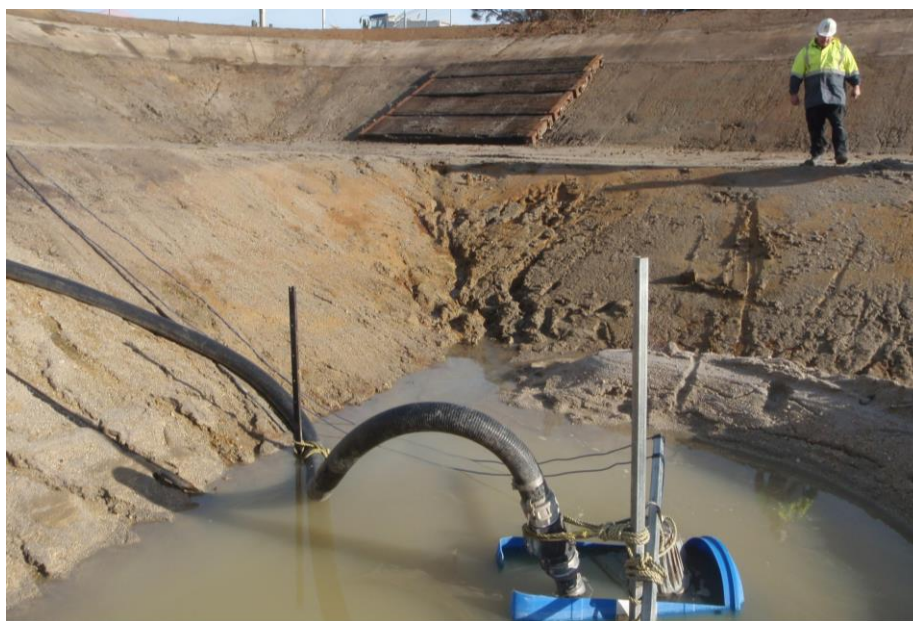
The wet weather conditions generated increased groundwater inflow into the empty lagoon and in some cases soft spots formed in areas with increased permeability. A slight gradient across the lagoon base allowed for pooling in the lowest northwest corner of the lagoon. A submersible pump was operated via a duckfoot float system to automatically dewater the lagoon. However, due to shifting sands from the original subgrade the temporary wet well regularly became inundated requiring continual maintenance and manual operation of the pump to remove accumulated groundwater.

*Photograph 3: Dewatering pump working in the low corner of the lagoon base*

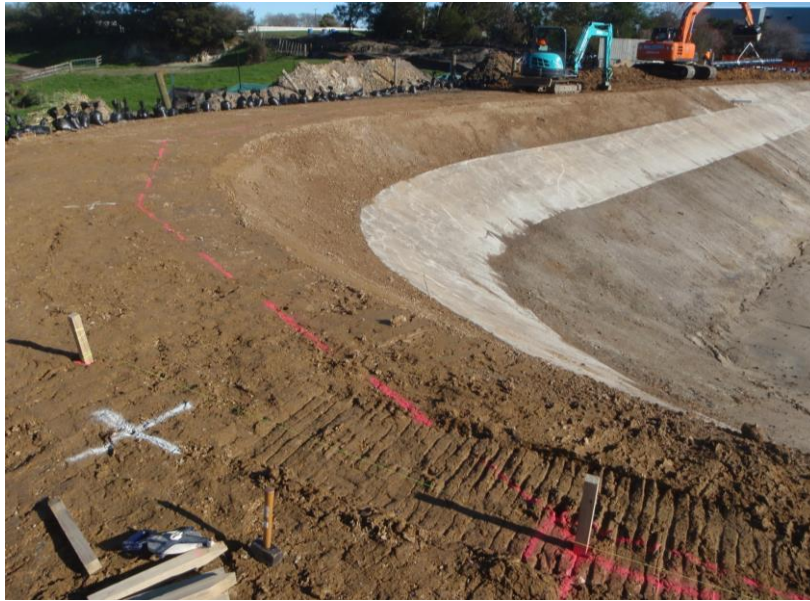
The anchor trench was designed to be 500 mm from the crest of the embankment. The photograph below shows the design co-ordinates (white crosses) and onsite mark-up (pink dashed lines) of the start of the anchor trench. The design had been based on a survey completed at the beginning of the project and embankment levels had changed somewhat significantly after that.

It was decided on site that some parts of the lagoon would have a greater separation distance than 500 mm between the crest and the start of the anchor trench. These parts were particularly soft after multiple rain events. Some parts were also stripped more than other parts to dispose of unsuitable material and were filled with clay. The increased separation distance between the anchor trench and internal slope was employed to increase the soil shear strength and ensure that this critical part of the embankment would not slump after the installation was complete.

*Photograph 4: Difference between the anchor trench design done in-house and on site*

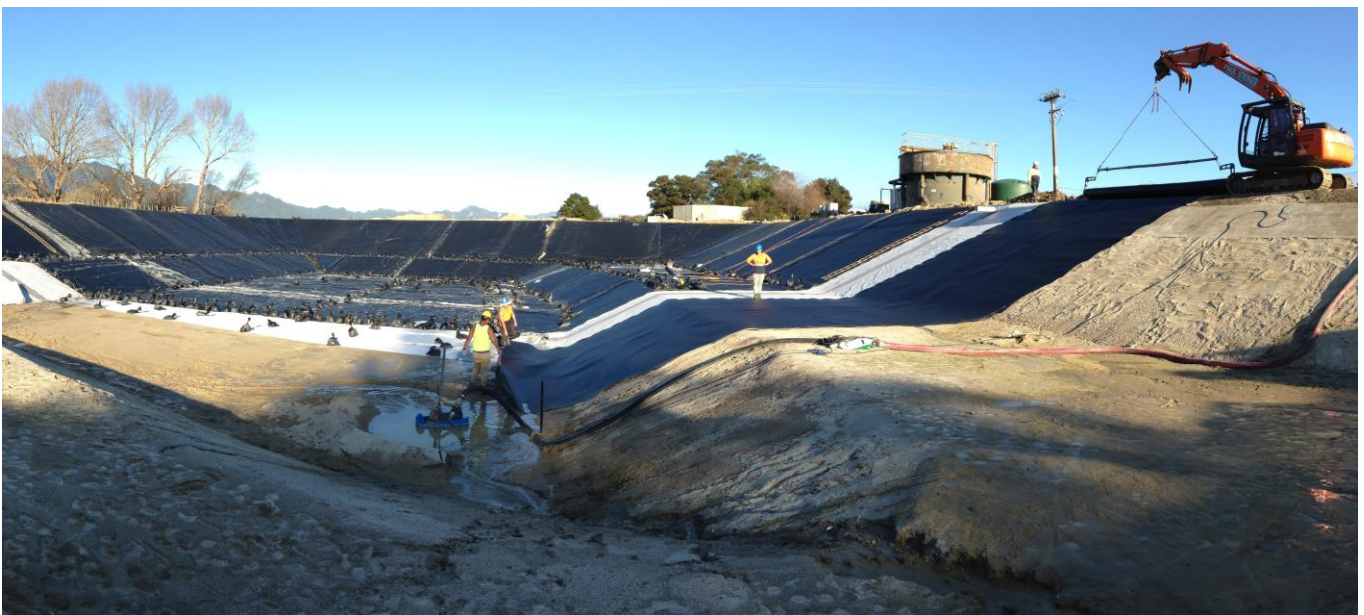
*Photograph 5: Relining of the SBR underway*

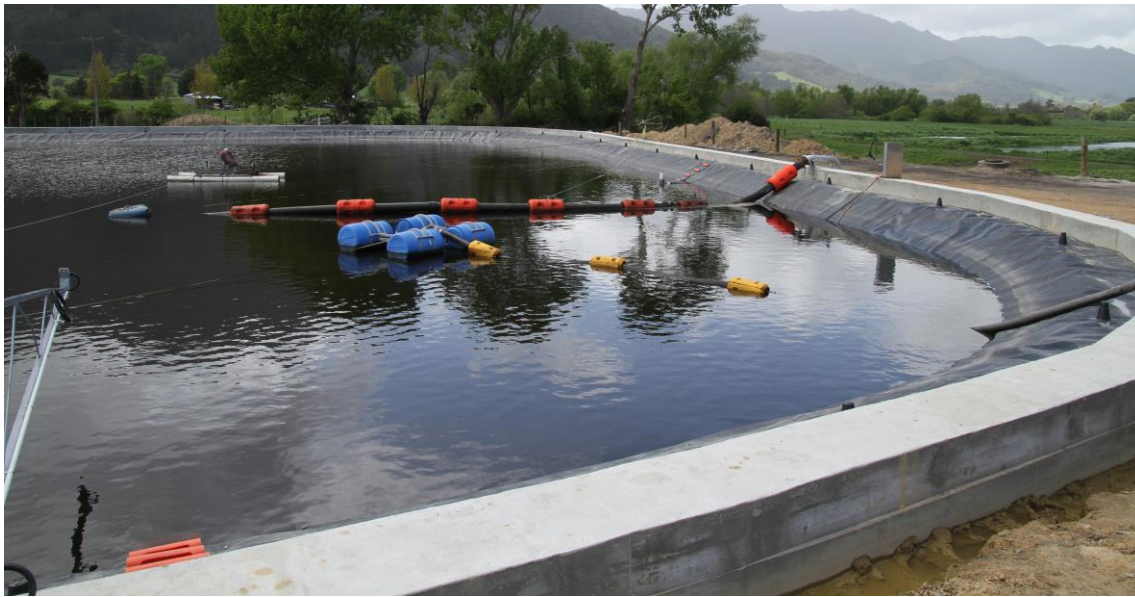
The completed anchor trench works and the aerators placement, with decant pump and outlet pipes are shown in Photograph 6.

*Photograph 6: Completed Relined SBR in Normal Operation*
