# MANAGING THE INTERFACE WITH NATURAL SYSTEMS

## ABSTRACT

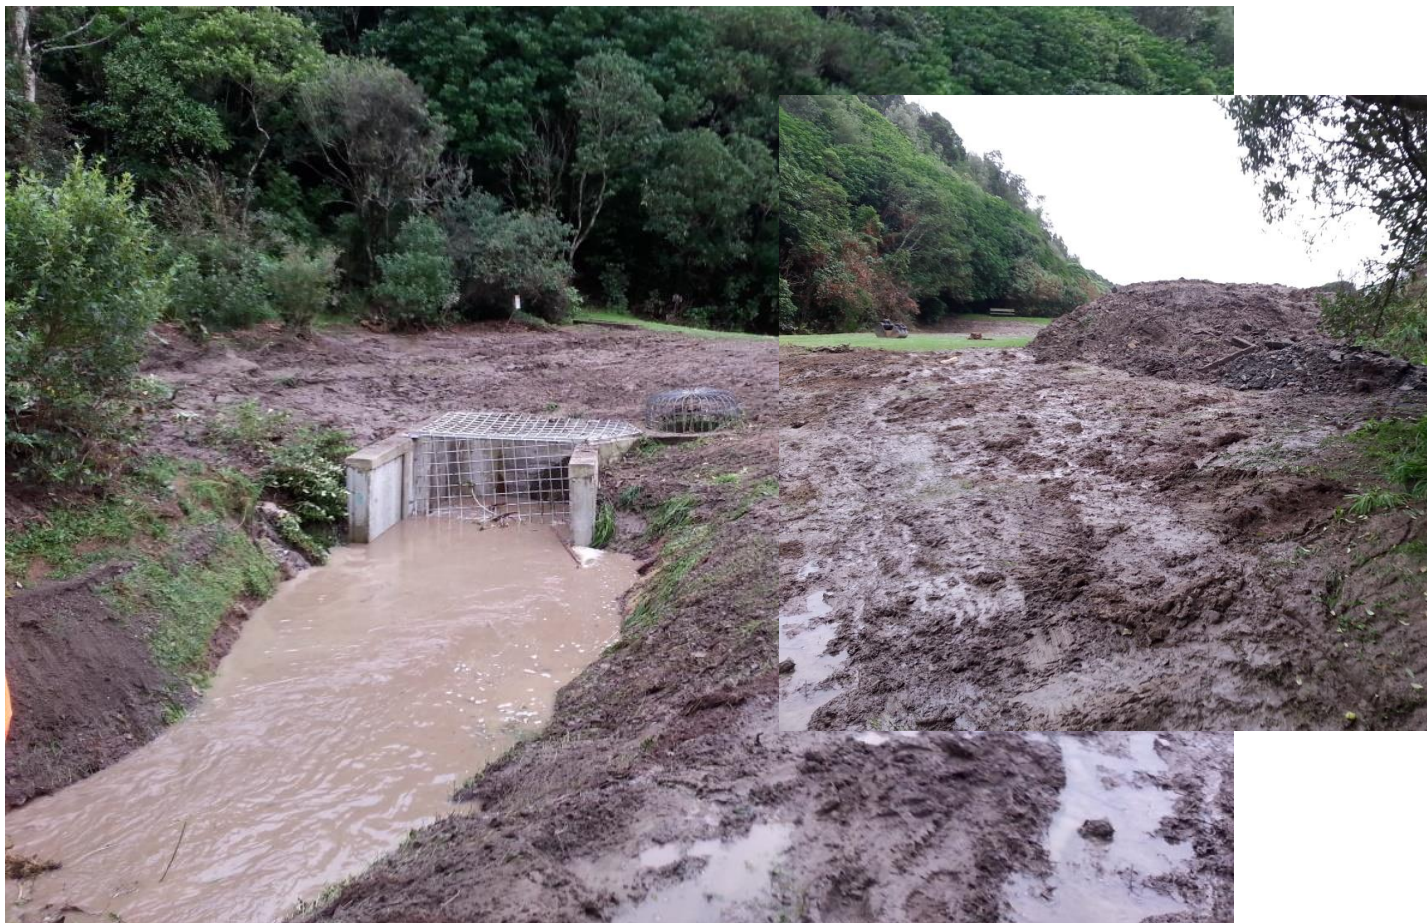
The Takapuwahia Stream catchment is within the zone of the highest rainfall intensity and was significantly affected by this event. The volume of flow and debris overwhelmed the inlet structure at the upstream end of Porirua Scenic Reserve (see Figure 6) and flood waters then tracked overland before flowing through gardens and garages on Rangituhi Crescent (see Figure 7).

*Figure 6 - Inlet structure upstream end of Rangituhi stormwater network*

Emergency works were undertaken to redirect the channel back into its existing course at the downstream end of Rangituhi Park as well as clearance of the debris blocking the inlets at the upstream end of Porirua Scenic Reserve. During a post event site inspection an option for improving the upstream end of the overflow path in the Porirua Scenic reserve with an increased bund protecting the adjacent properties was discussed. This would need to be combined with regrading of the road adjacent to Rangituhi Park to allow secondary flow into the park via an engineered spillway rather than through neighbouring properties. There could also be an opportunity to use the park as a temporary detention dam for extreme events to reduce downstream flows.

Investigation and a resource consent application is currently being sought for a sediment trap upstream of the culvert inlet to ensure that the piped system can be utilised rather than effectively being “empty” due to a blocked inlet and total upstream flow being conveyed by secondary flow paths.

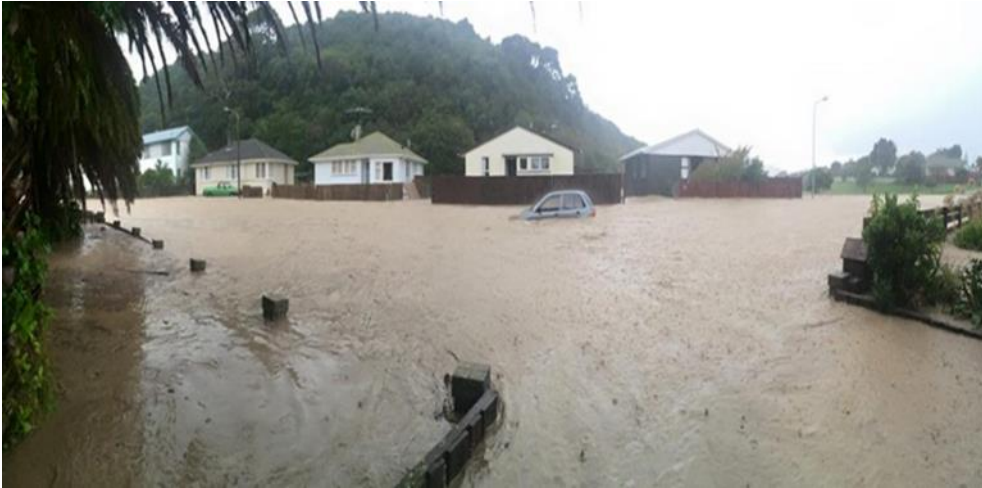
Figure 7 - Rangituhi Crescent adjacent to Rangituhi Park near peak of event

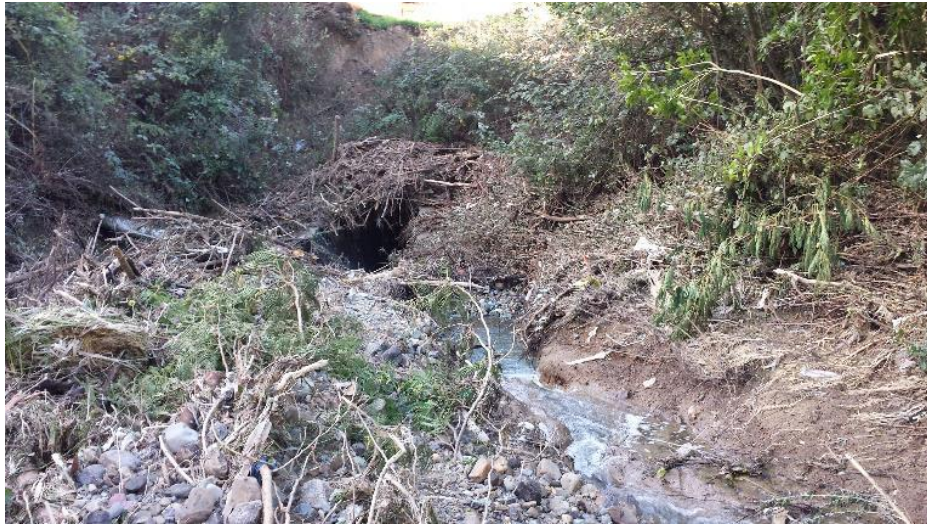
Mitchell Stream was also significantly affected during the event with a large volume of water and debris (see Figure 8) flowing down the stream and causing the Raiha Street culvert to block. This blockage resulted in water building up on the upstream side of the structure and then flowing through the road embankment fill. The water flowing through the road embankment fill washed out the finer material resulting in slumping of the road (see Figure 9) and erosion around the culvert trench at the downstream end (see Figure 10). This failure mechanism is known as “piping” and is more commonly encountered in embankment dam situations. It is fortunate that this piping failure didn’t result in full failure and collapse of the road embankment as this would have likely resulted in a sudden wave of sediment and water down Mitchell Stream.

*Figure 8 - Debris upstream Raiha Street Culvert – Mitchell Stream (post event)*

The road was immediately closed due to the risk of collapse through the voids in the embankment above the culvert. Services were also isolated on both sides of the culvert to mitigate the risk of gas/sewer/water leaks. Following initial investigations the damaged fill was excavated and then re-compacted with the road reinstated. There is also a design and resource consent application underway for a large sediment/debris trap upstream of the culvert to mitigate the risk of future blockage.

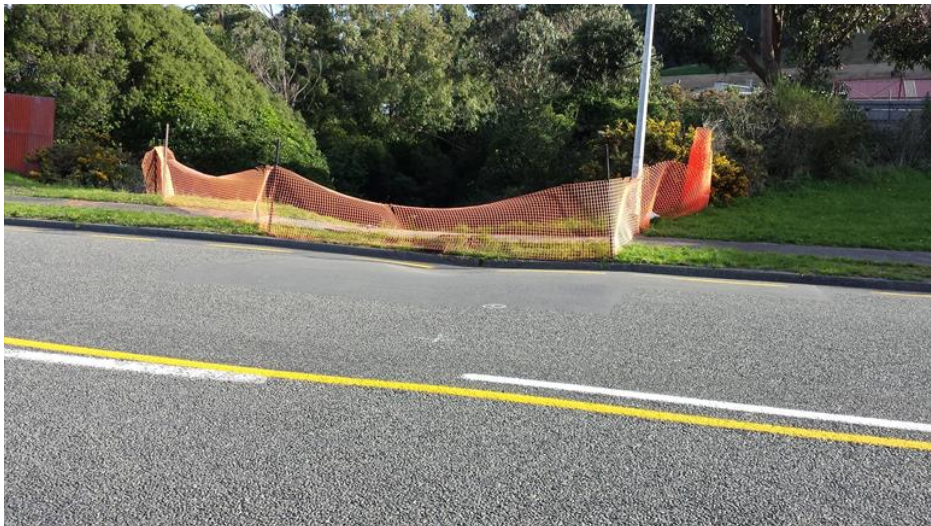
Another significant problem was the Raiha Street culvert on Mitchell Stream. This culvert became blocked with debris during the event and water flowed through the road embankment fill resulting in material being internally eroded (piping) and the road slumping.

*Figure 9 - Slumping of Raiha Street above culvert*

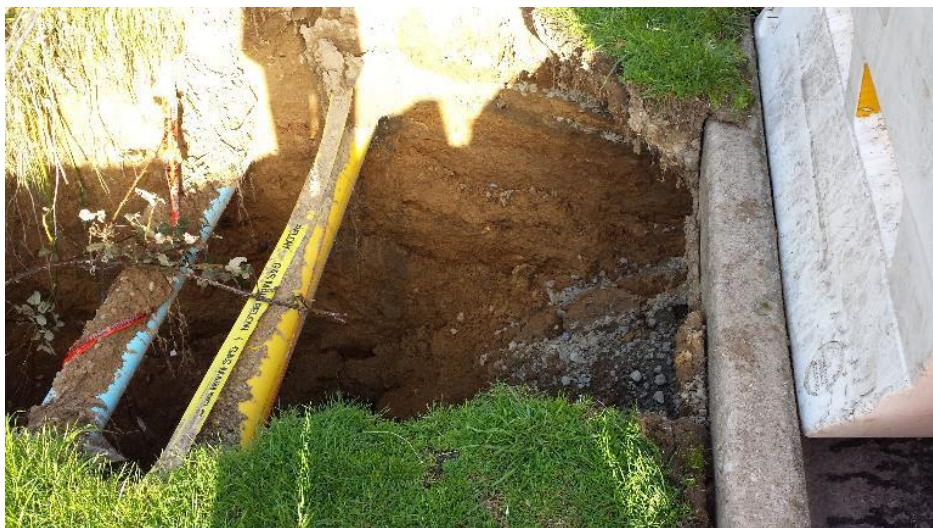
*Figure 10 - Piping failure of embankment fill (downstream side)*

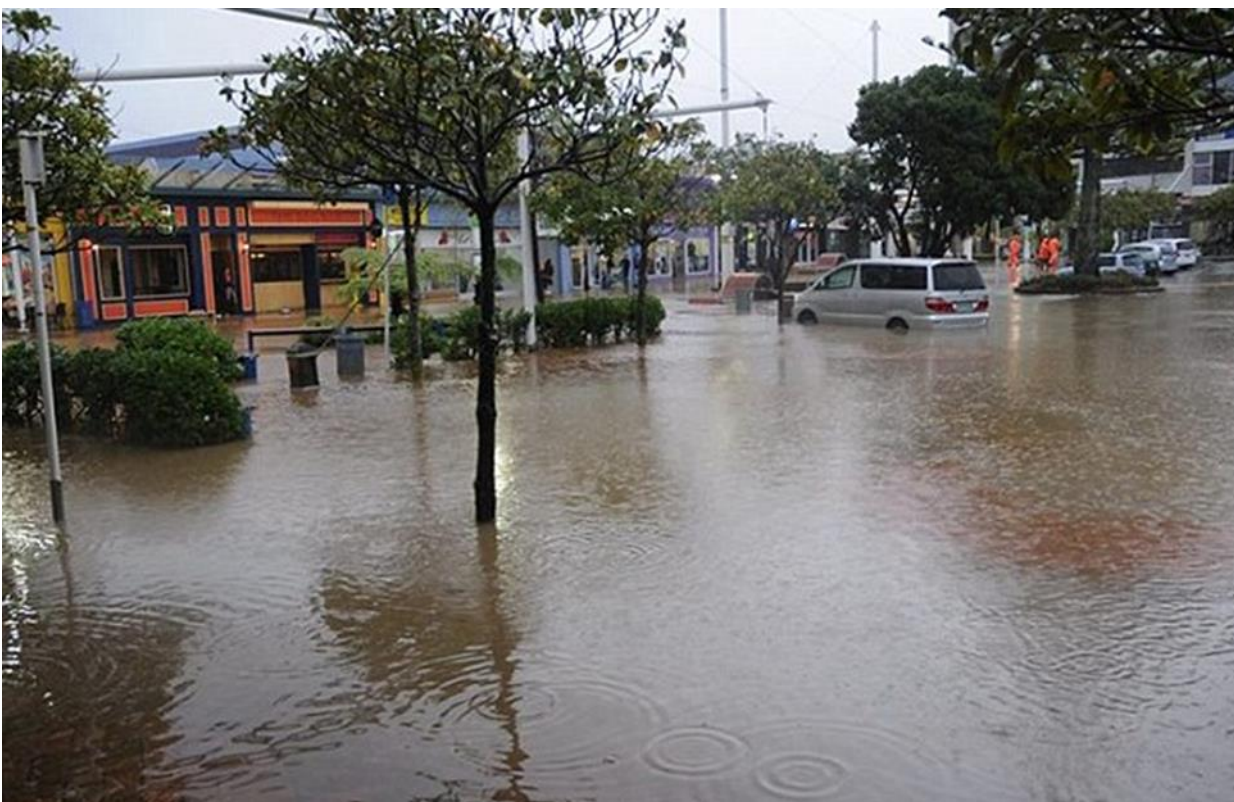
Vast areas of the CBD were affected by this event with water entering a large number of commercial properties (see Figure 11). This water was partly sourced from the overflows occurring from the Raiha/Prosser system in addition to the rainfall landing directly on the CBD itself. The outfalls from the CBD stormwater network are likely to have been affected by gravel build up in Porirua Stream and were either partially or completely blocked during the event. The extent of this gravel build up appears to be from the Porirua Stream flow gauging station down to the confluence with Kenepuru Stream. Visual inspection suggests that 0.5 m to 1.0 m of gravel has built up through this reach (See Figure 12). It is not clear how much of this build up occurred during the event.

*Figure 11 - Porirua CBD 14 May 2015 (Source: Greater Wellington Regional Council)*

The proposed Titahi Bay Road stormwater interceptor project would capture a significant portion of the overland flows before they reached the CBD and would have an outlet that would be less affected by channel aggradation. Notwithstanding this the functioning of the CBD stormwater network relies on the outfalls into Porirua Stream operating effectively. As highlighted above these were buried by gravel at some stage during the event. Emergency works were undertaken to clear the gravel build up within the immediate vicinity of the outlets. Subsequently Greater Wellington Regional Council have confirmed bed levels through this reach have risen since the previous survey and have removed 4,000 m<sup>3</sup> of gravel from this reach.

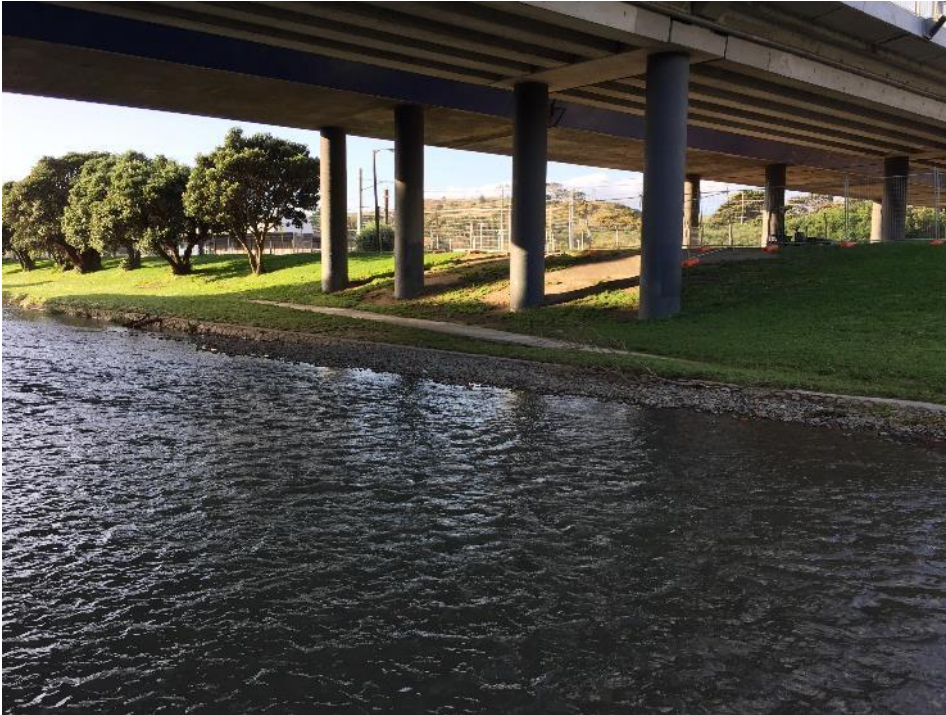
*Figure 12 - Gravel build up to the top of the ~ 1 m high river bank walls in Porirua Stream*
