THE LONG-TERM PERFORMANCE OF PERVIOUS PAVING

Steve Crossland, Stuart Girvan, Firth Industries Ltd

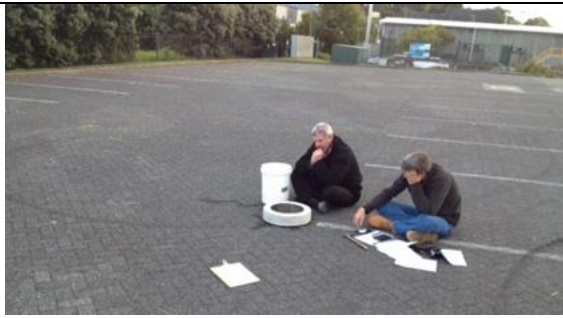
North Shore Events Centre, Porous Blocks, Parking

| Pervious Surface Type and Test Location | Year Constructed and Age of Pavement when tested (years) | Surface Infiltration Rate (mm/hr) | | |
|---|--|---|---|---|
| - Tested 2016 ⁽⁴⁾ | 12 years | 290 (weeds) | 1,100 | |

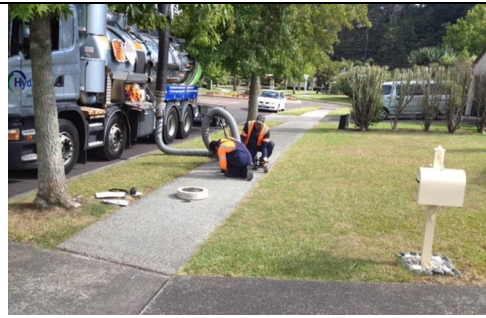
Clemow's Lane, Porous Concrete, Footpath

- The greatest infiltration rate was from the Grass Pavers filled with 2/5mm chip at 14,000mm/hr (Earthsong Ranui Grass Pavers Parking) and the Porous Concrete footpath of 12,600 to 14,300mm/hr (Clemow's Lane, where it had been clear of any overhanging trees).

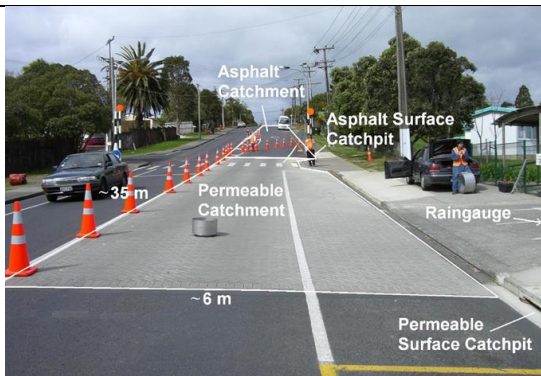
Birkdale Road, Porous Blocks, Traffic Lane and Parking Bay

| Pervious Surface Type and Test Location | Year Constructed and Age of Pavement when tested (years) | Surface Infiltration Rate (mm/hr) | | |
|--|--|---|---|---|
| - Birkdale Road, Parking Bay ⁽⁴⁾ | 2010 – 6 years | 430 | 1,260 | |

- To minimise joint filler loss Firth Ltd are trialing a water based acrylic joint stabiliser solution with initial good results.
- The worst performing was the Birkdale Road traffic lane trial on a local road with significant traffic loads (on a bus route) where the Porous Blocks have experienced 'high' depressions, joint filler loss and damaged pavers, along with 'medium' rutting and joint widths. In contrast, the adjacent parking bay has performed well with all 'low' severity performance. The Birkdale Road was a trial to test the performance of the pervious surface to significant traffic loads and reinforces the recommended design practice of restricting pervious paving for parking areas and driveways.

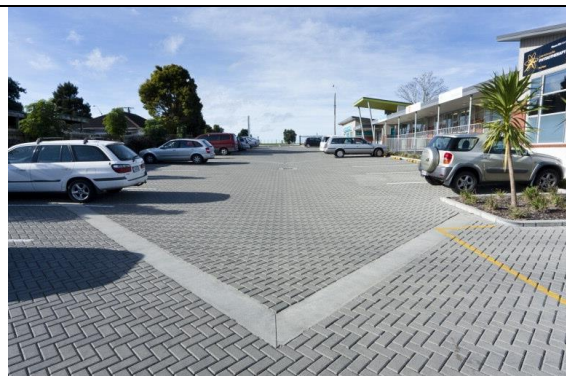
Te Atatu Medical Centre, Porous Gaps, Parking

| Pervious Surface Type and Test Location | Year Constructed and Age of Pavement when tested (years) | Surface Infiltration Rate (mm/hr) | | |
|---|--|---|---|---|
| - Te Atatu Medical Centre Parking ⁽⁴⁾ | 2009 – 7yrs | 1,800 | 11,000 | |

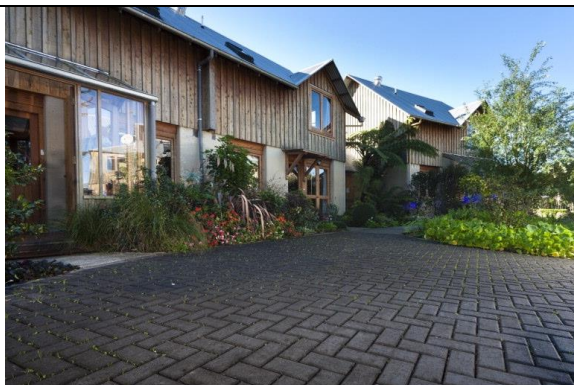
Earthsong Ranui, Porous Gaps, Parking

| Pervious Surface Type and Test Location | Year Constructed and Age of Pavement when tested (years) | Surface Infiltration Rate (mm/hr) | | |
|---|--|---|---|---|
| - Earthsong Ranui Parking ⁽⁴⁾ | 2008 – 8yrs | 1,000 ⁽⁸⁾ | 1,600 | |

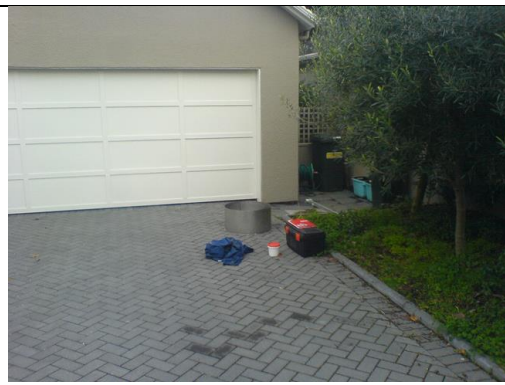
Upland Road, Porous Gaps, Driveway

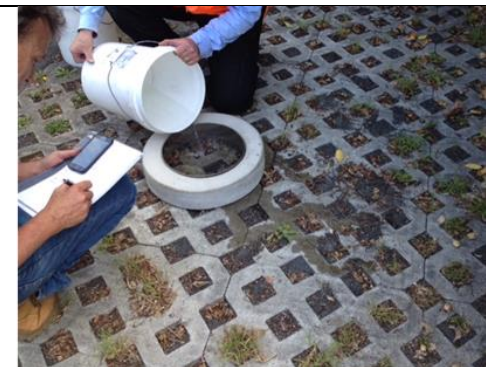
Earthsong Ranui, Grass Paver, Parking

| Pervious Surface Type and Test Location | Year Constructed and Age of Pavement when tested (years) | Surface Infiltration Rate (mm/hr) | | |
|--|--|---|---|---|
| - Earthsong Ranui Parking ⁽⁴⁾ | 2008 – 8 years | 14,000 | N/A | |

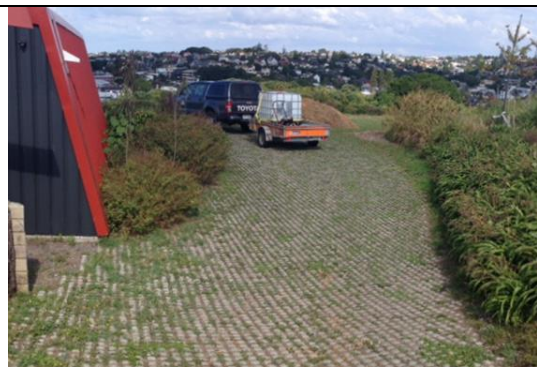
Orakei Ahikaroa, Gobi Block, Driveway

- The Gobi block at Orakei Ahikaroa, filled with soil, had an infiltration rate of 5,500mm/hr, actually greater than the adjacent grass which had an infiltration rate of 3,800mm/hr.

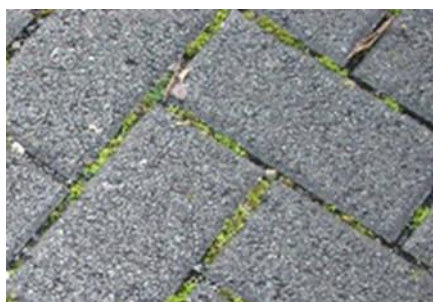
Photo 6: Before cleaning.

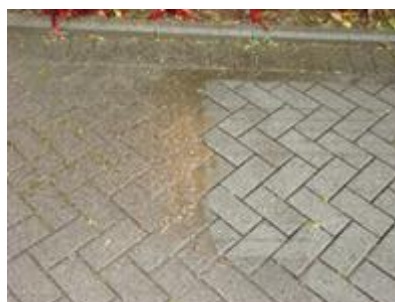
Photo 7: During cleaning

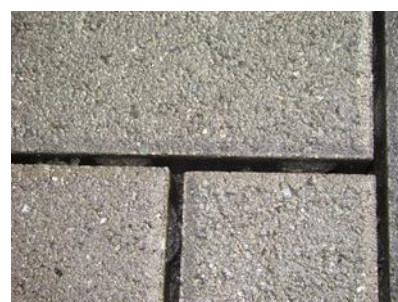
Photo 8: After cleaning, before rechip.

After cleaning the Porous Gaps and Porous Blocks the joints are refilled with a 2/7mm chip (Porous Gaps) or a clean sand (Porous Blocks) and vibrated with a plate compactor.
