P-CAT™ – PIPELINE CONDITION ASSESSMENT TECHNIQUE FOR WATER AND SEWER MAINS

*Young-il Kim, Penelope Wrightson, Mason Erkelens and Stephen Simmons
Detection Services Pty Ltd, Sydney, NSW, Australia*

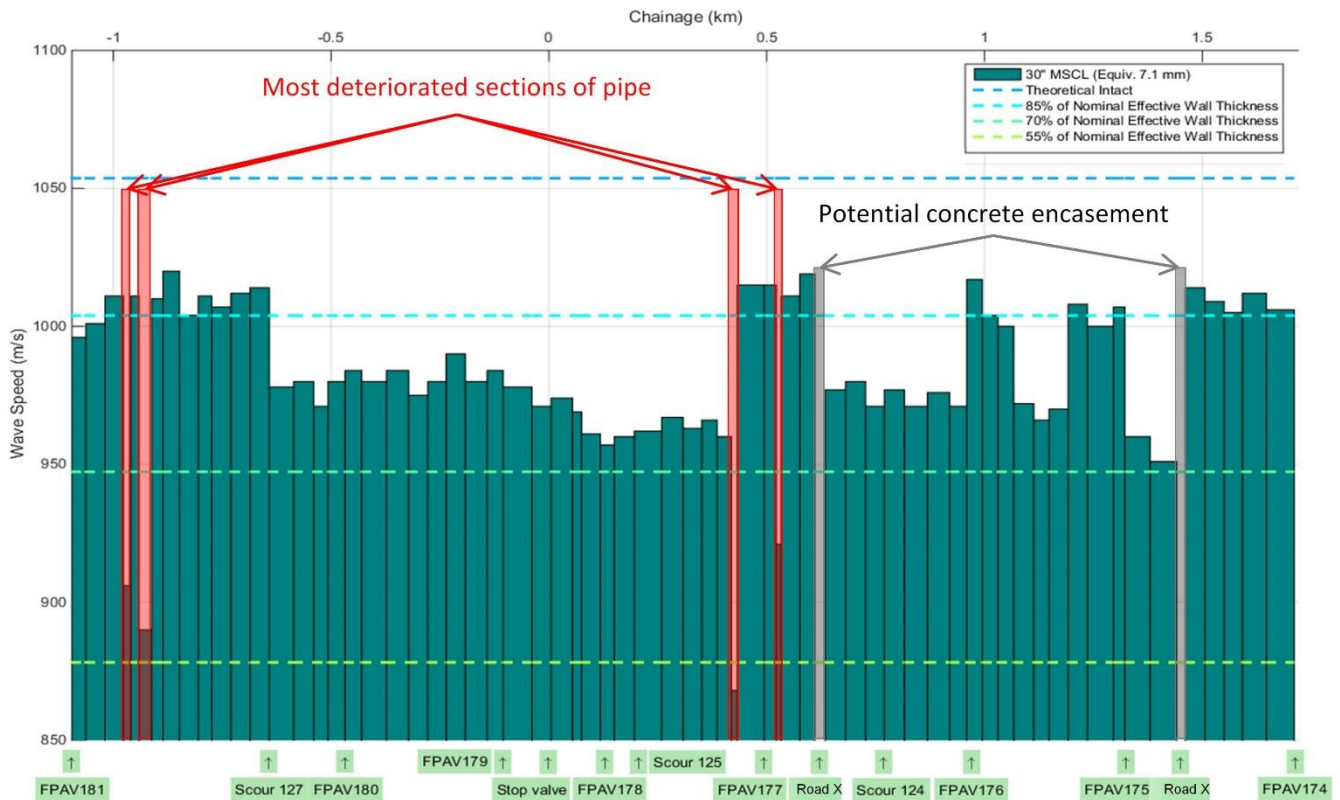
Figure 4: Internal pipeline wall deterioration for Case Study.

- 2% of the pipeline was found to be in the most deteriorated condition with a remaining wall thickness of between 50% and 64%.
- 68% of the pipeline showed to have some deterioration with a remaining wall thickness of between 70% and 84%.
- The rest of the pipeline (29% of the total length) has remaining wall thicknesses of between 85% and 90%.

See Figure 4 for a visual summary of the pipeline wall condition transient analysis results.

With regards to the tested section of the pipeline, it was recommended for Client 1 to conduct further investigations into the potential sections of deterioration as well as the possible presence of an air pocket and blockage.

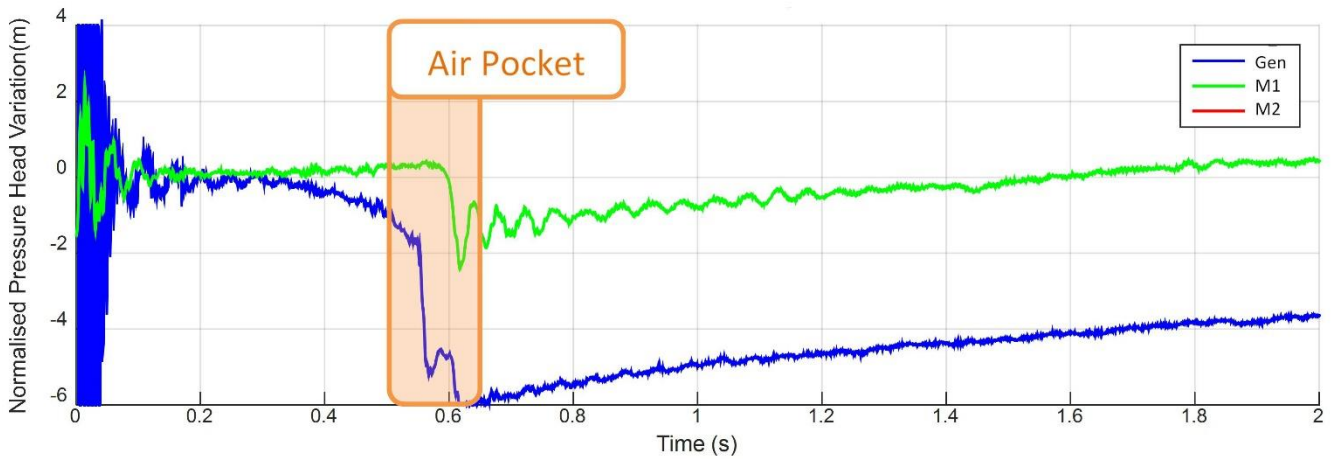
Figure 5: Air pocket at northern end of Case Study 2 pipeline.

- Three medium priority anomalies;
 - A non-sealing valve and two locations of a moving air pocket (See Figure 5).
- Six low priority known system components;
 - Four off-takes and two sections of MSCL replacements.

With regards to the tested section of the pipeline, it was recommended for Client 2 to further investigate the presence of an air pocket and the sealing status of the southern inline valve.

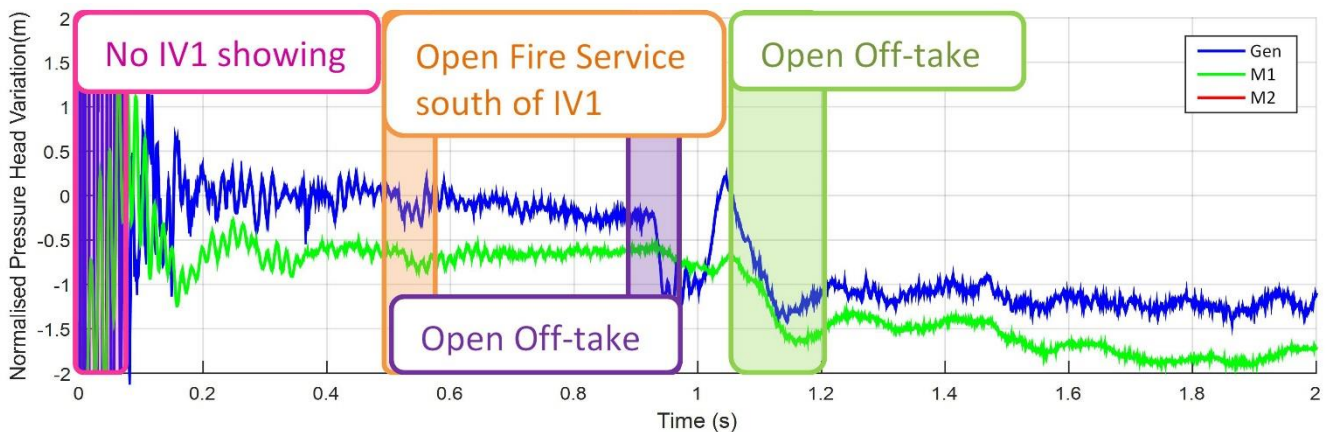
Figure 6: Example of anomaly identification for transient generated in Case Study 2.

Results from the transient analysis indicated that either the valve at the southern boundary of the pipeline section of interest (IV1), the associated bypass valve or both were not sealed during the first day of testing, although all valves were operated to isolate the tested section of the pipeline. Corroborating this result, anomalies corresponding to outside of the testing area were recorded during testing. The wave speed and the locations of pipeline features in this section of pipeline were not measured during testing as it was outside of the section of interest, however approximate locations matching some known features have been distinguished by assuming a similar wave speed to the adjacent section of pipeline (see Figure 6).

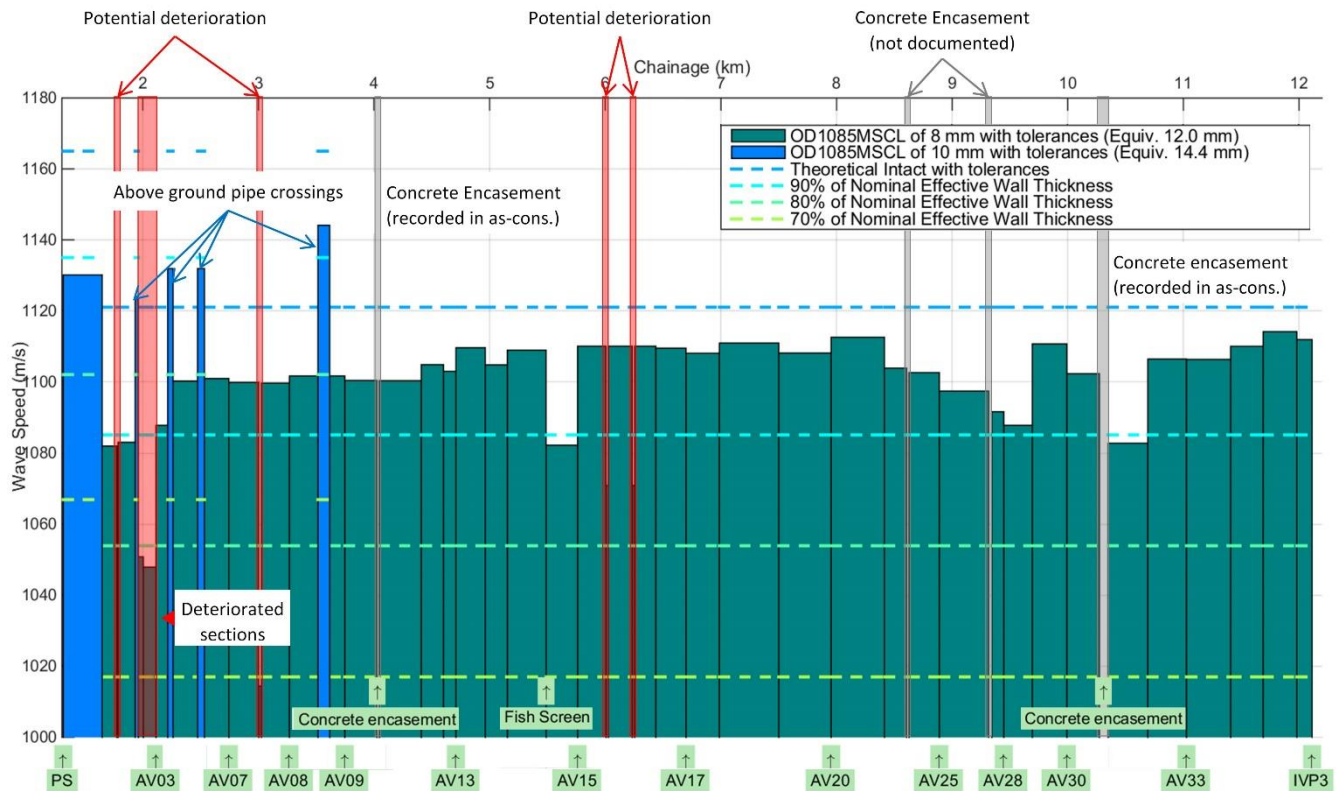
Figure 7: Internal pipeline wall deterioration for Case Study 3.

- For the sections with an original wall thickness of 8 mm:
 - 1.7% of the length of the pipeline was found to have the highest deterioration with remaining wall thickness of between 67% and 80%.
 - 9% of the pipeline showed to have remaining wall thickness of between 80% and 90%.
 - The rest of the pipeline (83% of the total length) has remaining wall thicknesses of between 90% and 98%.
- Sections with an original wall thickness of 10 mm (5.3% of the pipeline length) had a remaining wall thickness of between 87% and 93%

- Fourteen medium priority anomalies representing:
 - The presence of a blockage or partially closed isolation valve at an isolating valve pit at 12.11 km.
 - Four short lengths of deterioration or replacement of lower wave speed pipe material.
 - Four short lengths of deterioration, replacement of lower wave speed pipe material, or branch of a known pipe feature
 - Five potential concrete encasement sections or the presence of a blockage.

See Figure 7 for a visual representation of the pipeline wall condition and anomalies.

The results provided from this analysis will assist in the assessment of the current condition of the pipeline. This information can assist Client 3 to make accurate decisions in planning and budgeting for future maintenance programs. It was recommended for the client to further investigate the presence of replacement material sections before concluding that sections are deteriorated and to further examine the sealing status of the isolation valve.

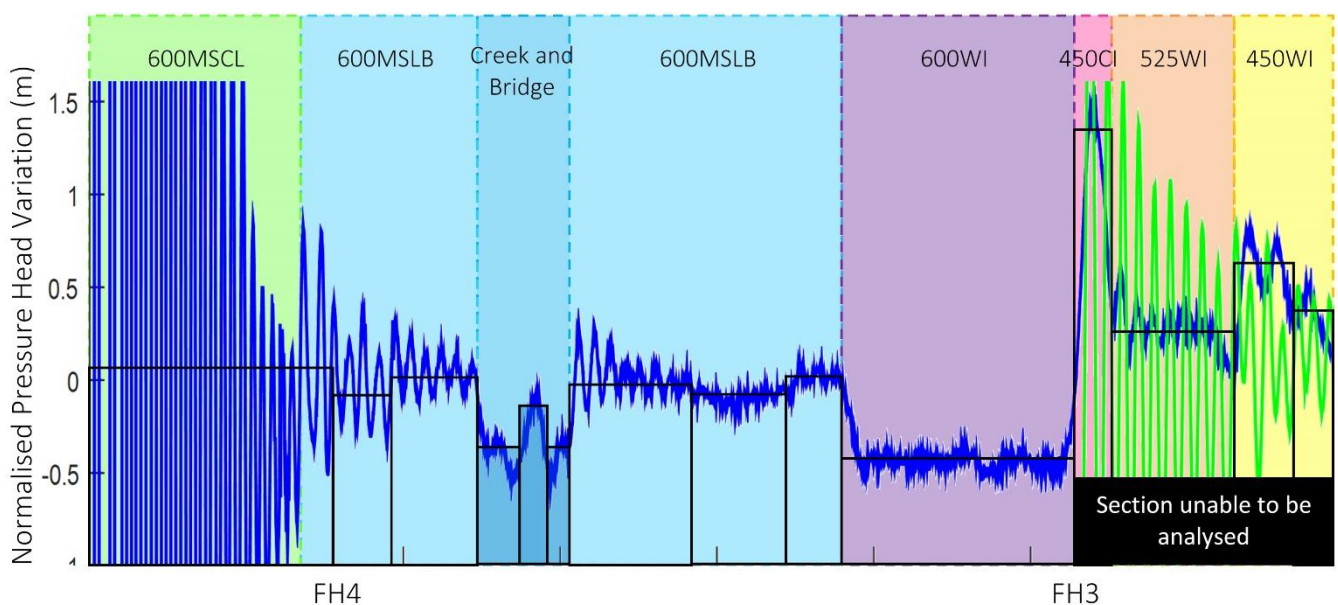
Figure 8: Pipeline configuration of the end cap boundary of Case Study 4.

Due to the complicated and uncertain pipeline configuration at the end cap boundary, and the number of material changes within the section (see Figure 8), the first 257 m of the pipeline was not able to be accurately assessed using Sub-Section Partitioned Wave Speed Analysis™. A short section of 750 MSCL was also not assessed due to the inability to isolate an off-take near that section.

With regards to the tested section of the pipeline, it was recommended for Client 4 to conduct further investigations into the potential sections of deterioration especially around the creek. Further information into the configuration of the pipeline would allow for the results to be expanded in the sections of pipe that were unable to be completely analysed.

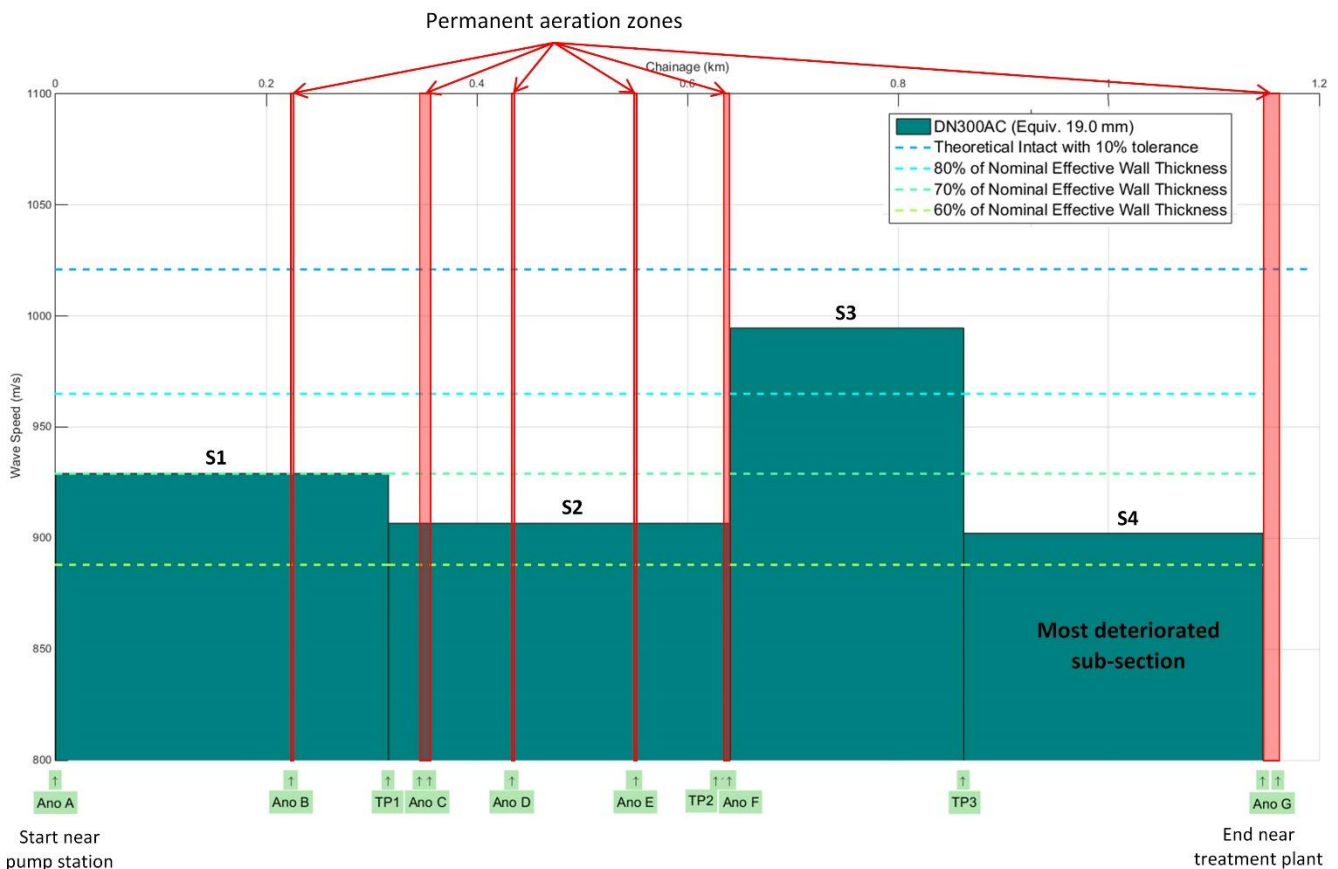
Figure 10: Pipeline wall deterioration for Case Study 5.

- Sub-section 1 (length 316 m) had 70% remaining wall thickness.
- Sub-section 2 (length 325 m) had 64% remaining wall thickness.
- Sub-section 3 (length 222 m) had 90% remaining wall thickness.
- Sub-section 4 (length 284 m) had 63% remaining wall thickness.

The calculated wave speeds were affected by the entrained air generated by the pump station and the presence of numerous permanent aeration zones, which absorb the energy of the generated transients as the signal propagates along the pipeline. Hence the determined wave speeds, and the thus wall thicknesses, represent the worst-case scenarios of the current pipe wall condition.

- Six high priority anomalies representing permanent aeration zones of various lengths.
- One low priority anomaly representing the pipe transition from D.N.200 CI to D.N.300 AC near the first pump station.

See Figure 10 for a visual representation of the pipeline wall condition and anomalies.

Due to the flat terrain where the pipeline was laid, air bubbles generated by the pump could easily accumulate into permanent aeration zones anywhere along the pipe length, particularly at the bends, and consequently accelerate internal corrosion. It was recommended for the client to change the pump size and/or speed such that the impacts of cavitation are minimised. Periodic vigorous flushing programs to remove potential gas pockets should also be considered.

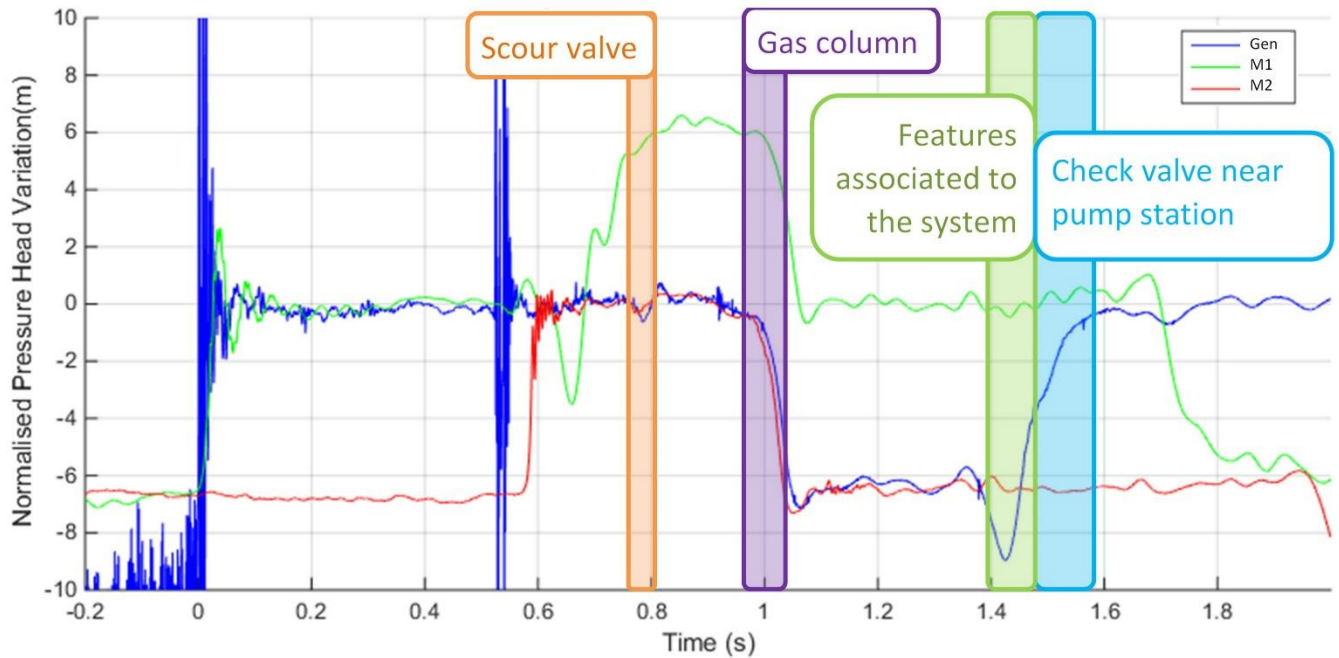
Figure 11: Pipeline wall deterioration for Case Study 6.

- Assuming O.D.419MSCL
 - Consistent condition, with the remaining equivalent wall thickness determined to be approximately from 92% to 97%.
- Assuming O.D.457MSCL Section:
 - Consistent condition, with the remaining equivalent wall thickness determined to be approximately from 99% to 106%, which is within the tolerance specified in ISO559:1991.

- Four low priority anomalies representing a check valve, two scour valves and a feature associated with the system.
- One high priority anomaly representing a significant gas pocket within the system located 134 m downstream from the scour valve located near the southern end (See Figure 11). It is recommended that the client take action to remove this gas pocket as it will be affecting system performance and there is an increased likelihood of localised internal deterioration at this point.

It was recommended for the client to take immediate action in regard to the existence of a significant gas column in the system. The gas pocket should be removed as it would be effecting system performance and represents a location at which localised deterioration is most likely to occur. Presence of an air valve shown on the as-built maps near this anomaly could not be confirmed in the field. Furthermore, it was also recommended for the client to update the GIS systems based on the features found during site inspections and in as-constructed drawings.
