# OPTIMISED LONG TERM CONDITION-BASED RENEWALS OF HASTINGS DISTRICT COUNCIL TRUNK SEWERS

**Author: E. Gandashanga, Stantec New Zealand Limited**

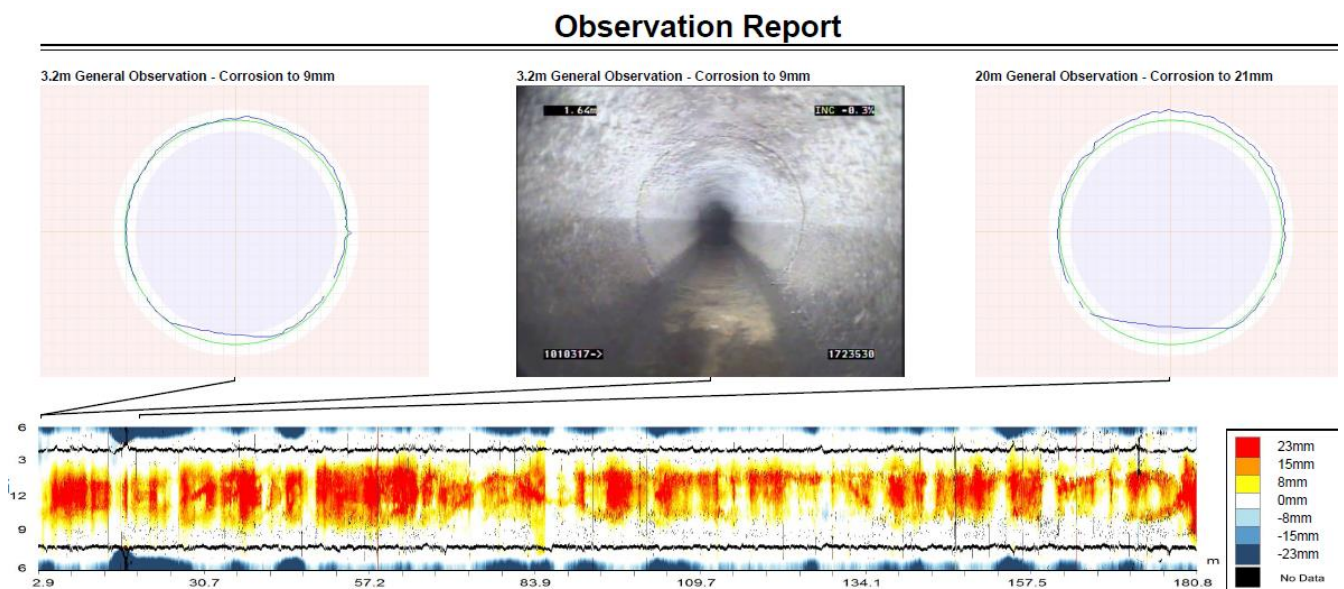
Figure 2 Profiling Visual Summary of the Pipe SUFI ID 51155384

For the Frimley Trunk Sewer, the laser profiling was carried out on various sections of the trunk main. The results showed some isolated areas of corrosion of up to 34 mm. Most of the pipes have insignificant areas with mild corrosion. However, some of the pipes were observed to be in high risk with the poorest condition. These sections are summarized in Table 5 with a description of their conditions and the general locations.

Figure 2 provides a visual summary of the high risk Frimley Trunk Sewer pipes with the poorest conditions.
