Optimised Long Term Condition Based Renewals of Hastings District Council Trunk Sewers

Elias Gandashanga, Stantec NZ Ltd.

September 2017

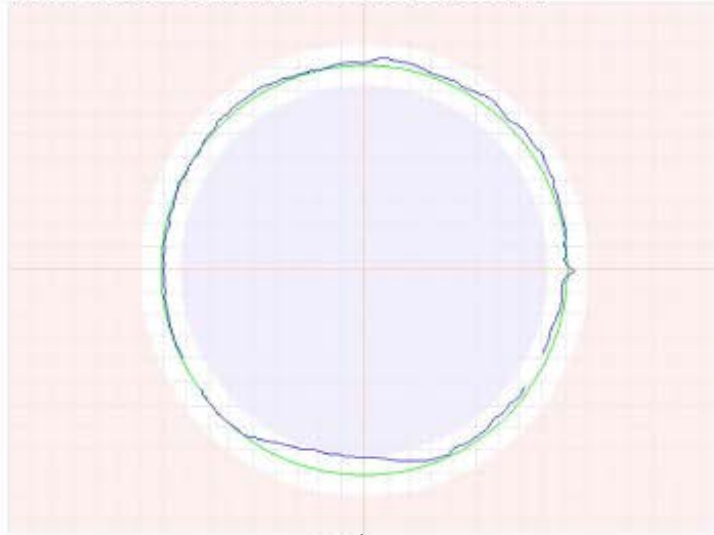
3.2m General Observation - Corrosion to 9mm

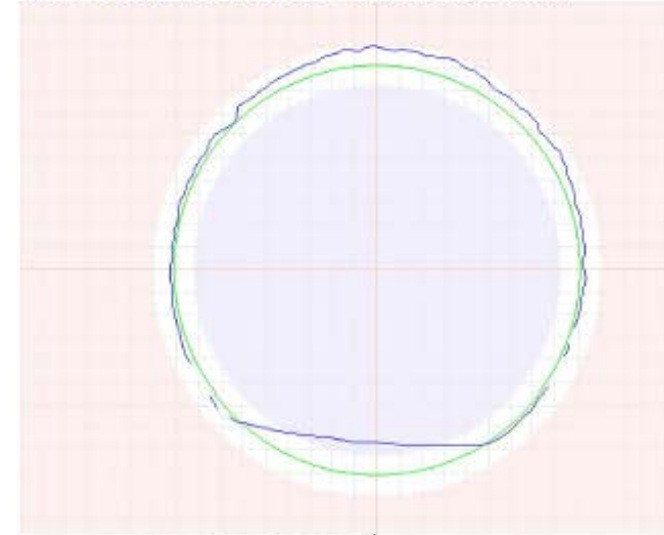
20m General Observation - Corrosion to 21mm
