No Dig Resin Based Sewer Rehabilitation Performance Post 2014

Water New Zealand Conference
September 2017

Gerard Cody – Water Services Reticulation Engineer
Timaru District Council

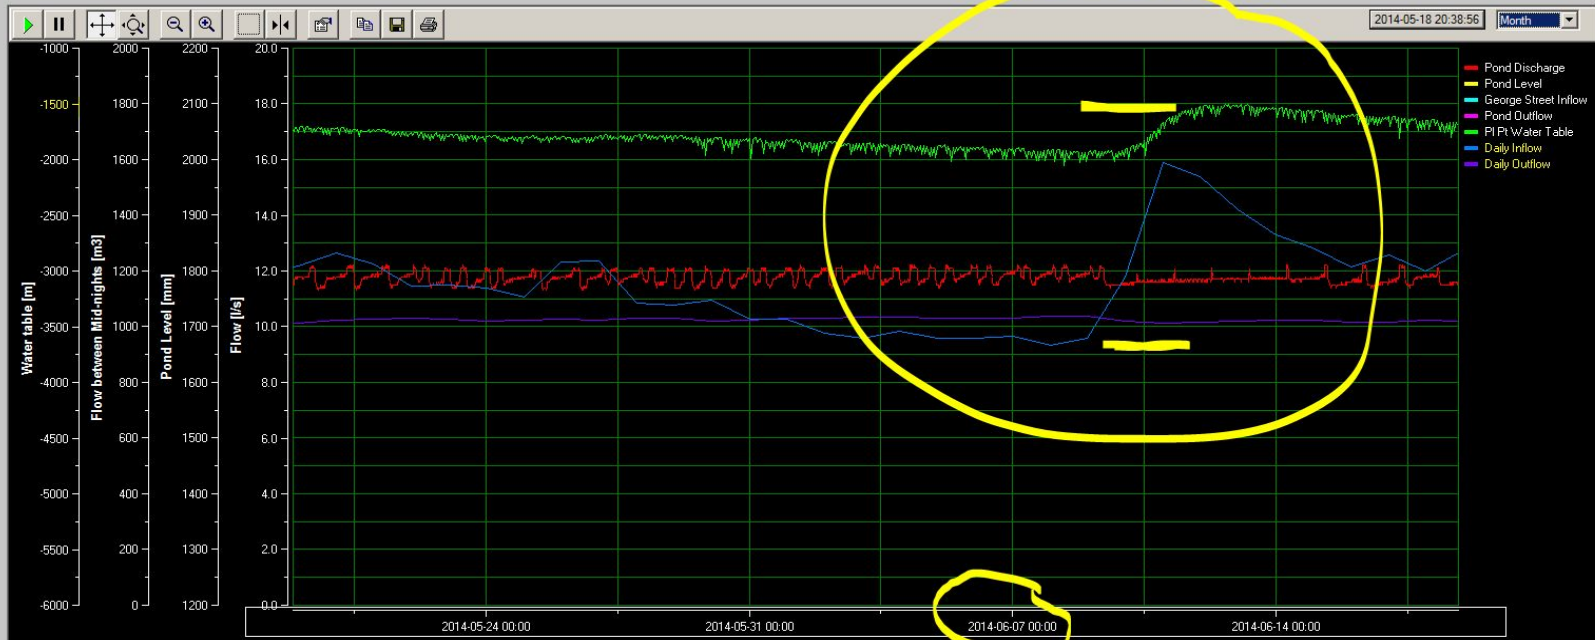
- Telemetry 07/06/2014 Showing water table in green – 1.5 meters below GL and pond inflow in blue 1600m³ for the day.

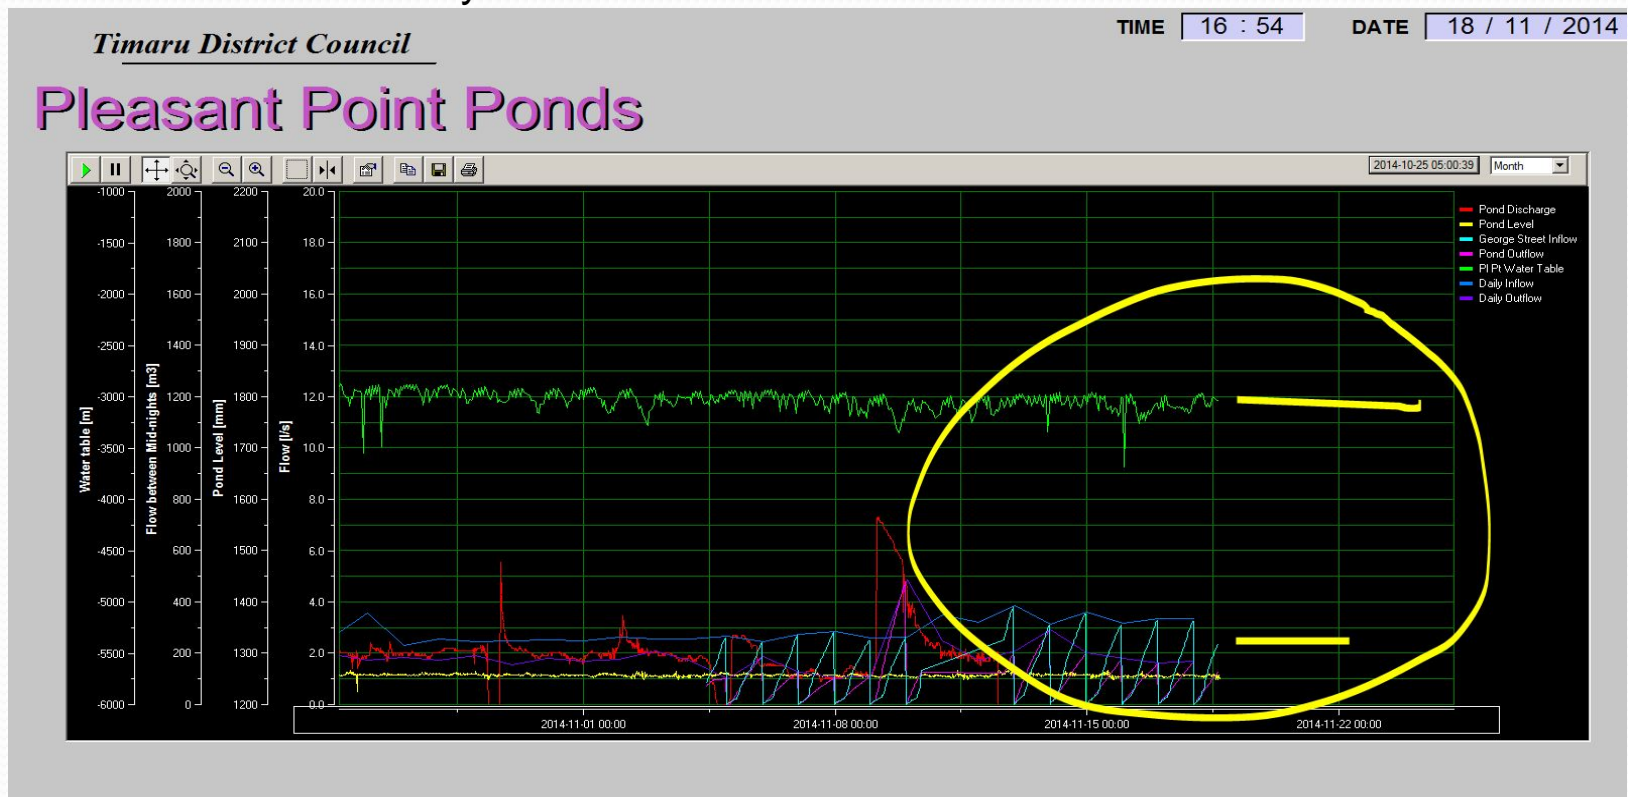
Telemetry reading after drop in water table

- Telemetry Showing water table in green – 3.0 meters below GL and pond inflow in blue 310m³ for the day.

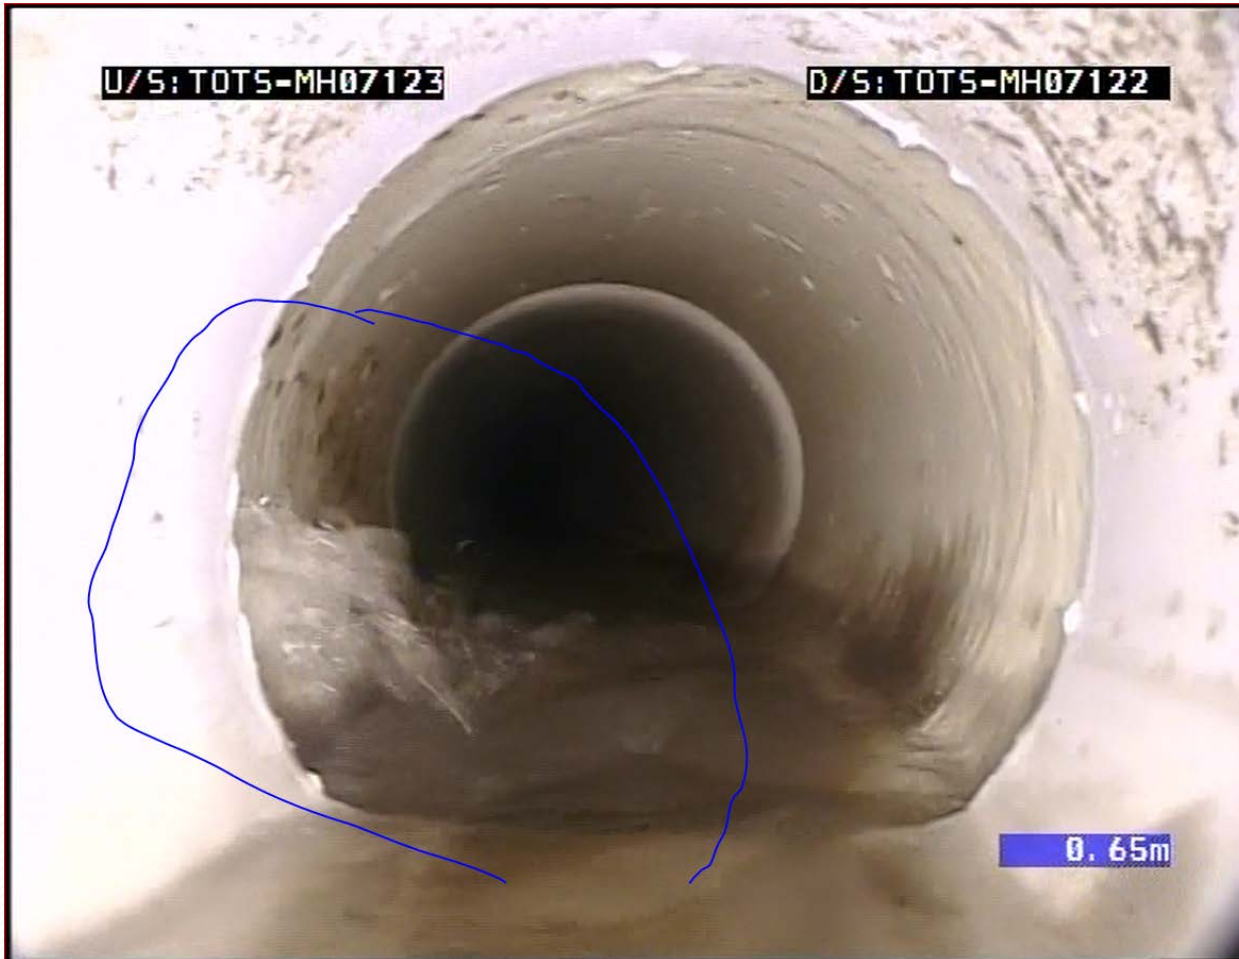
Network Issues

- PVC main joints and Manholes allowing ground water into reticulation. –Installed 1984
- Ground water pressure finding weaknesses in the reticulation. Poor PVC Jointing methods and manhole base installation
- Storm water inflow from low gully traps on private property
- Downpipes directed to gully trap
- Ground Water entry the major problem
