CRITICAL INFRASTRUCTURE IN VULNERABLE LOCATIONS

A. Donaldson (Hamilton City Council), P. Patel (Hamilton City Council)

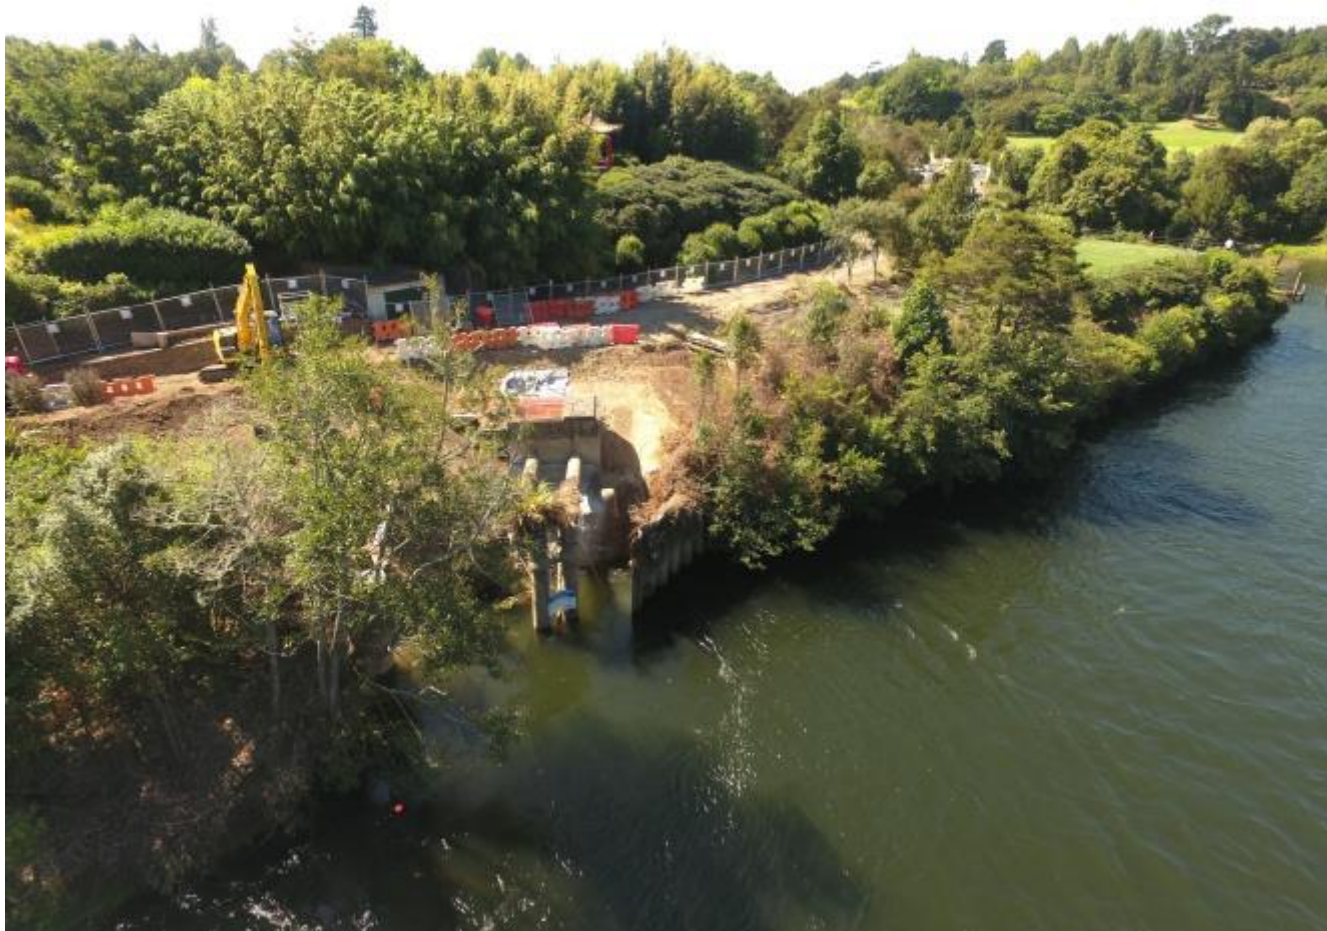
Figure 2. Aerial location of the eastern bulk mains and valve chamber in proximity to Waikato River

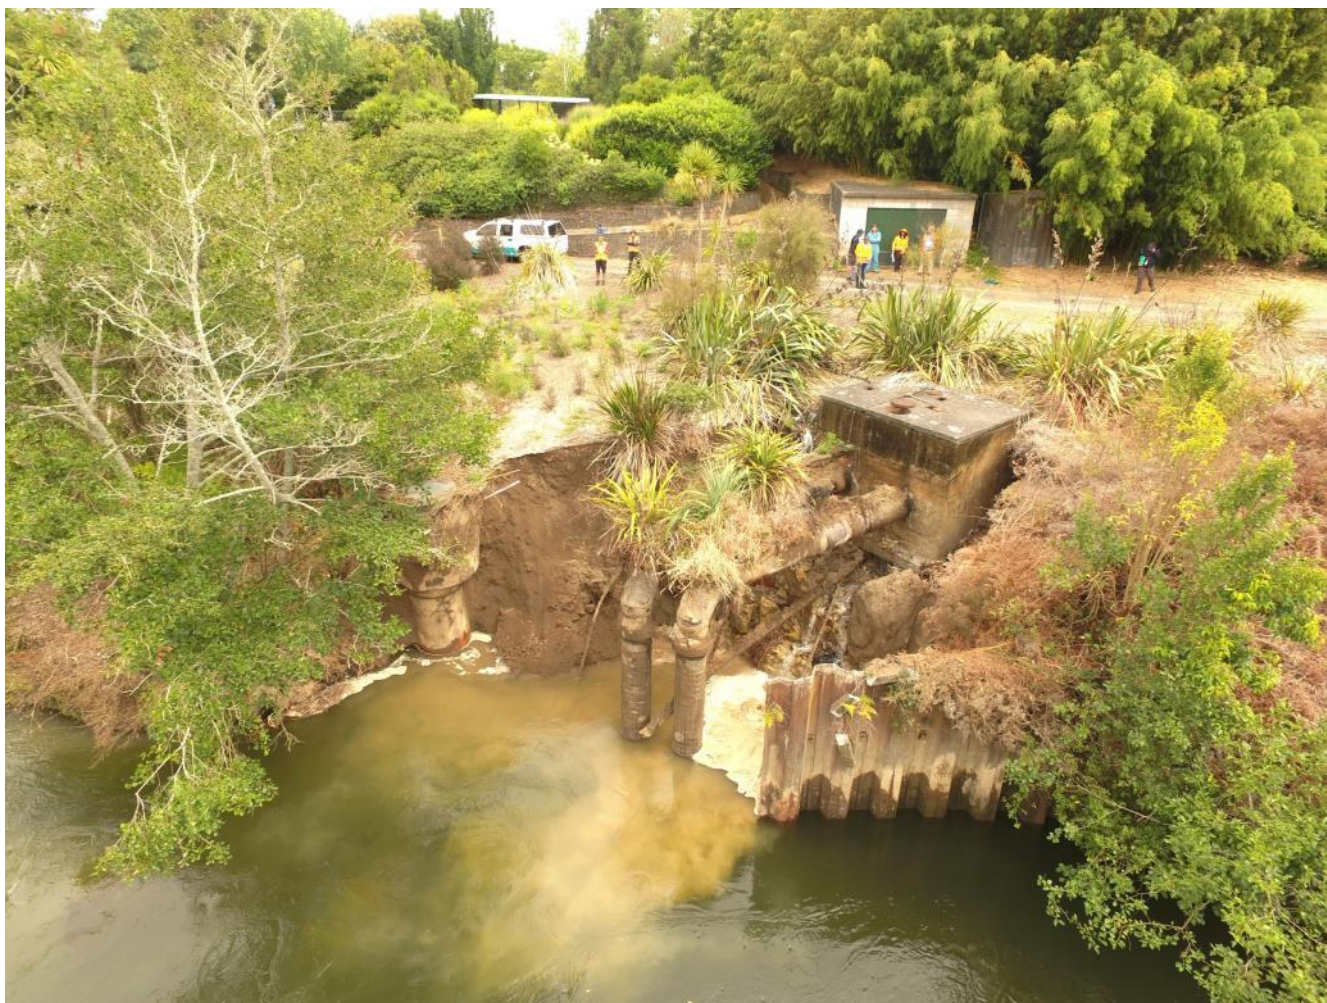
Figure 3. Aerial view of the erosion site shortly after erosion event occurred showing removed section of sheet piled structure

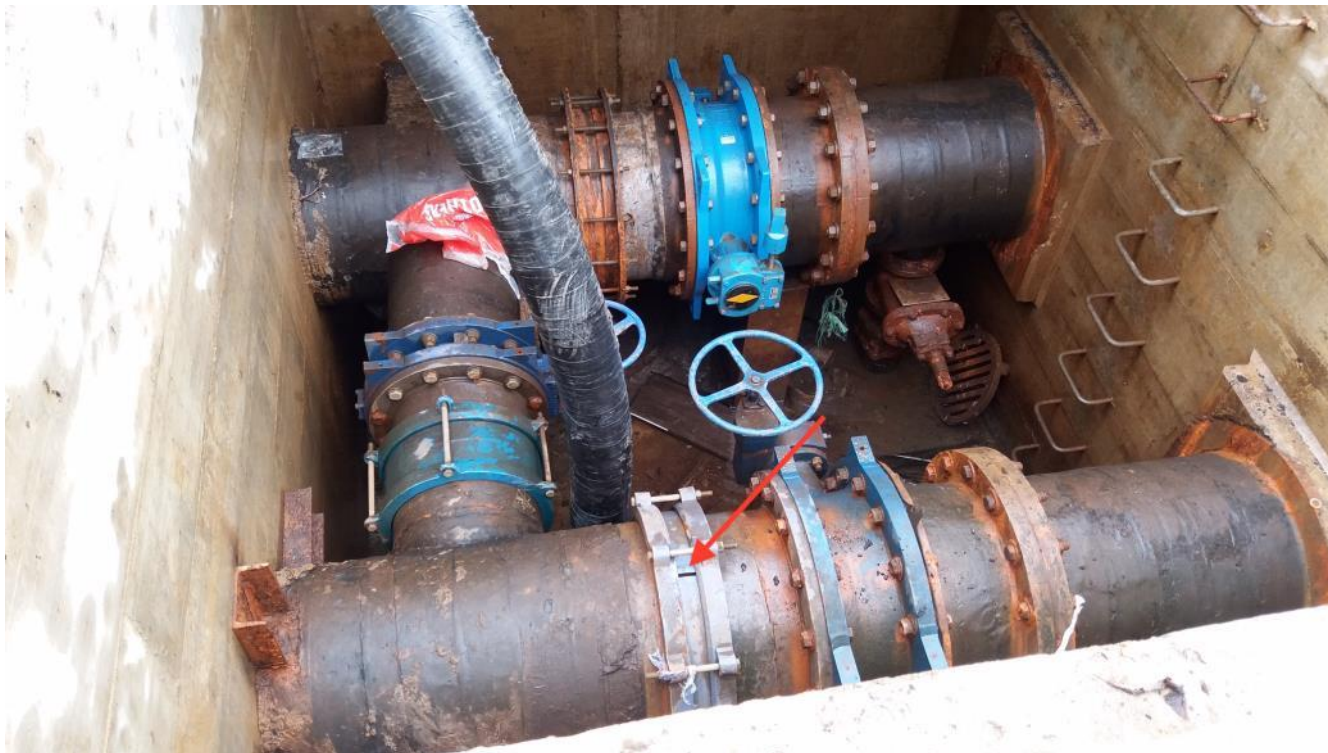
Figure 4. Photograph showing exact location of gibault failure once isolated

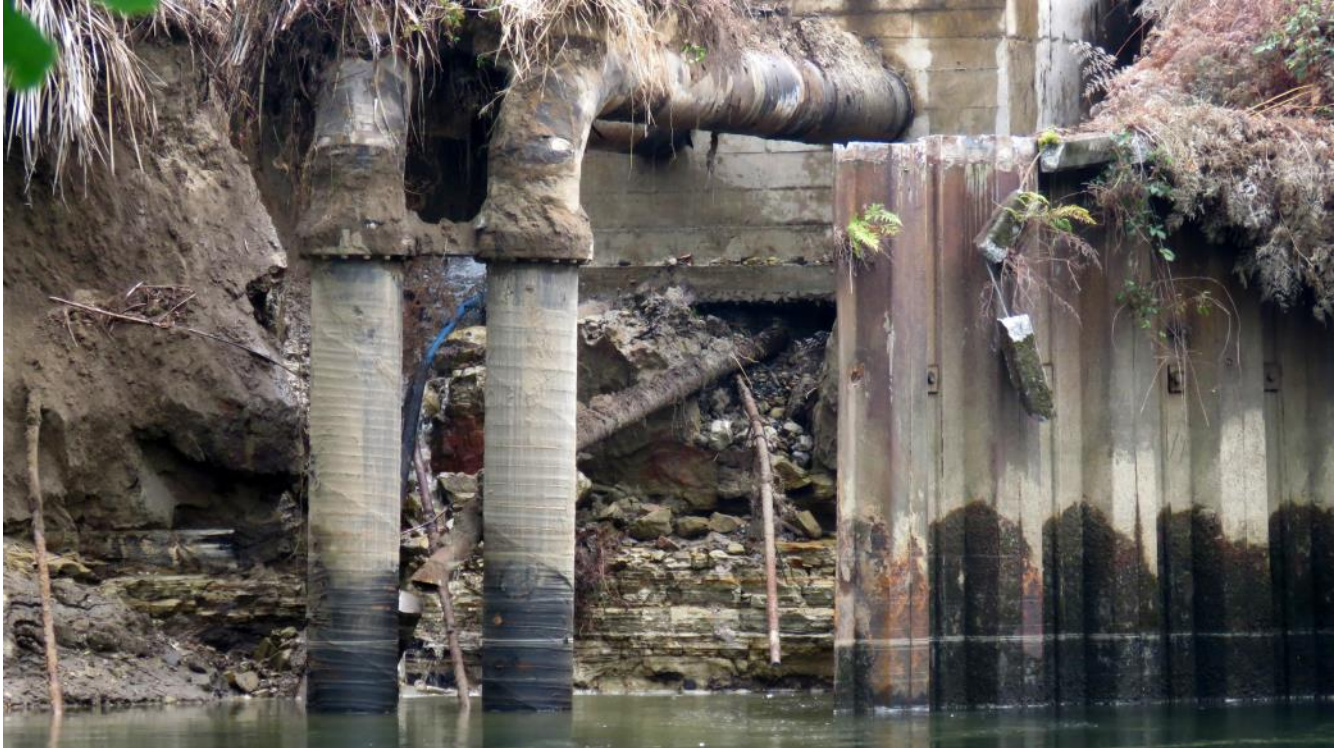
Figure 5. Photograph showing failure of sheet pile wall and erosion extent

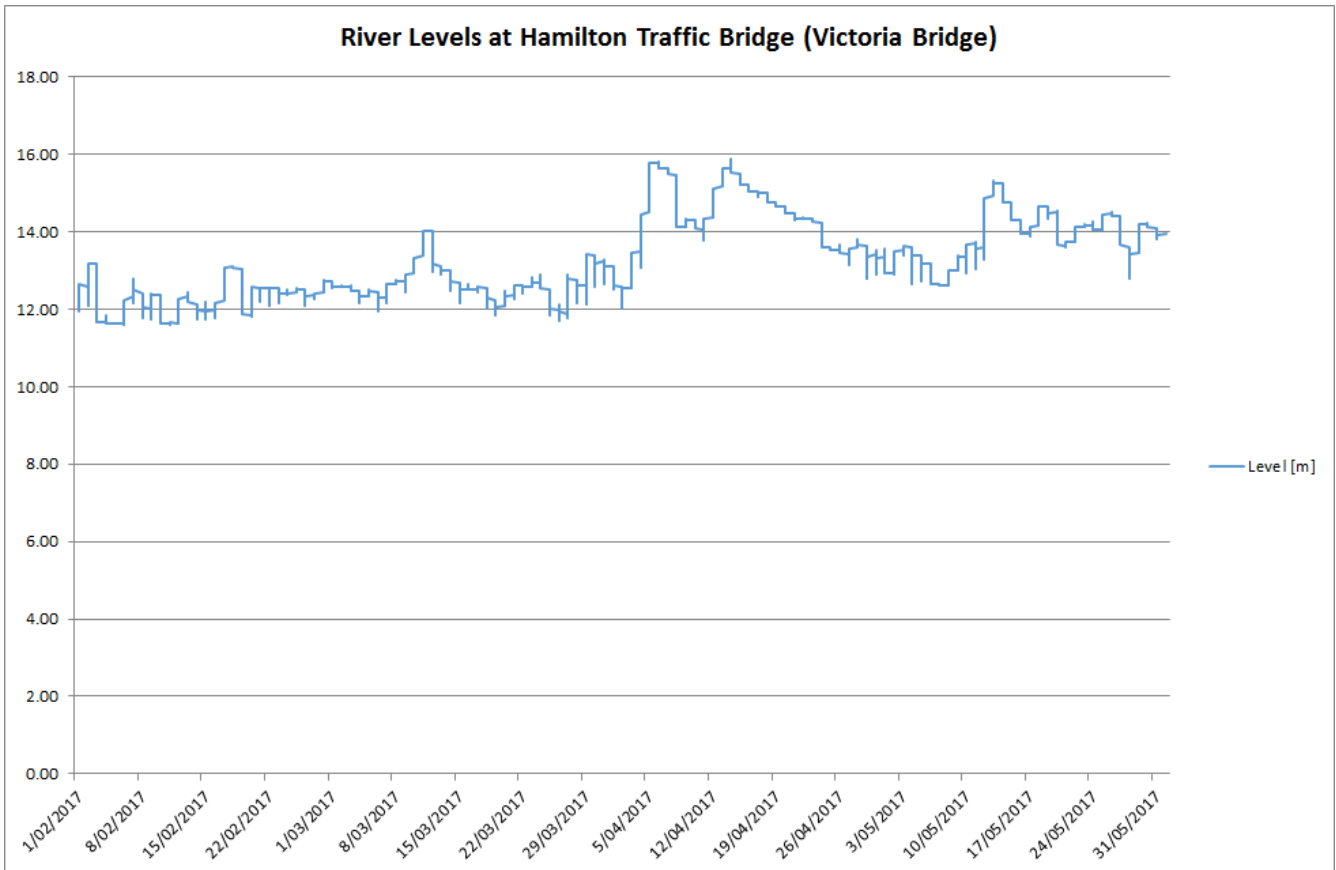
Figure 6. Waikato River Levels (Source: WRC website) Note: Levels taken from Victoria Bridge Hamilton approximately 200mm lower than recorded levels at slip site.

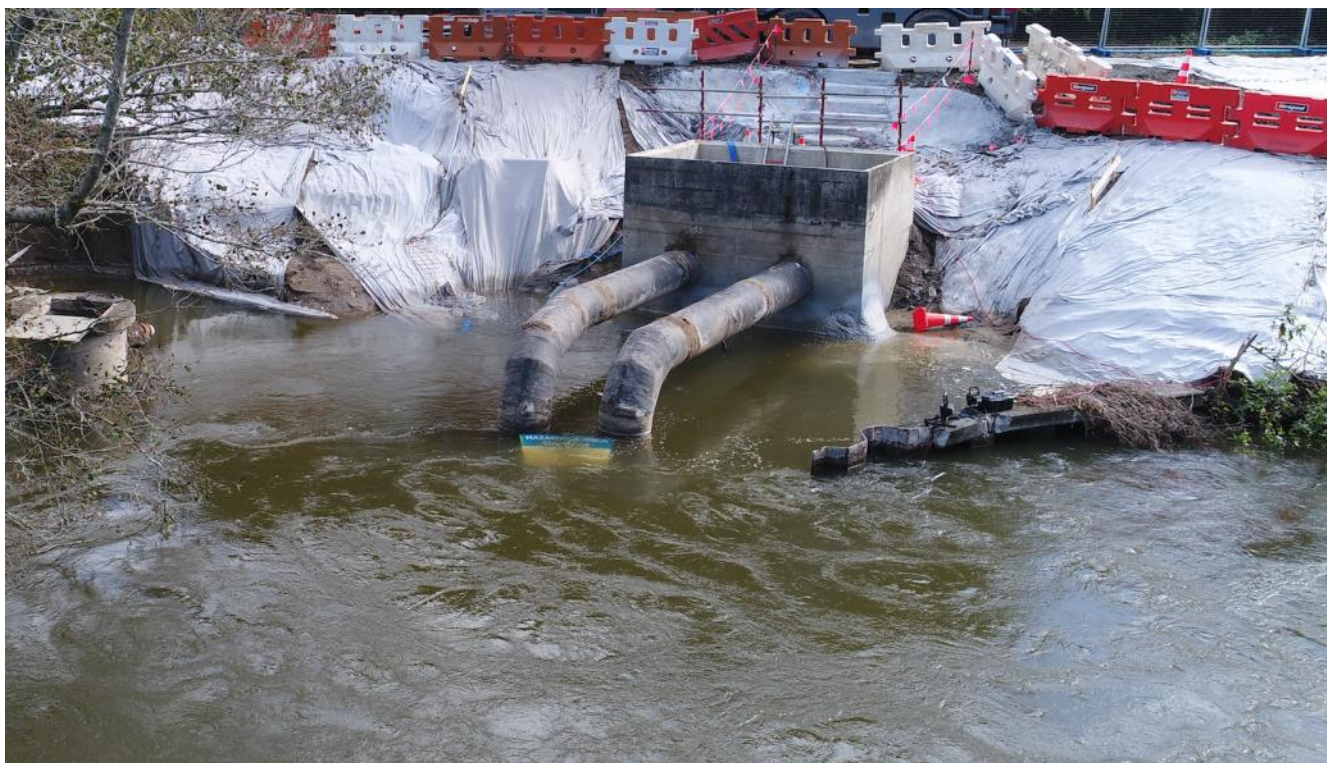
Figure 7. Extreme river levels at bulk main site
