Critical infrastructure in vulnerable locations

A near catastrophe

Adam Donaldson - Waters Operations Manager
Parvati Patel - Asset Engineer

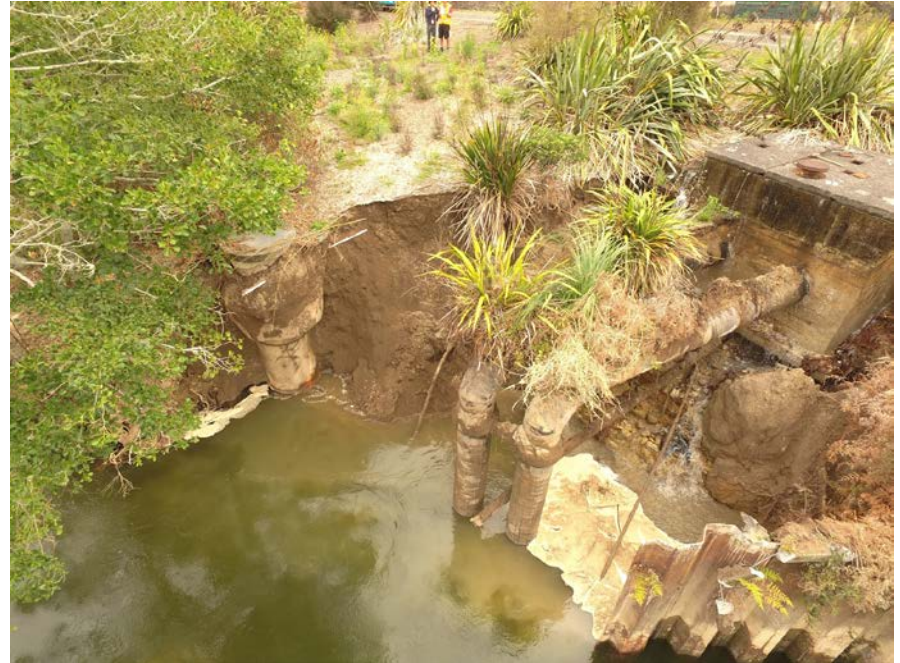
“Looks as though some stormwater has caused a slip near our bulk main valve chamber...”

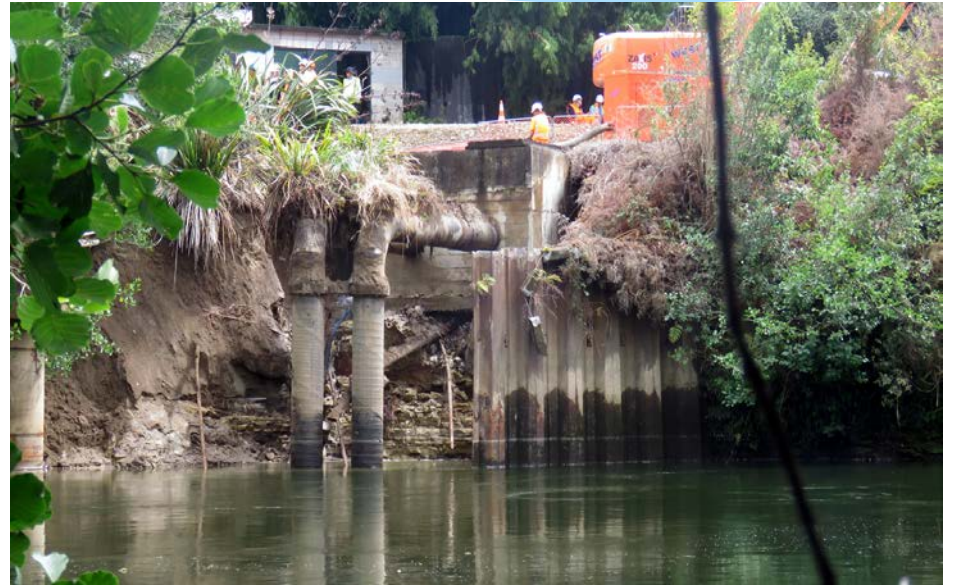
- Critical Assets no longer protected by river embankment and sheet piling
- Loss of bedding material beneath the chamber
- Stability of remaining riverbank uncertain
- Specialist engineering advice
- Undertaking a condition assessment

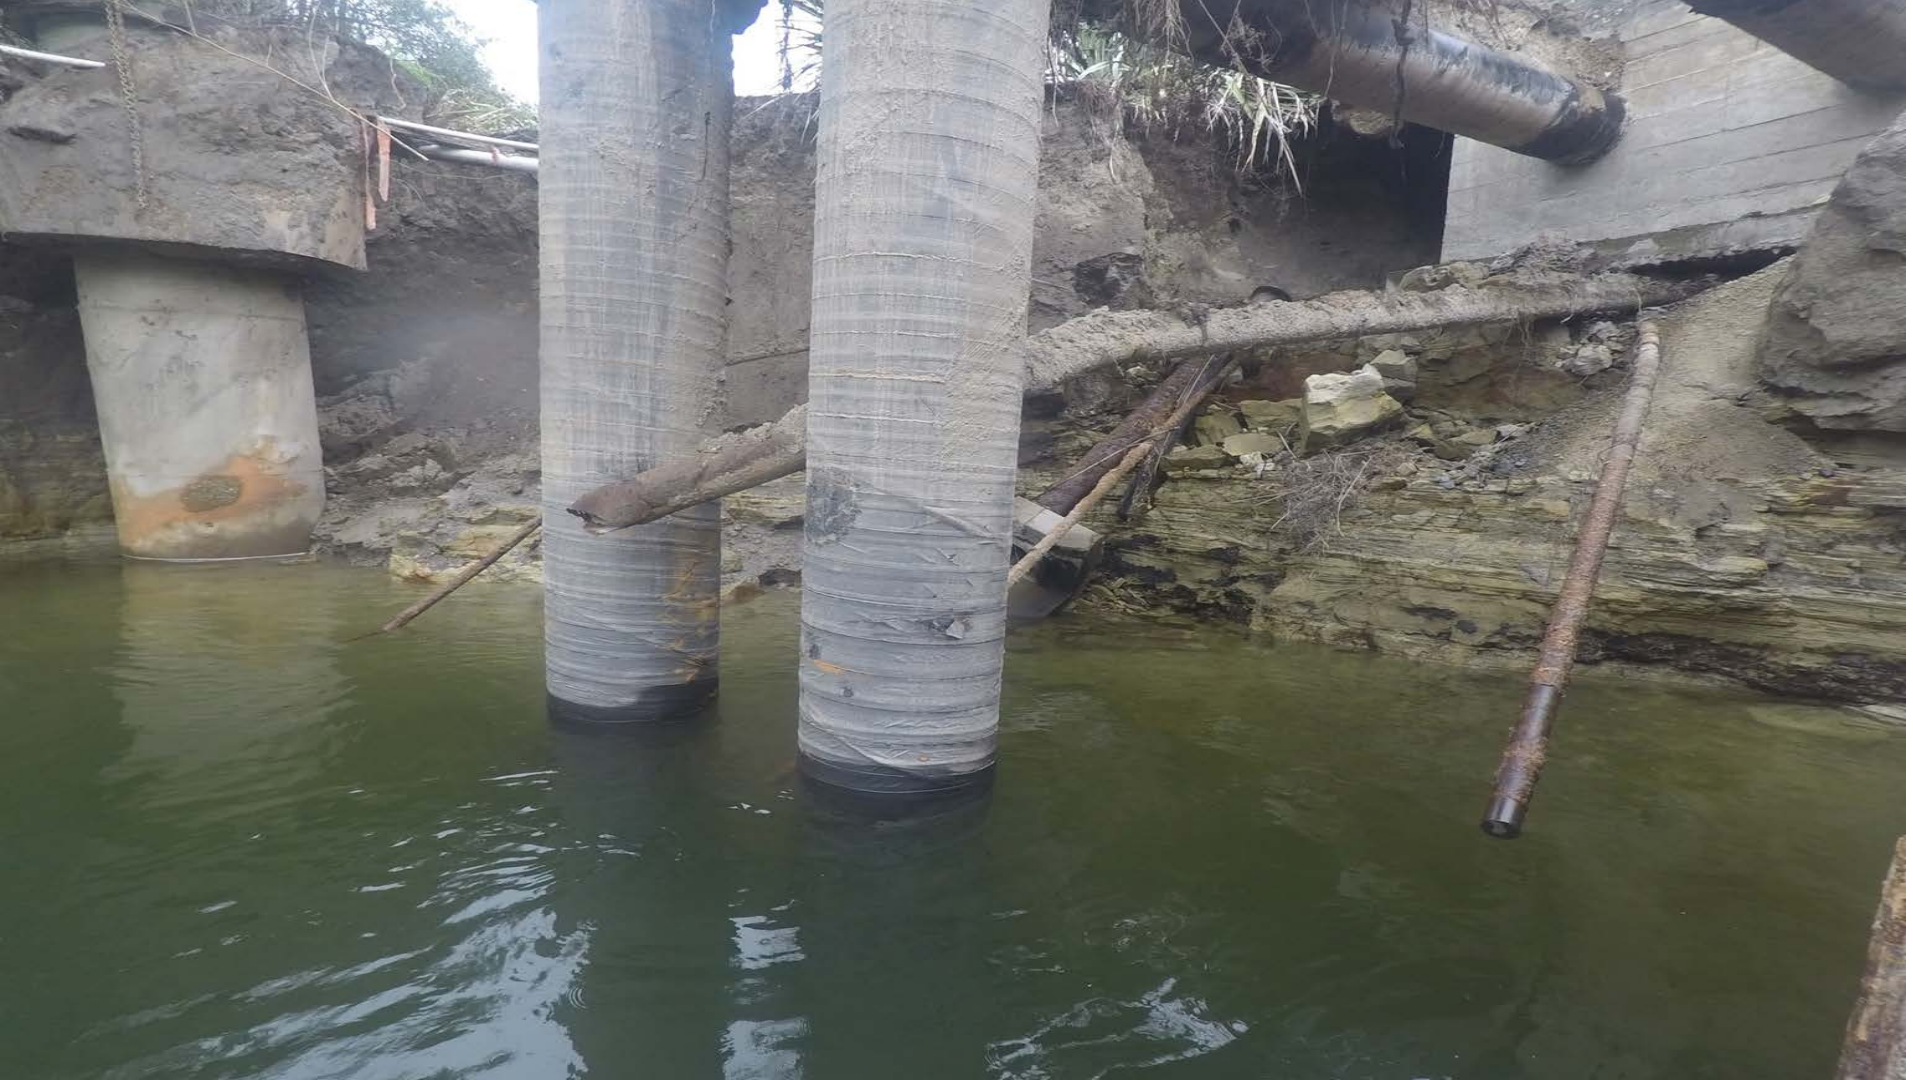
- Material holding the bank had failed, along with the sheet piling anchors evidenced from the sheet piles bent over under the water line.
- Along with exposure of the twin pipes and the water intake, material had been lost from beneath the concrete chamber.
- The remaining material in the immediate vicinity of the pipe and the chamber was classified as weakly cemented alluvial soils, hence presenting a risk of further erosion.
- Continued water seepage from the bank was observed following the isolation of the water supply.
