DIGITAL RADIOGRAPHY CONDITION ASSESSMENT OF VALVES, FIRE PLUGS, AND PIPES.

Dr Mason Erkelens (DS Insight, Detection Services), Mr Stephen Simmons (DS Insight, Detection Services), Dr Young il Kim (DS Insight, Detection Services).

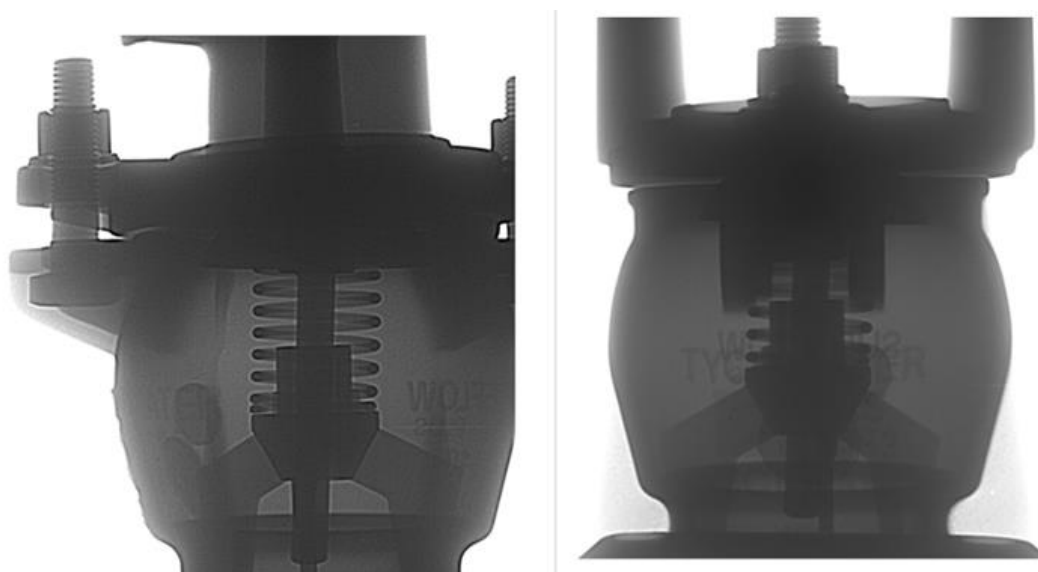
The first sample we investigated was a fire plug that would be commonly used within the eastern states of Australia. The images clearly display the inside mechanics of the fire plug. Within the imaged we placed a 50cent coin and a \$2 coin in the fire plug, this is to represent the presence of a foreign object. Both the coins were clearly observed within figure 1. Old fire plugs commonly suffer from tuberculation, this can reduce the flow rate of a fire plug causing it to fail fire flow testing. A potential use of digital radiography is to image the fire plug to determine the presence of tuberculation.

Figure 1, An X-ray image of a fire plug with two foreign objects.

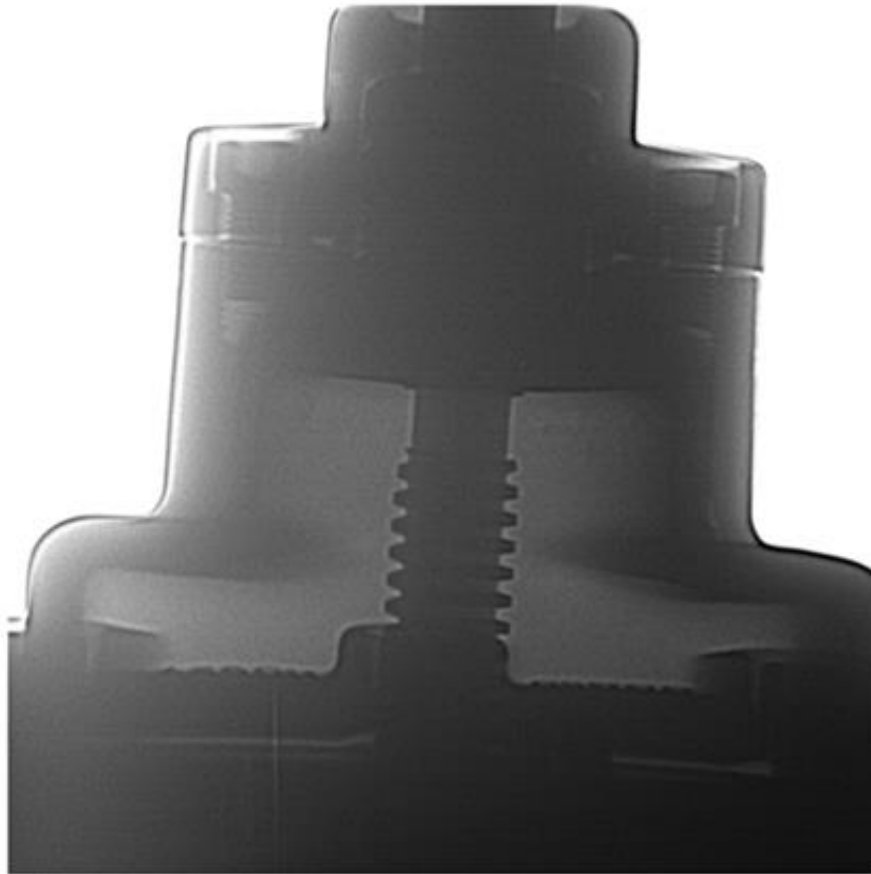
A 100mm valve was inspected using digital radiography to determine its ability to assess the internal mechanics (Figure 2, Figure 3). Two areas of interest were imaged, firstly the valve spindle and secondly the sealing of the valve. The image of the valve spindle was very clear (Figure 2), the depth of the bolts on either side of the valve spindle can also be clearly observed. Commonly the valve spindle is one of the main problems with broken valves, the main issue is due to over torquing and snapping the spindle. Once the spindle is snapped that valve can be turned and provide the impression the valve is operational, though the valve is non-functional.

Figure 2 X-ray image of a valve spindle.

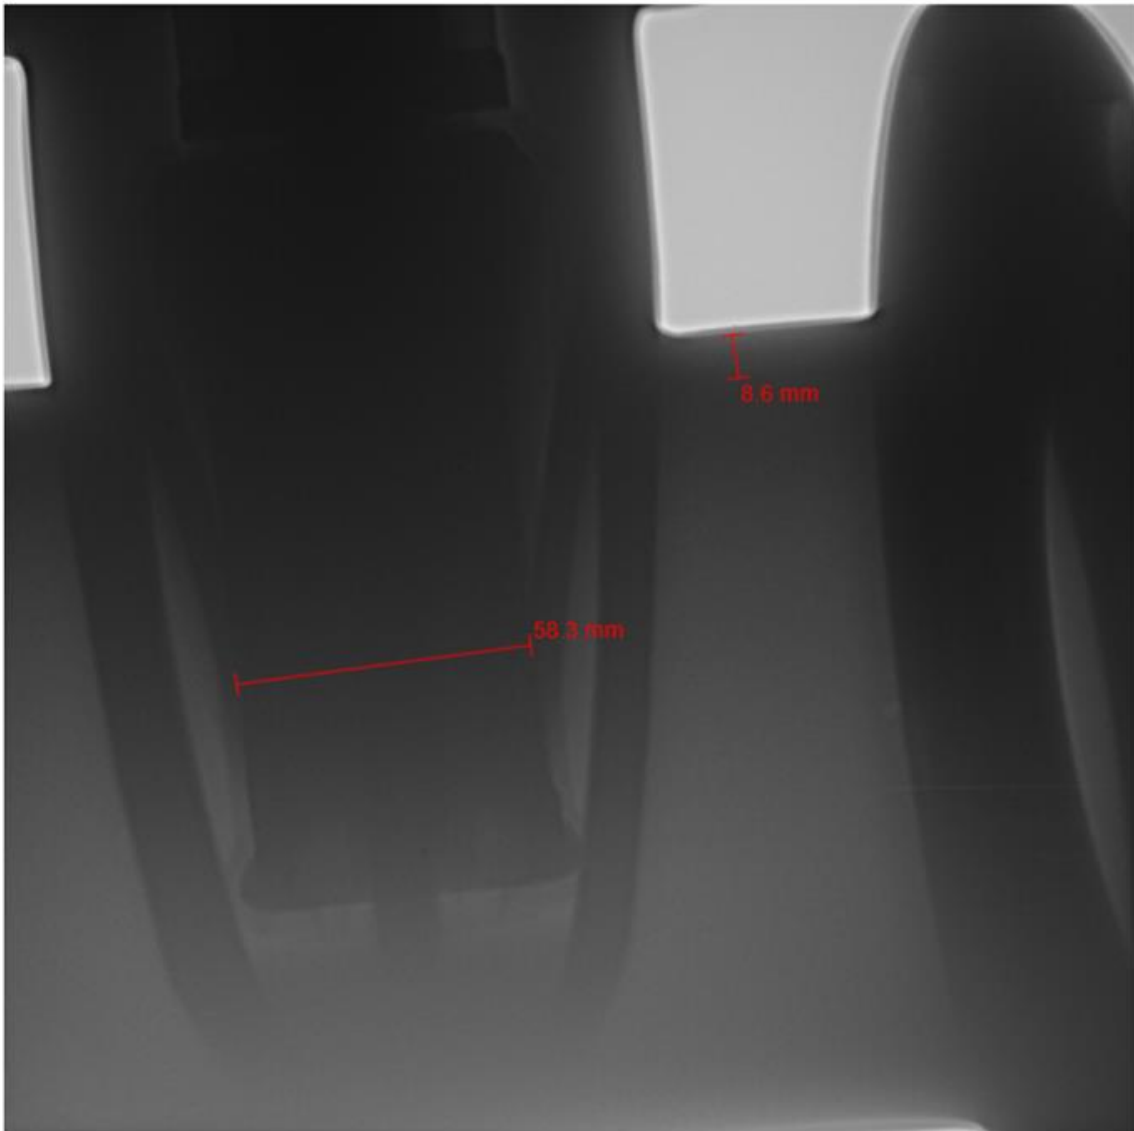
The valve seat was also imaged using digital radiography (Figure 3). The X-ray images obtained were very clear allowing us to inspect the internal condition. Commonly the valve seat can have tuberculation present or something lodged in the seat preventing the valve from completely sealing. This image was obtained instantly allowing us to assess this valve and make a quick assessment of its condition.

Figure 3 X-ray image of a valve.

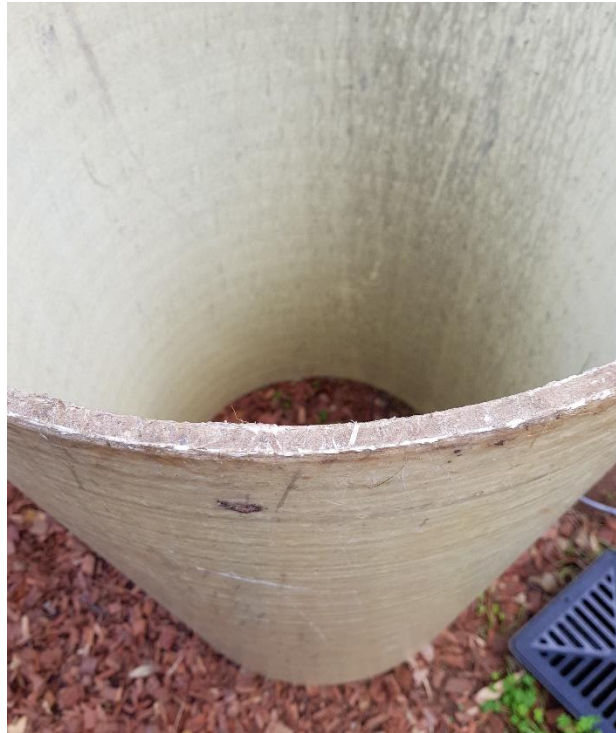
Figure 4 A side picture of the GRP pipe imaged

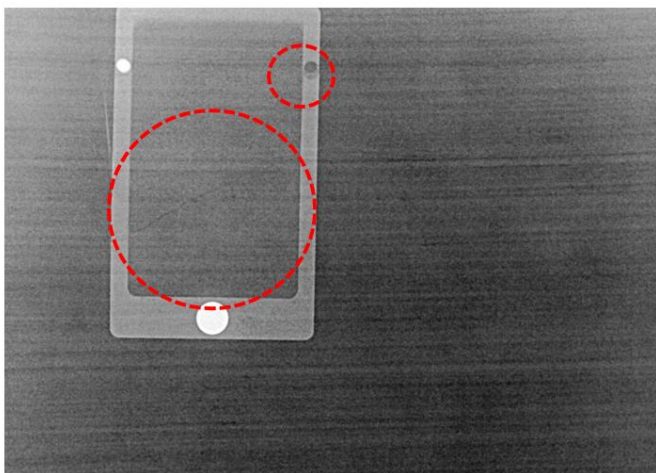
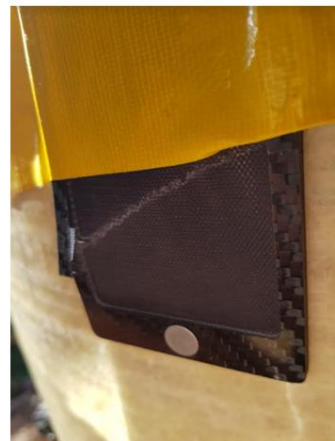
A GRP pipeline 600mm in diameter was scanned to determine the presence of a possible split or crack (Figure 4, Figure 5). We introduced a small piece of carbon fibre panel which we split and placed behind the 600mm fiberglass pipe. It was clearly observed within figure 5

that the weaves from the fiberglass pipe could be clearly identified. Additionally, the carbon fibre sheet with the split was also clearly observed within the image.

Figure 5 (left) X-ray image of the GRP pipe, (Right) The example defect using the carbon fibre flat panel.

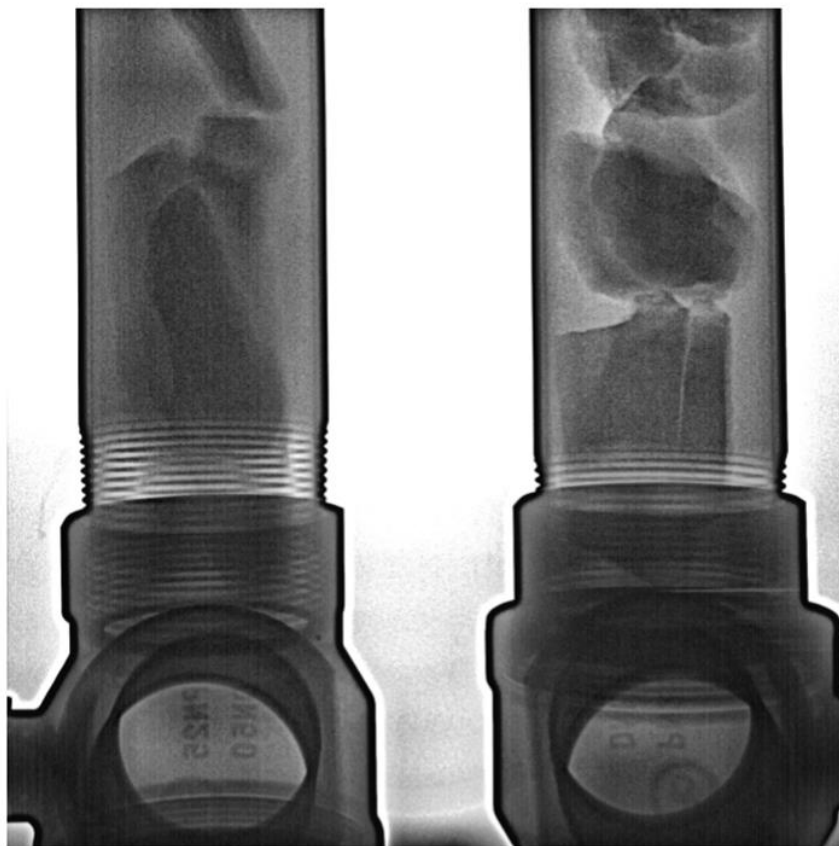
pipes. The 50mm pipe was formed by 5mm thick pipe wall with a 50mm ball valve at the bottom, the pipe was filled with stones to represent a blockage. In figure 6 it is clearly observed that the presence of water for a 50mm pipe had little effect on the image and we were able to generate a clear image. A large 150mm with and without water was also compared (Figure 7 and Figure 8). The 150mm mild steel pipe without water was very clear, though when water was placed in front of the pipe the image quality was not as clear. Therefore, the presence of water for pipes 150mm and above would cause an issue with the image quality and dewatering the pipeline would be suggested.

Figure 6 X-ray image of a 50mm pipe with rocks, the left pipe is with water and the right no water.

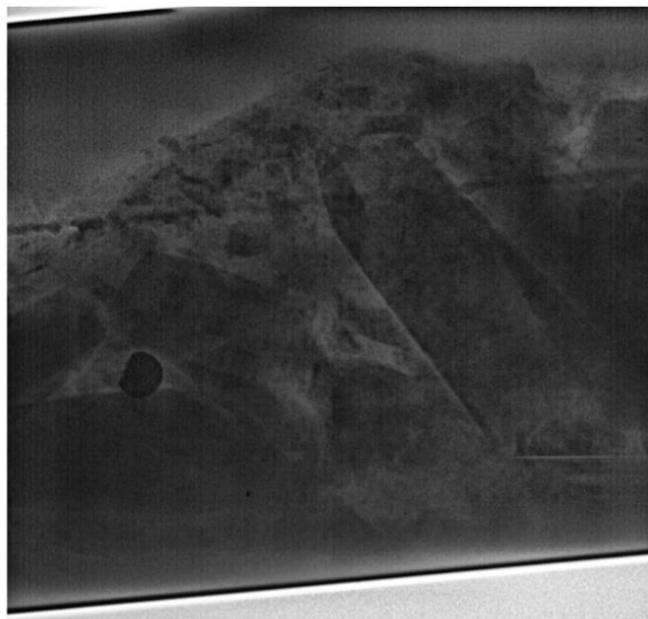
Figure 8 An X-ray image of a 150mm pipe without water and with sediment.
