DON'T TEAR DOWN THIS WALL – RENEWAL OF A U SHAPED SEWER

Andrew Owen, Stantec New Zealand and Steve Hutchison, Wellington Water Ltd

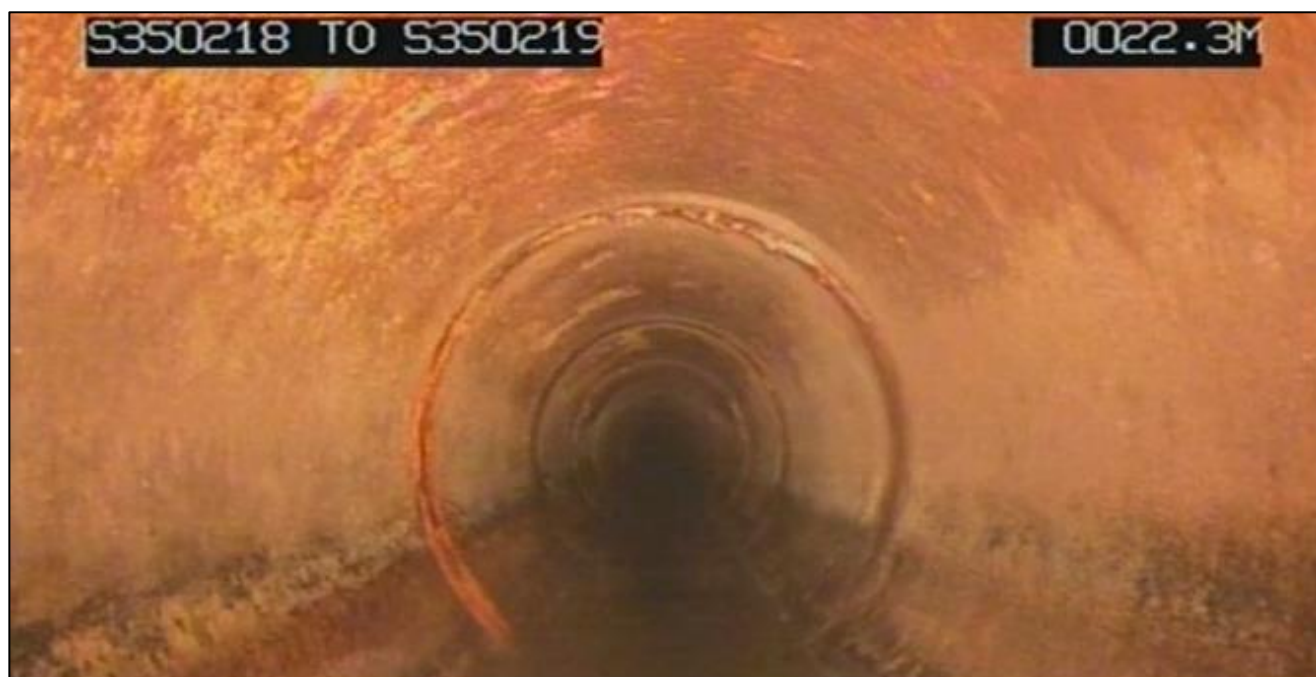
Figure 2: DN900mm Circular Main

All manholes along the alignment were non-compliant with the Wellington Water Regional Standard for Water Services (RSWS) 2012. The PCC operations team informed Stantec that entering the majority of the manholes on this alignment had a high risk status due to the narrow access, rusted step irons and depth of up to 4m to invert. CCTV was completed of the two pipe profiles as shown below in Figures 2 and 3. The condition of the U-shaped main was more deteriorated than the DN900 main.

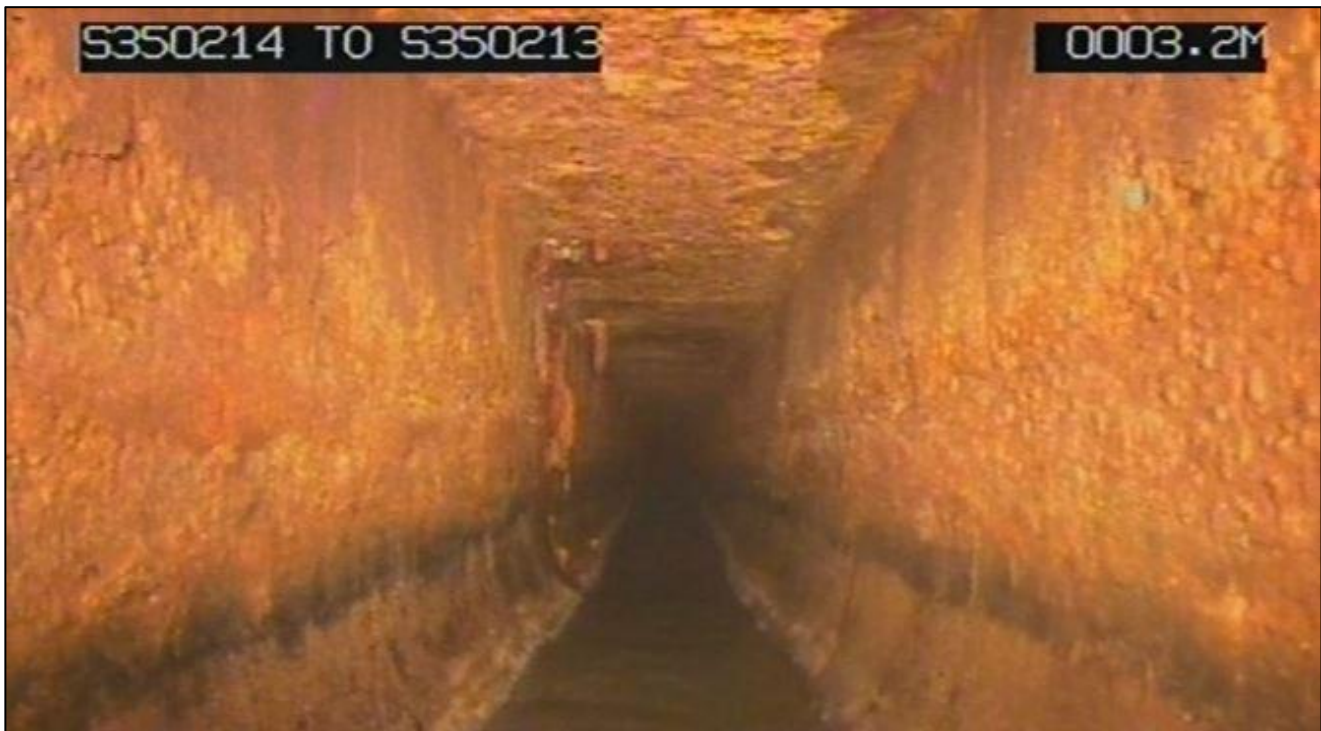
Figure 3:1000mm x 685mm U-Shaped Pipe

The U-shaped sewer had high levels of aggregate exposure with areas of reinforcing exposed. Encrustation was found to be present at most joint sections along the alignment with several areas showing significant material build-ups and deposits.

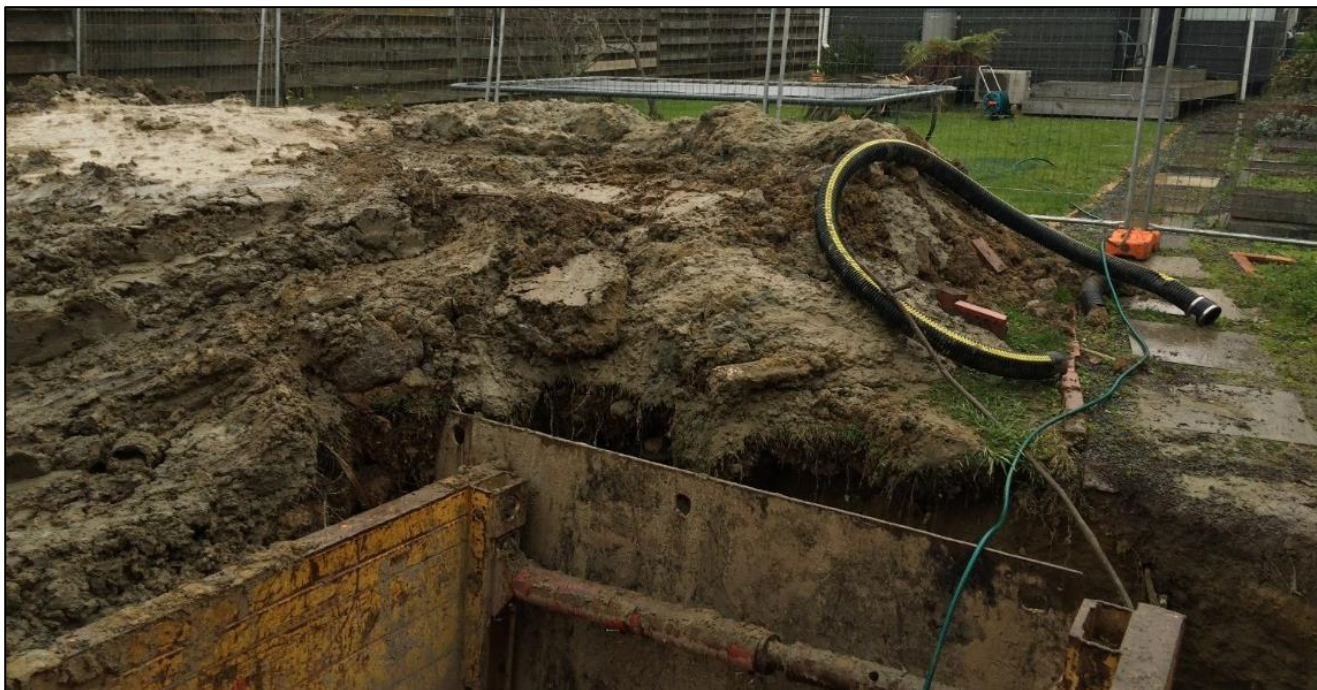
Figure 4: Manhole Replacement in private property

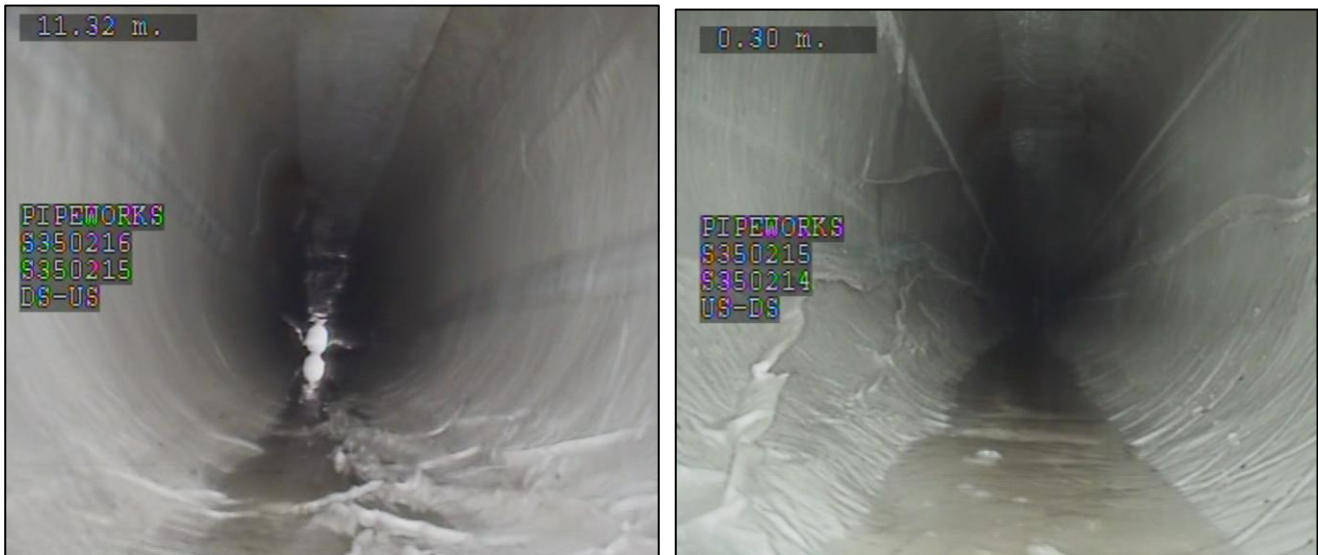
Whilst the liner was successfully inverted in the U-Shaped host pipe, a number of longitudinal fins were found to be present. In addition, bunching of the liner had occurred at the invert of the pipeline at some locations.

Figures 11 and 12: Photos of lined pipe showing longitudinal fins and invert wrinkling

The fins and invert wrinkling occurred to an extent that was non-compliant with the contract specification requirements. This states that wrinkling could not occur in an excess of 2.5% of nominal pipe diameter and that a hydraulically smooth finish was compulsory.

Once the remaining lining works and reinstatement phase of the project had been completed, a meeting was held with PipeWorks, Stantec and Wellington Water to discuss the impact of these defects on the liner. It was suggested by PipeWorks that the longitudinal fins along the U-Shaped main could be removed by a worker entering the pipeline to cut them off whilst at the same time remedying a number of the invert wrinkles. The liner supplier was consulted and confirmed that cutting the fins off would not have any negative impact on the structural performance of the liner.

PipeWorks commenced remedial entry works. This was completed in relatively short span of time. PipeWorks manually removed majority of the fins, with specific focus on ones located in the lower half of the pipeline. A measure of the remaining fins were completed which showed that they were within the specification tolerances of 2.5% of the nominal pipe diameter.

Although the fins have been removed some invert wrinkling remained. This is to be monitored by ongoing inspection for the duration of the Defects Notification Period.

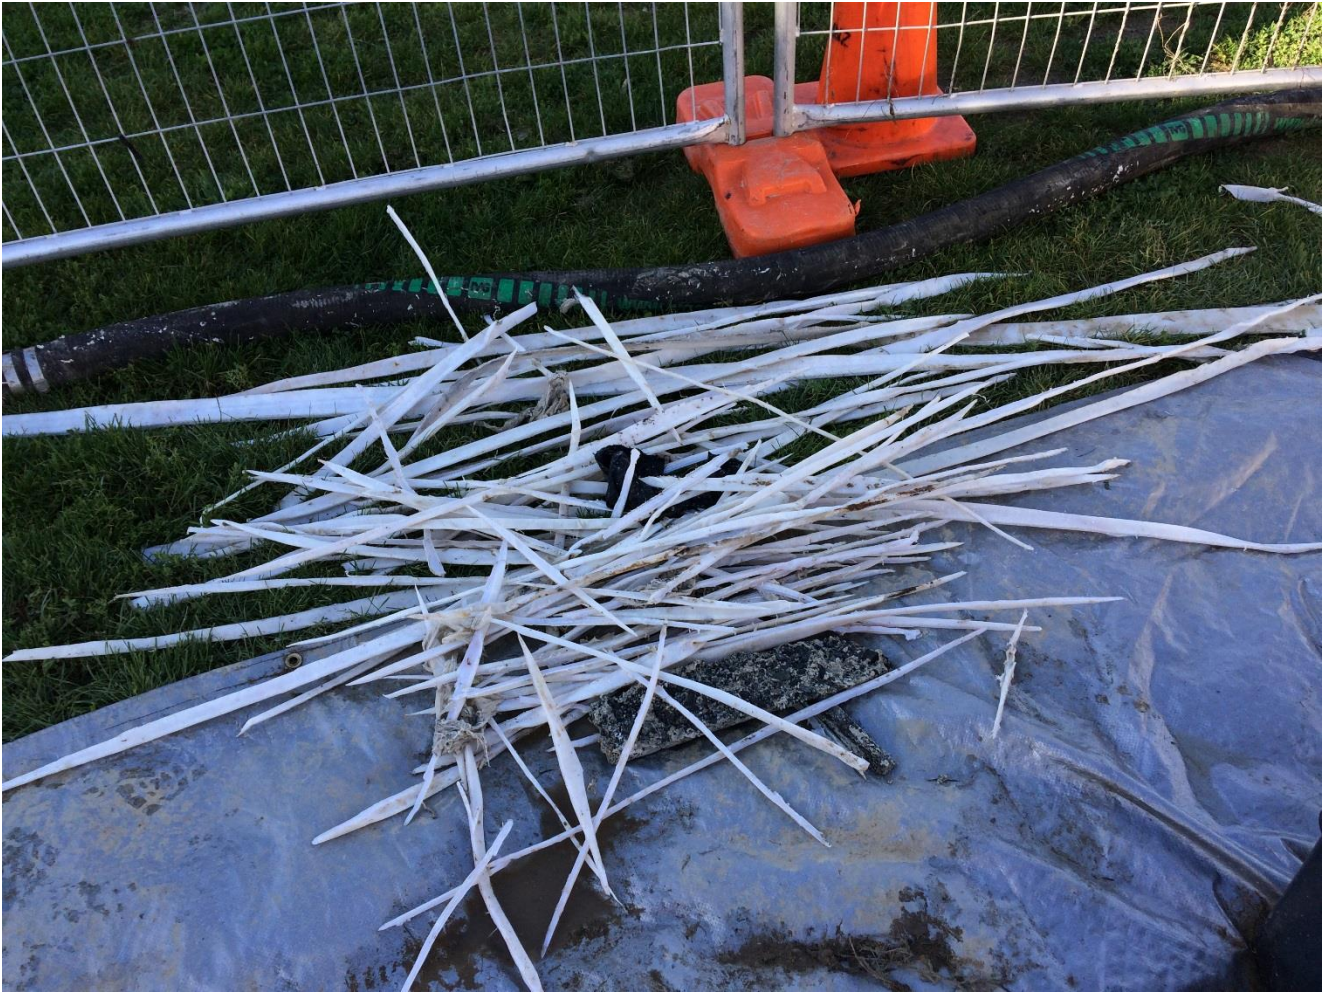
Figure 13: Cut liners removed from the U-Shaped Pipeline.
