# WHEN “TOO HARD” IS NOT ACCEPTABLE – MARINE PARADE WASTEWATER UPGRADE

*Jason Climo (Veolia), Simon Leary (Queenstown Lakes District Council), Jekabs Rozitis (Veolia)*

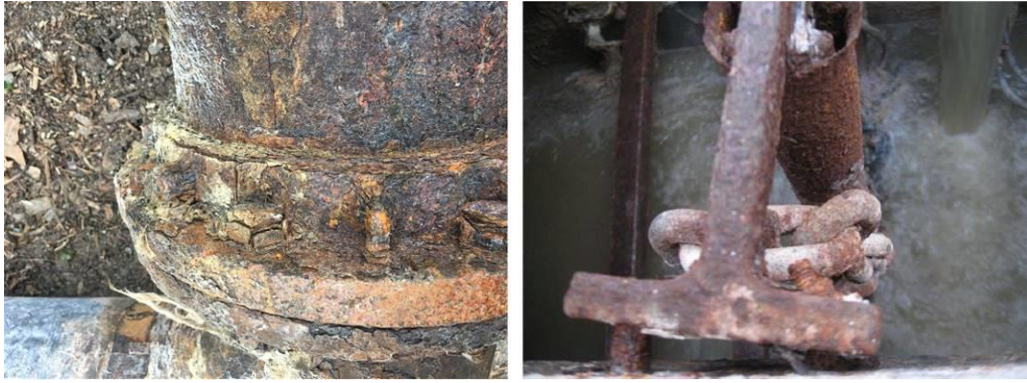
The pump riser pipework, brackets and rails were in poor condition. Additionally, the discharge manifold was mild concrete-lined steel, and not suitable for the conditions. Weeping was observed from a number of the welds. This had been observed at other pump stations in the district, prompting projects to rectify them.

Figure 4: Examples of asset condition. Corrosion on flange bolts of riser (left) and rail bracket coming away from wall (right)

New risers were designed, constructed from 316SS, with two takeoffs at the top end. One takeoff would bolt into the existing manifold, and the

These risers were locally manufactured, with excess length on the end to allow confirmation of fit on site. To confirm the bottom flange pattern, the methodology included removing the old riser from one pump and sending it to the local engineering workshop to copy the pattern on the replacement risers. At the same time, one of the new risers was lowered into position to confirm the length. The new riser was also returned to the workshop for cutting to length, passivating, and welding of the appropriate flange and backing ring. One riser was replaced at a time to ensure availability of at least two pumps at all times.

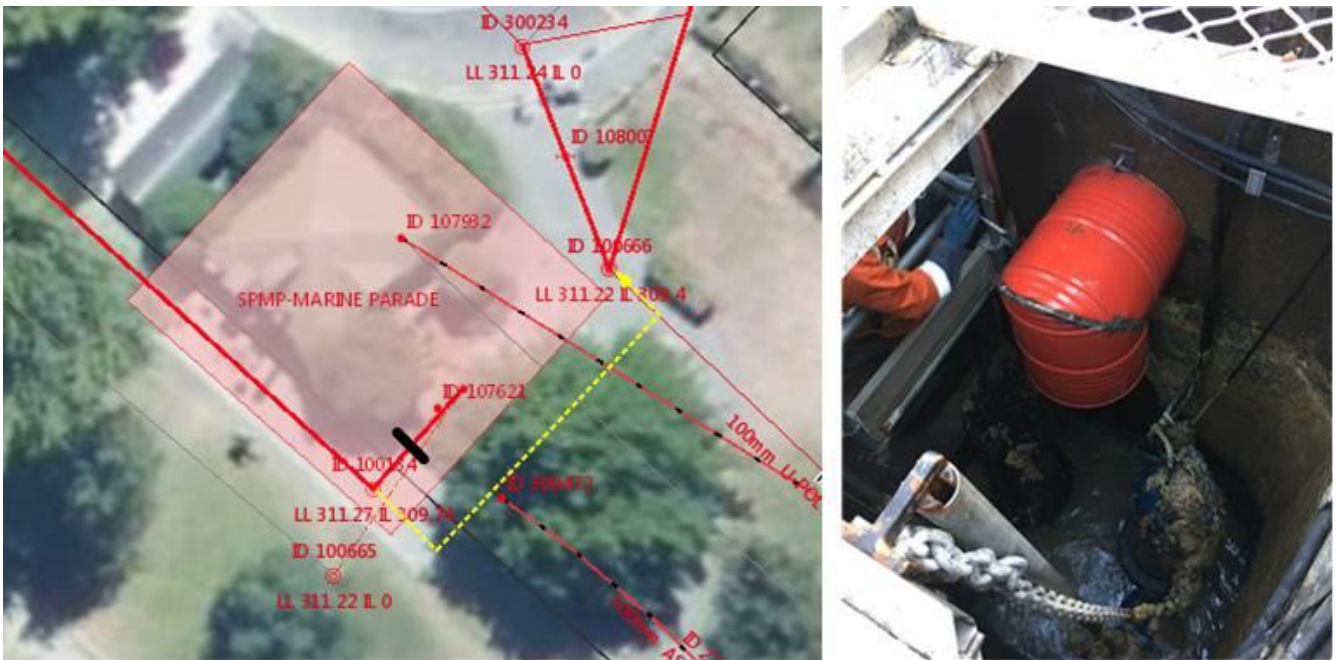
Figure 5: During a low-flow period, an inflatable bung was inserted into the pipe from Fernhill (at the black line) and a pump-around set-up (yellow) to enable fitting of a temporary baffle to protect workers in the well (right photo).

To enable well entry, it was necessary to control the flows going into the well. This was achieved by firstly examining flow patterns to schedule the phases of work. Then a pump around was arranged using a Selwood S150 mobile pump and inflatable bungs to isolate the Fernhill inflow during off-peak time so that a temporary baffle could be fitted to that outlet. Once the baffle had been fitted, the pump-around was reversed to ensure that all flow went through the baffled inlet, minimizing exposure to operators working in the well.

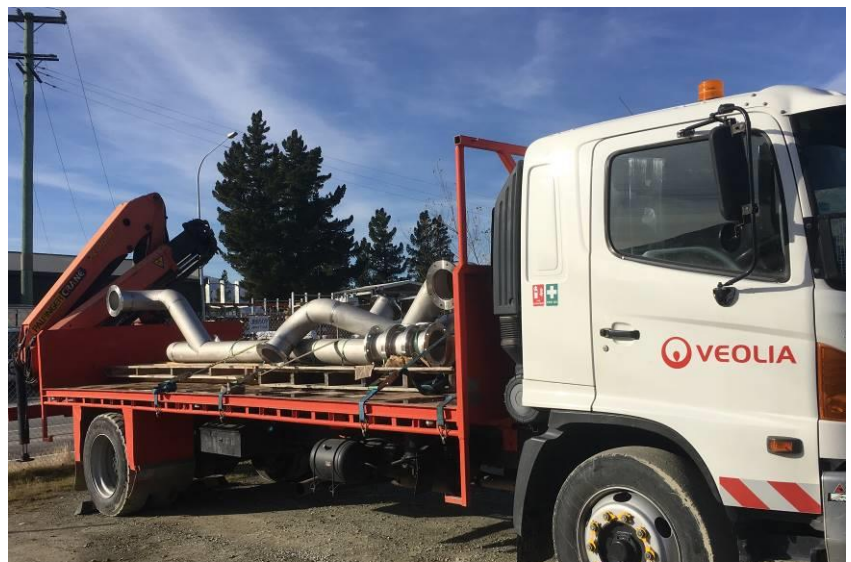
Figure 6: Replacement risers ready for transport to site

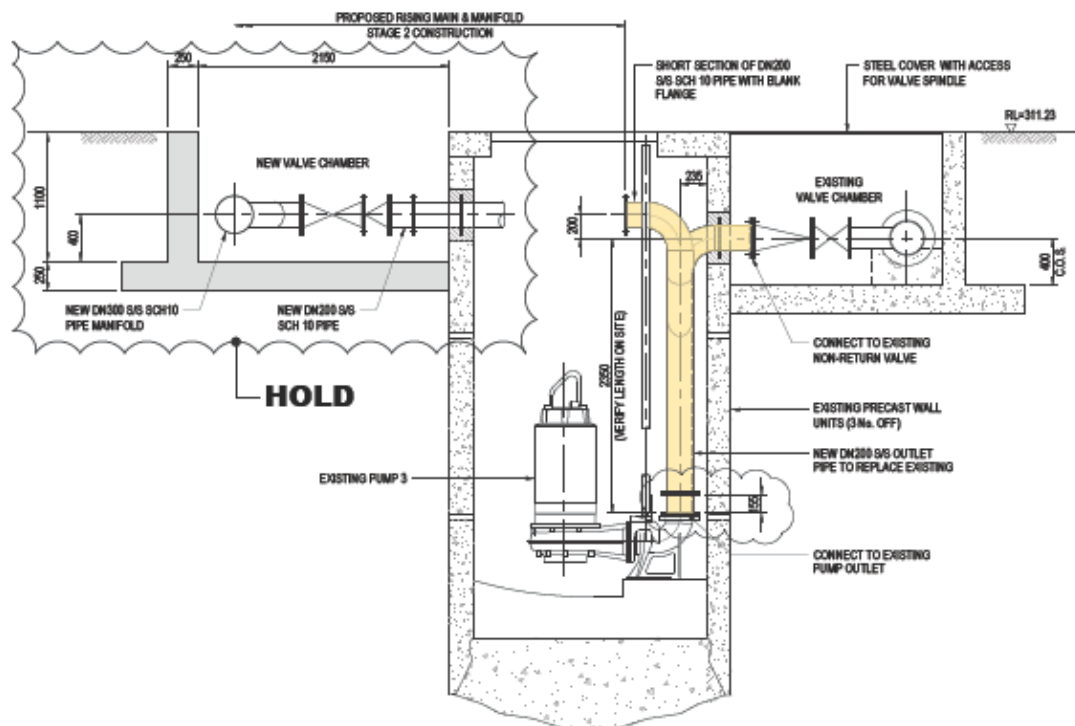
Figure 7: Elevation view of the new risers (orange shaded) with an additional blanked-off take-off to a future valve pit and manifold

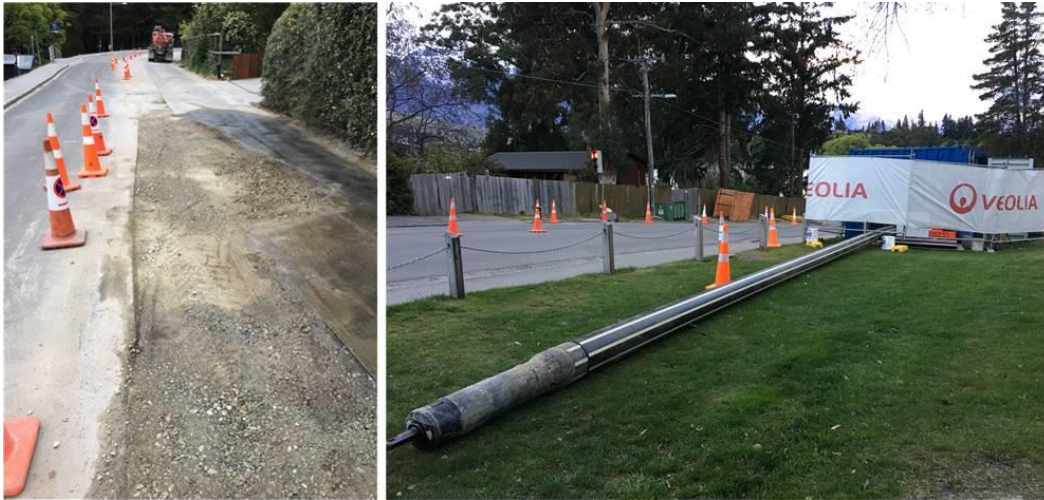
However, this required considerable planning and surveying to make sure that the line was where recorded. For example, a section had been removed from the corner of Park Street, meaning that either the pipe would need to be open trenched, or pulling pits would need to be established in the Park Street carriageway. This would lead to many weeks of traffic disruption in a very busy area. The methodology was revised after identifying this missing section. A DN300 duct was very quickly installed in the missing section to enable the full pull, with minimal traffic disruption. This enabled establishment of the third pit off the carriageway, and in an area where pipe strings could be easily welded and laid down.

*Figure 8: Detailed investigation and measurement identified a missing section in the abandoned main. Replacement duct (left) was laid within a short space of time, minimizing traffic restrictions on Park St, allowing pull pit and welding to be established off the carriageway (right).*

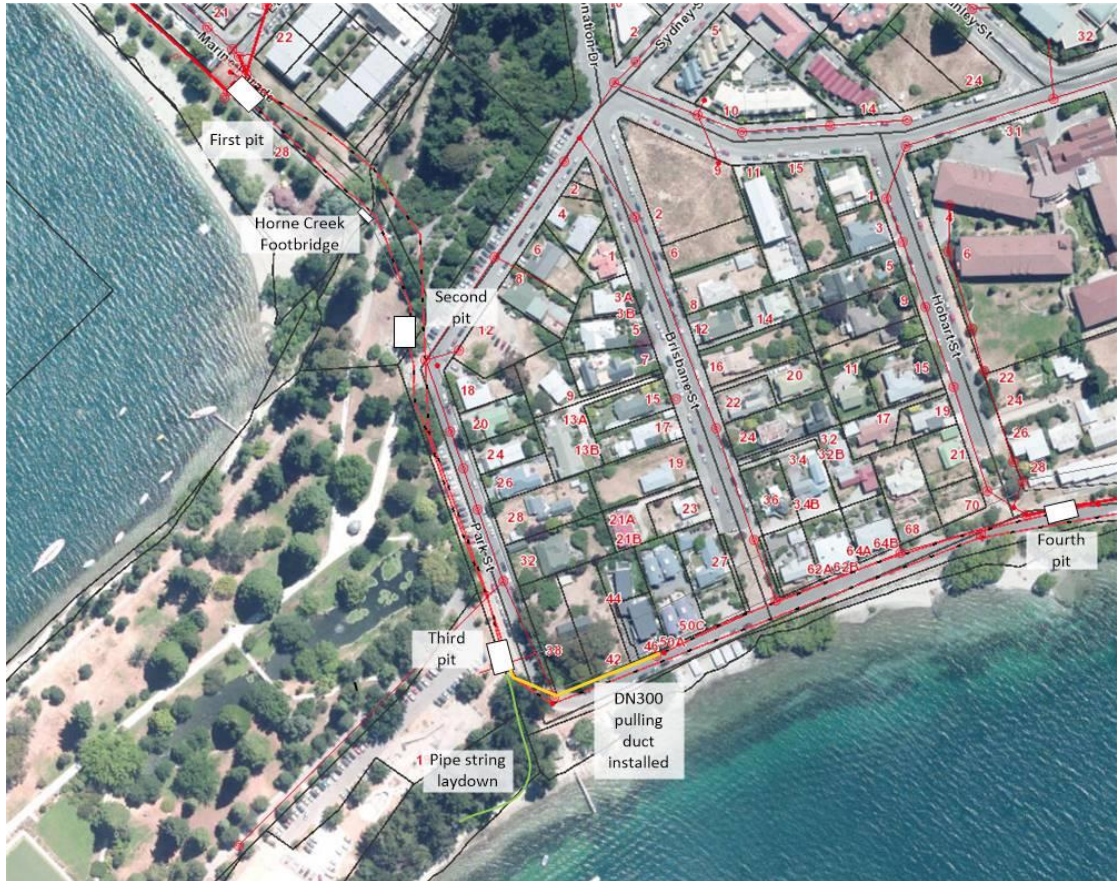
Another aspect which was impacted by variable records was the design of footings of the pedestrian bridge across Horne Creek between the first and second pits. The dimensions of this footing were larger than records showed, and interfered with the pull under the creek, leading to an injury in the team. This needed to be excavated and the excess footing removed. By using the hydroexcavator the footing could be very precisely exposed without any silt mobilization into the creek.

*Figure 9: Overview of works through the Botanic Gardens. Minimal impact on public amenity, environmental and historical values through slip-lining. Adjusting the plan to suit found conditions avoided disruption to Park Street traffic*

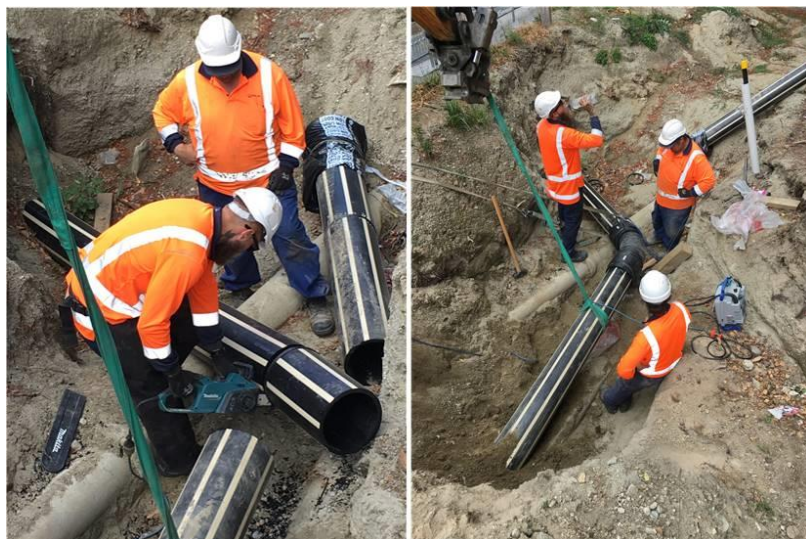
*Figure 10: Having the right fitting in the right place, the result of careful planning and careful measurement*

Critical areas were GPS located and/or potholed to ensure that the correct fittings were available to suit the pipe alignment. An example of this is the 45 degree electrofusion coupling at the third pit, which perfectly suited the alignment of both pulled strings

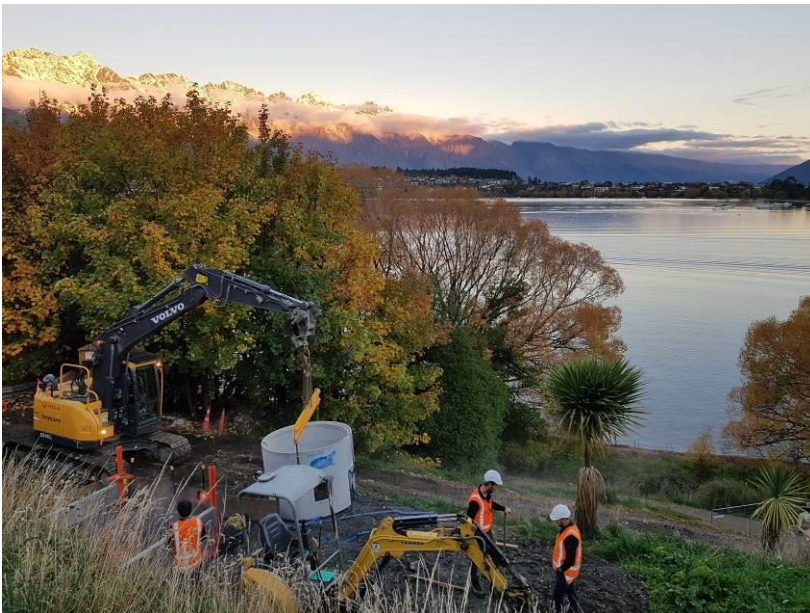
*Figure 11: No margin for error working on live sewer assets this close to the lake*

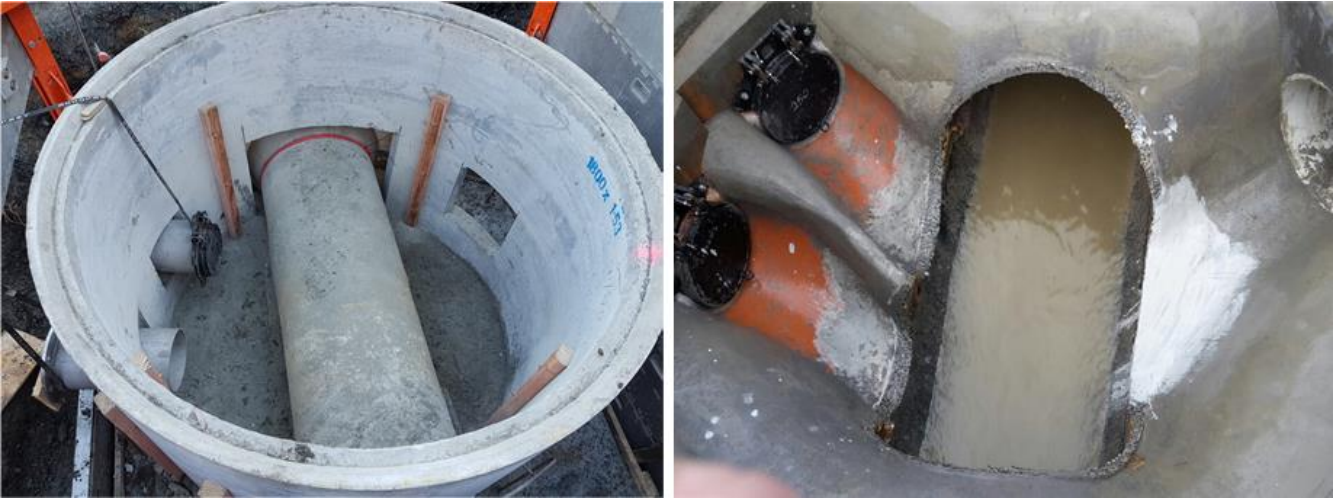
However, the manhole on top of the rising main is in very poor condition, and crowded with lots of penetrations and would not have taken another one. A new manhole was needed, installed onto a live asset (a DN600 concrete main constantly at half flow and above), within 100 m of a pristine water body.

*Figure 12: Building a manhole over live sewer assets.*

The solution was to partly expose the DN600 pipe and pour supports under it so that a 1050 long section could be completely exposed. A manhole riser was then lowered over the exposed pipe with penetrations cut to accommodate all required inflows, including a future pipe. Reinforcing steel was then

placed under the pipe, and concrete mass poured and haunched to suit the incoming pipes. Finally the top of the concrete pipe was removed, and shaped to suit the haunching, and the new rising main joined in.
