# THE FUTURE OF WELL HEAD PROTECTION IN CHRISTCHURCH

*Mike Thorley (Beca), Lisa Mace (Beca), Bridget O'Brien (Christchurch City Council)*

## ABSTRACT

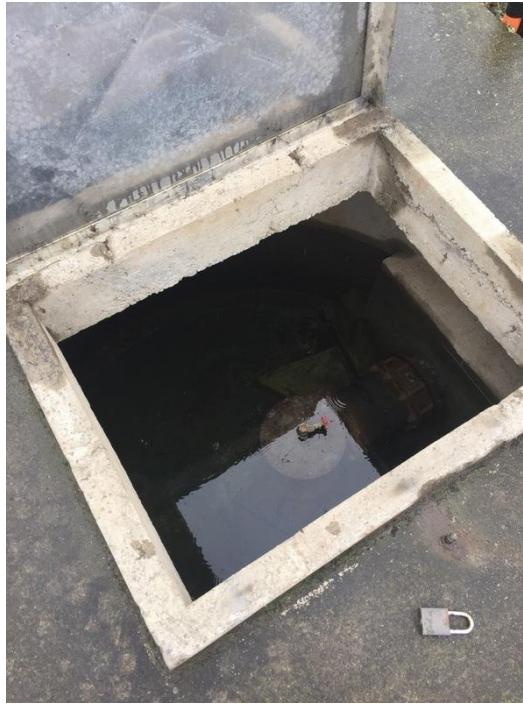
Generally, the condition of the well heads did not meet the current requirements of the drinking water standards. There were a number of well chambers that had water in them and some where the water level completely submerged the well head (see Figure 1). In some cases, this water was due to leakage from the well head, but in other cases the water entered the well head through the lid, unsealed well head penetrations, drainage pipes, and cracks in the well head. In a few cases there was only a gravel floor to the well head (i.e. no concrete floor had been installed).

*Figure 1: Example of a well head chamber filled with water*

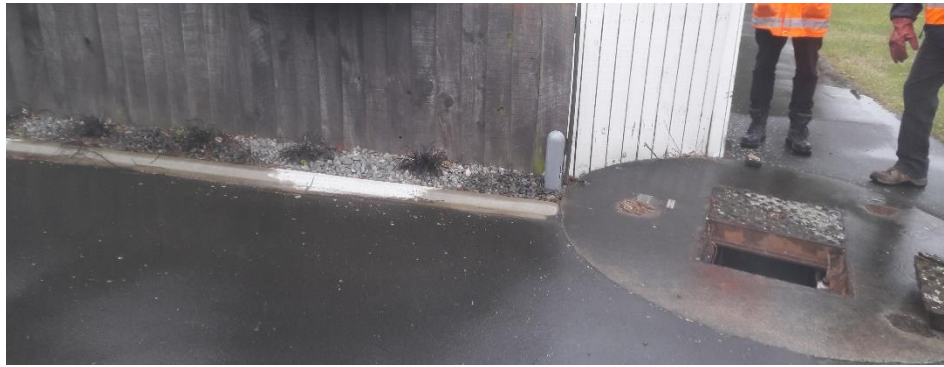
Some below ground well heads were positioned in a surface drainage pathway meaning that runoff from a road, footpath or driveway would enter the well head chamber if the lid was not sealed (see Figure 2). Another area of concern is the level of the well head relative to flood level. Below ground well heads located in flood prone areas have a risk of becoming inundated through any unsealed pathways. This surface water is likely to contain contaminants that have been collected as it passes over land. The surface water may also contain raw sewage e.g. near the Heathcote River where sewage overflows may occur during significant wet weather events. Three below ground well heads located near or on the banks of the Heathcote River were of particular concern and are highly likely to have been, or showed recent evidence of being, inundated by river water (see Figure 3).

*Figure 2: Example of a well head with surface water drainage paths into it*

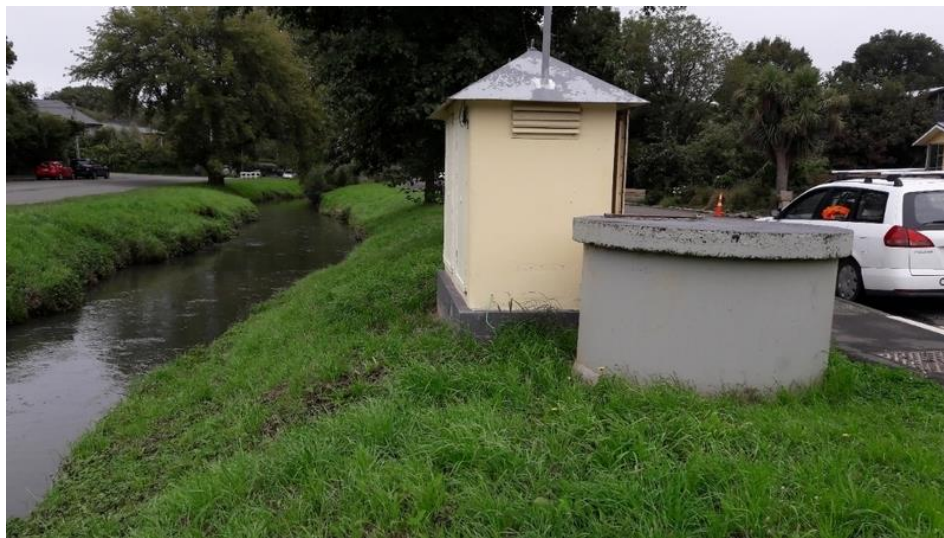
*Figure 3: Example of a well head on the banks of the Heathcote River*

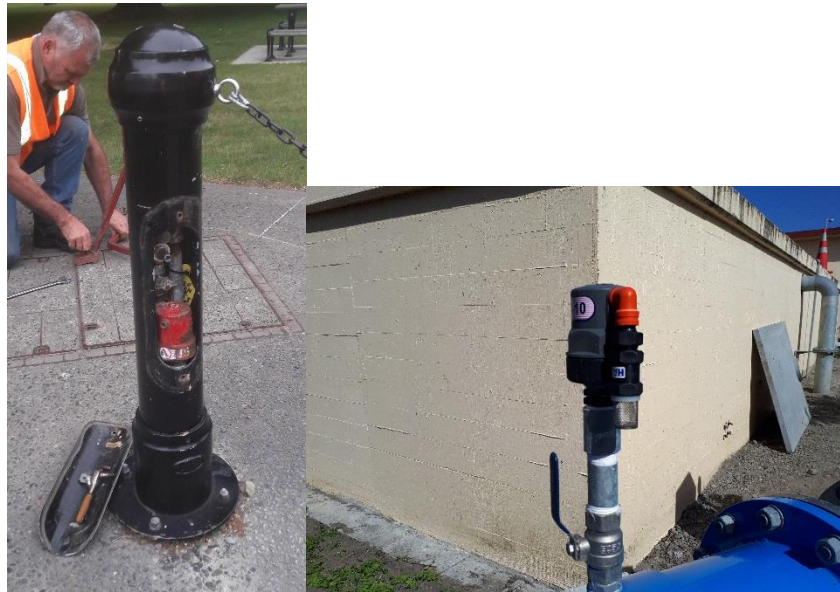
Figure 4 shows an example of how an air vent can be installed outside the well head. In left hand photo, the air vent is installed in a bollard together with the sample tap. The other photo, the air vent is positioned on top of the well head. Two way air valves can also be used where flowing artesian conditions occur at the well head. It is important to add mesh to the vent pipes including the valves to prevent access by vermin etc.

*Figure 4: Examples of an air vent outside of a well head*

Air vents were rarely installed on the wells. They are important for any pumped bore and those artesian bores where the surface pump suction head drops below the well head. When water is pumped from a well, the water level inside the well drops causing a vacuum or a void which needs to be replaced by air. If there is no air vent then there is no pathway for air to enter the well, and suction within the well develops. This may result in potentially contaminated water being drawn in from the ground and/or from surface through gaps in the well casing or the well head. Air vents must also be set above the 100 year flood level so that flood water cannot enter the well via the air vent.

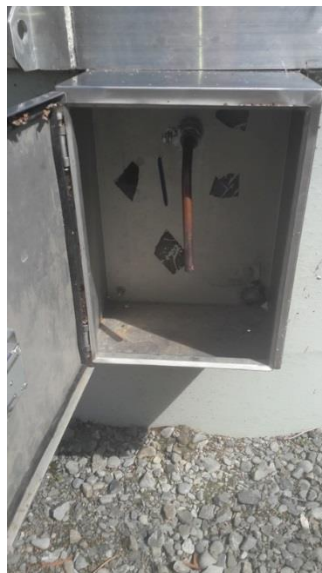
Some wells had sample taps installed within the below ground well heads while others had sample taps situated in cabinets outside the well heads. Locating sample taps outside the well heads is preferable as it is important to avoid draining of the sample tap into the well head (see Figure 5). We note that the sample taps should not form a direct connection to the main line and should have an air gap device to prevent material being potentially drawn through into the reticulation.

*Figure 5: Example of a sample tap outside of the well head*

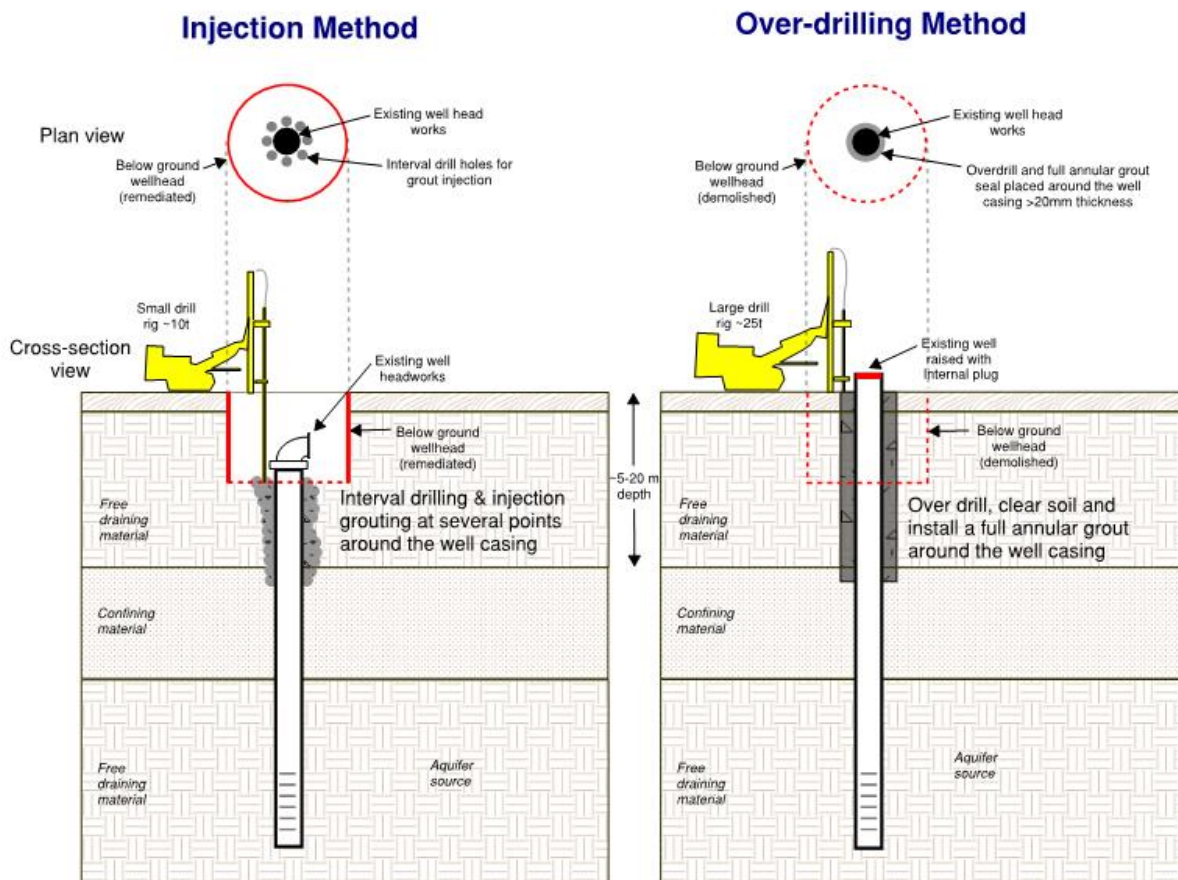
Figure 6: Schematic of options to retrofit annular grout seals to the well casing

Two methods for retrofitting grout seals were identified and are shown schematically in Figure 6. The first method involves injection of a bentonite/concrete fluid around the casing to the desired depth. The second method involves over-drilling the casing with a larger casing and then backfilling the annulus with the bentonite/concrete fluid while the outer casing is withdrawn. The advantages and disadvantages of each option are compared in Table 1. The injection method has been assumed for all wells where the below ground well head is to be maintained while the over-drilling method is assumed for chambers that are to be brought above ground.

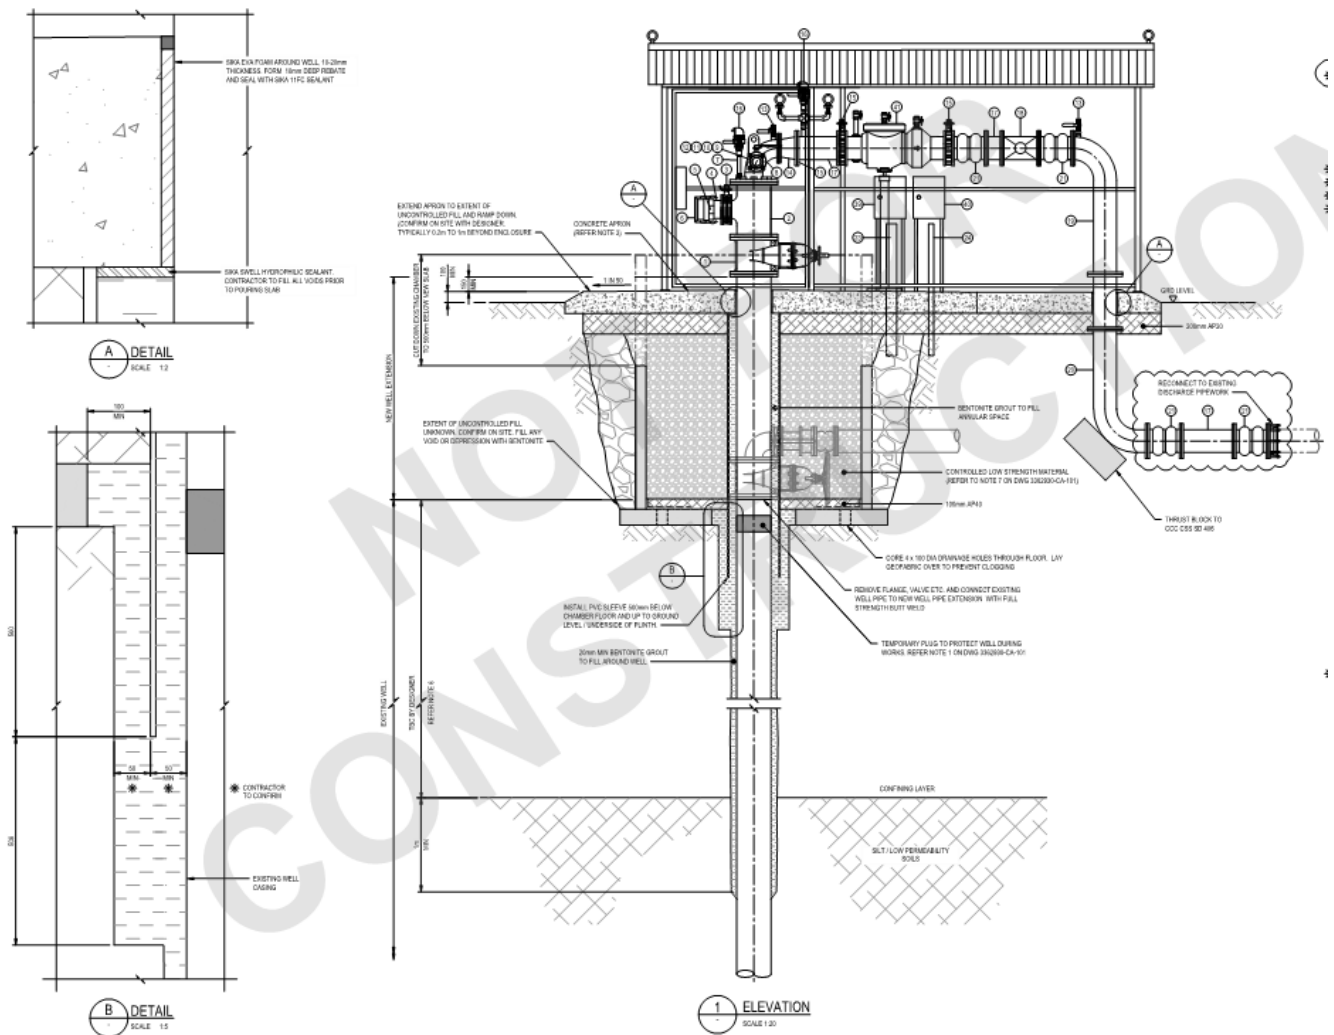
Figure 7: Standard drawing for raising a well head above ground

The standard CCC above ground well head design was adapted to include the retro-fitting of an annular seal, filling of the chamber, and the installation of an above ground head works. Figure 6 shows an example of one of the standard design drawings developed as part of the well head remediation programme.

1. Removing the existing well head works, adding a length of well casing to reach above ground and installing a temporary plug to hold back the artesian flow.
2. The chamber base is then cut back such that a drilling contractor can install a stabilised bentonite mix to at least 5 m and key into a confining shallow layer. This exceeds the current drinking water standards guidance requirements of 3 m and meets aspect of the Australian Drilling Standards. The grouting approach seals the potential pathway for contaminants to enter around the well casing.

3. Once the annular seal is near the chamber floor level a PVC sleeve is placed around the well casing to create a form work within with the stabilized bentonite seal is placed. Considerations of seismic resilience show a preference for a flexible stabilised bentonite mix, rather than a rigid cement grout.

4. The chamber floor is prepared by cutting drainage holes and cover and placing geofabric and a thin layer of drainage aggregate over the floor. The chamber walls are cut down to avoid pressure points on the underside of the plinth.

5. A low density low strength flowable fill is then added to the chamber for ease of filling, to avoid confined space entry, and to provide a light weight alternative to compacted granular material and minimise seismic risk.

6. A standard CCC well head works is then installed which includes a two-way low pressure air vent with mesh set above flood level, with double bellows and double check valves. Electrical upgrades including level sensors and a flow meter connected to SCADA will also improve the operational understanding of each well.

7. A trafficable structural apron around the well head is laid which is sufficiently wide to cap the underling chamber in order to prevent surface ingress. The connection with the apron and well casing includes a rattle space and flexible sealant to allow for movement in earthquakes.
