Rehabilitation of Stormwater Culverts

Jonathan Morris, Jayesh Dhanjee

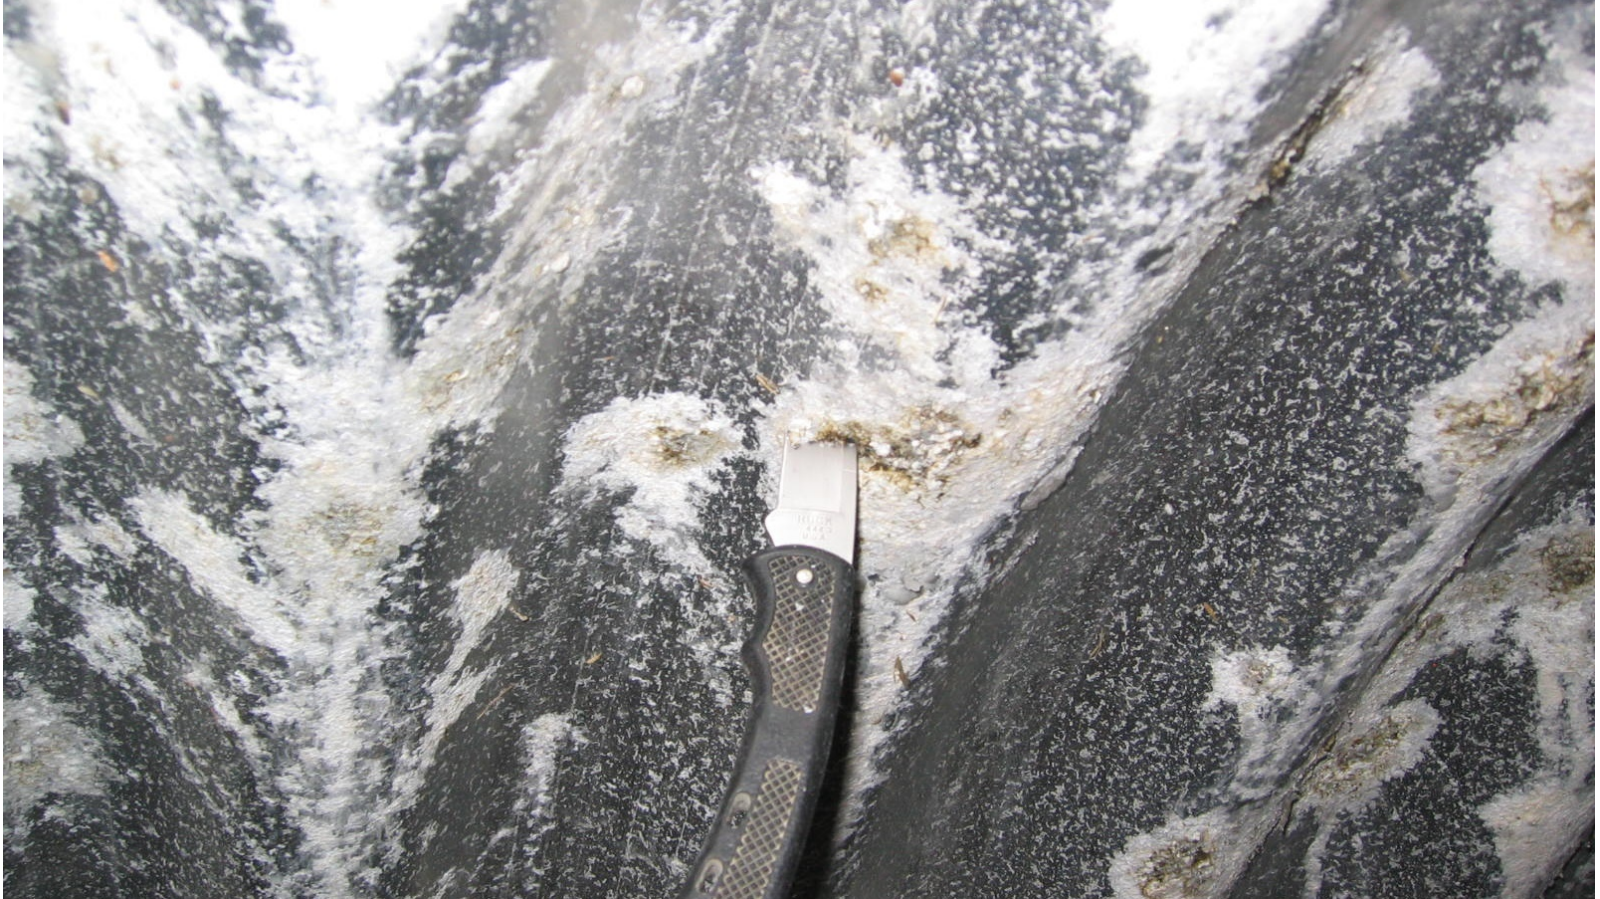
- 1987 - Constructed
- 2006 – Some pitting noted
- 2008 – More pitting observed
- 2010 – More and worse pitting,
Specialist corrosion investigation
- 2014 – March, started lining
April, practical completion

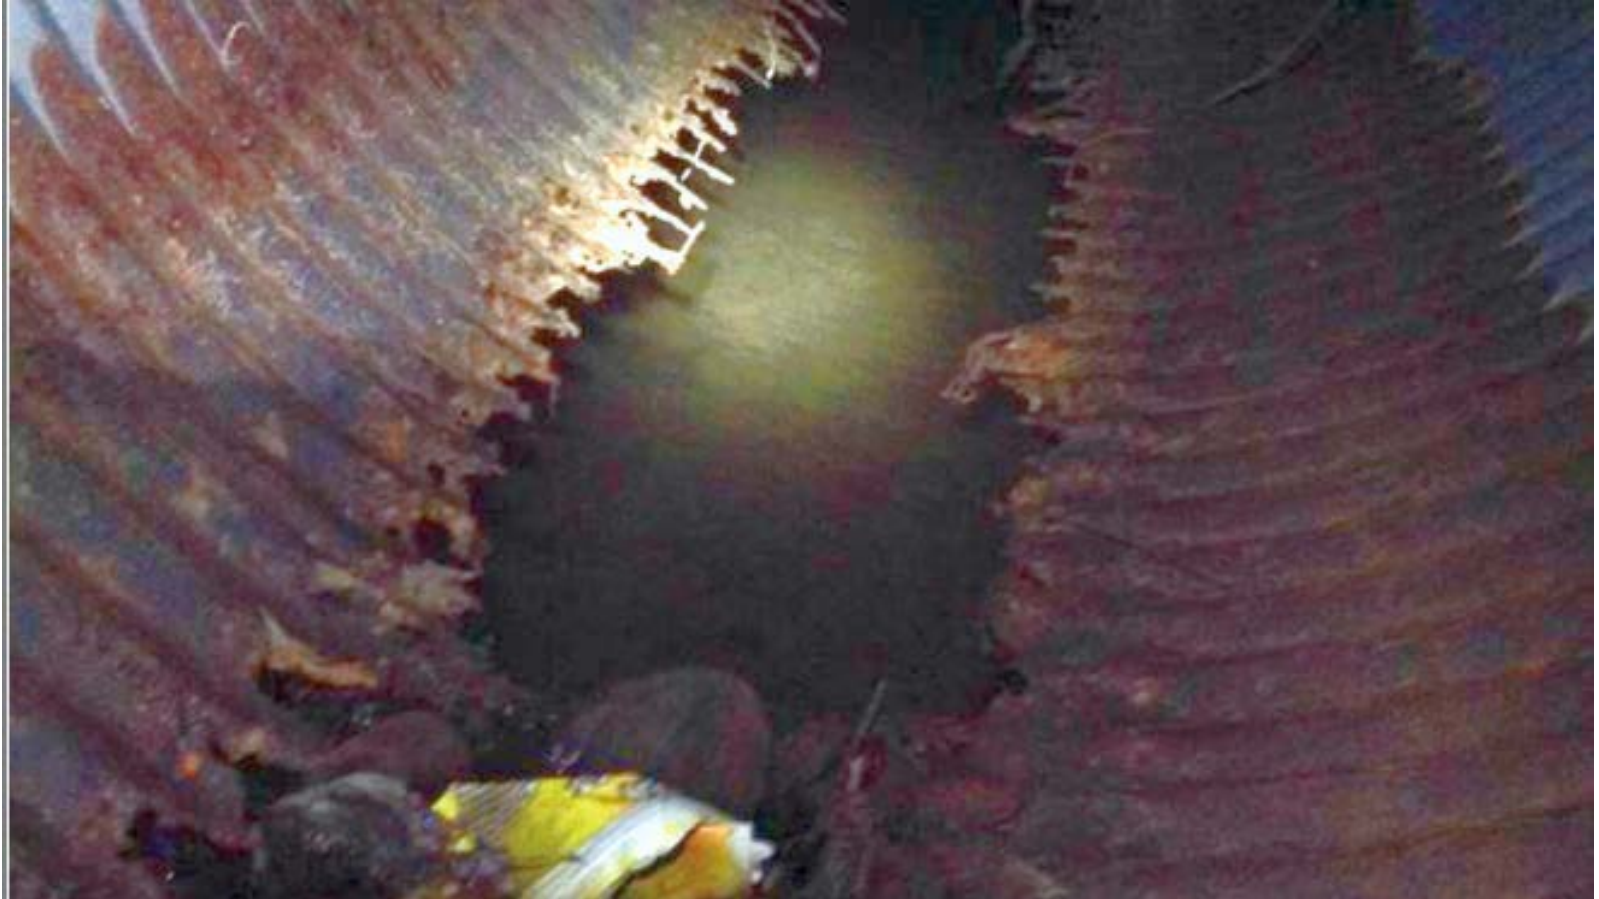
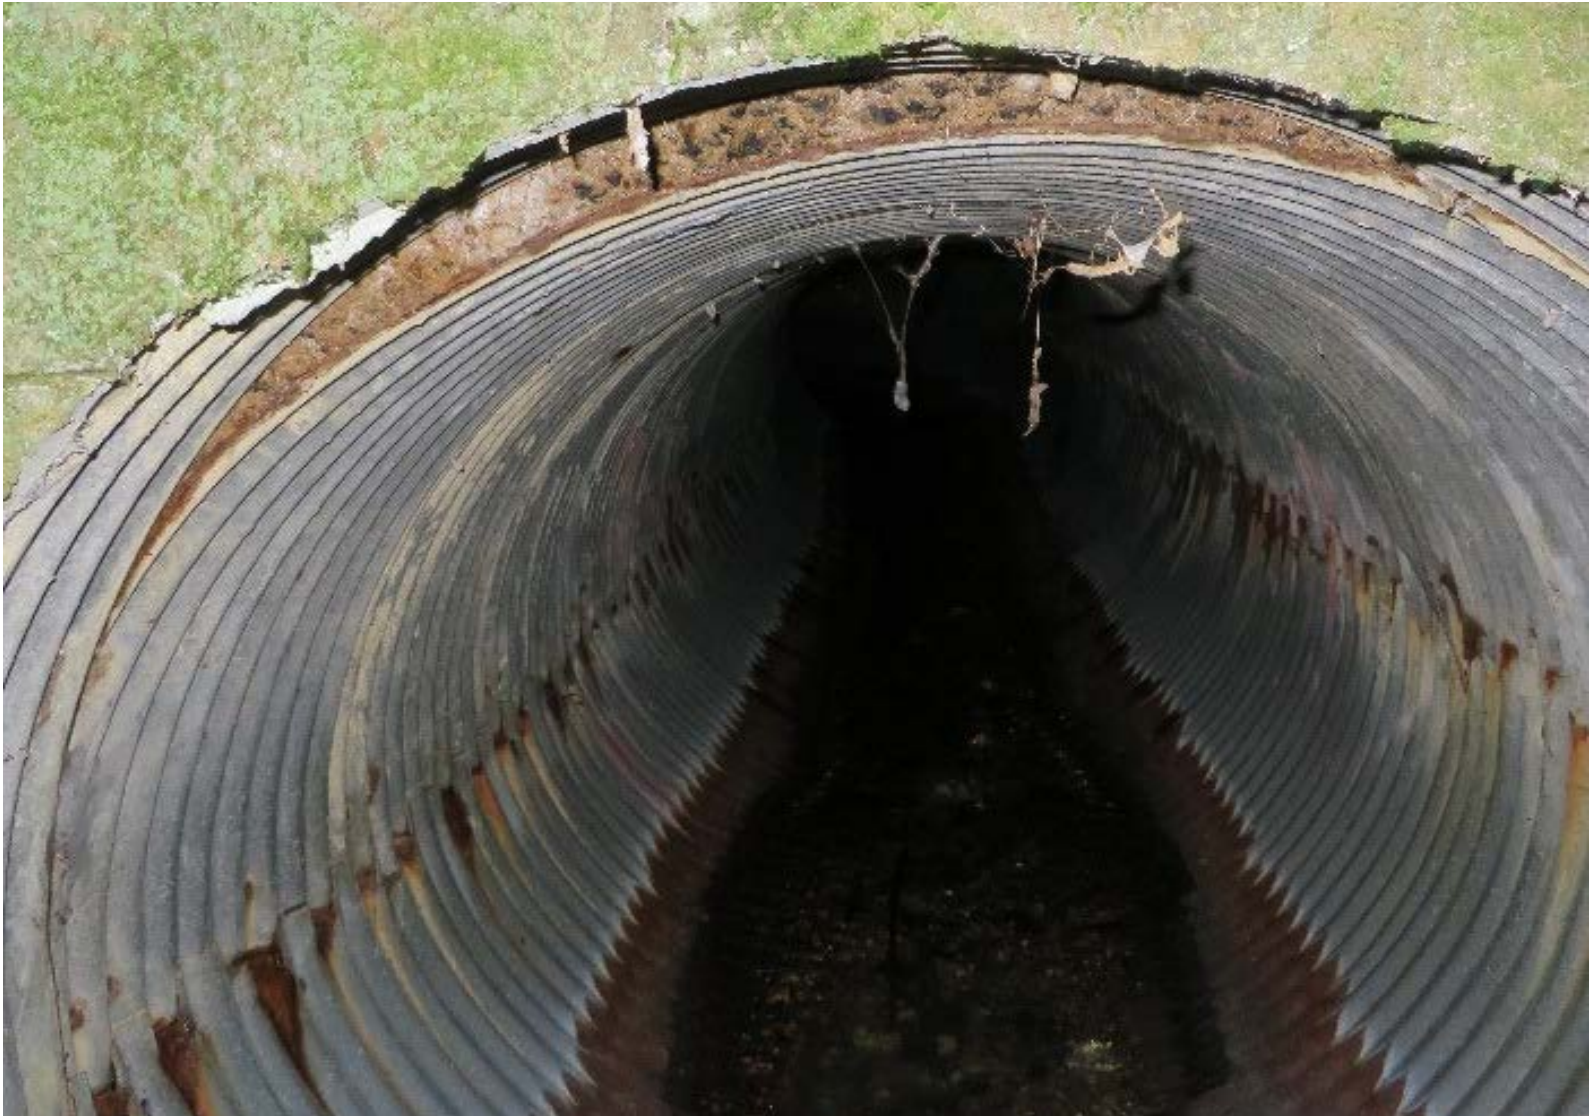
- 1978 - Constructed
- 2011 – Corrosion first identified
- 2014 – Opus engaged
- 2016 – April, HSAW Act
 - November, Kaikōura Seddon event
- 2018 – Practical completion
