RESILIENCE EXAMPLES IN RESERVOIRS, PUMP STATIONS AND PIPELINES – LESSONS LEARNED FROM THE CANTERBURY EARTHQUAKES

Dennis Hunt (CH2M Beca Ltd) and Gavin Hutchison (CH2M Beca Ltd)

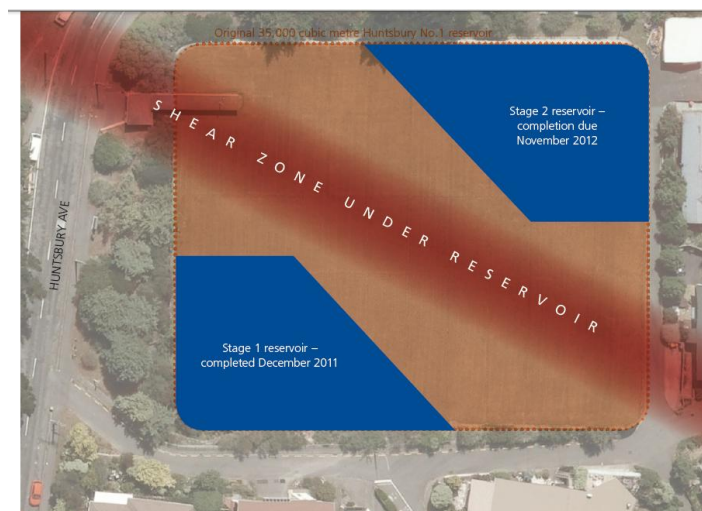
Photograph 1: Huntsbury No. 1 Reservoir Plan

A previously unidentified shear zone in the basalt under Huntsbury No 1 reservoir ruptured causing structure dislocation and loss of all stored water. It was estimated by the geologist who reviewed data from inclined boreholes done as part of a site investigation after the June 2011 earthquake that the last movement of this shear zone was in the order of 15,000 years ago.

The reinstatement of the reservoir was limited to sections each side of the shear zone as shown in photographs 1 and 2.

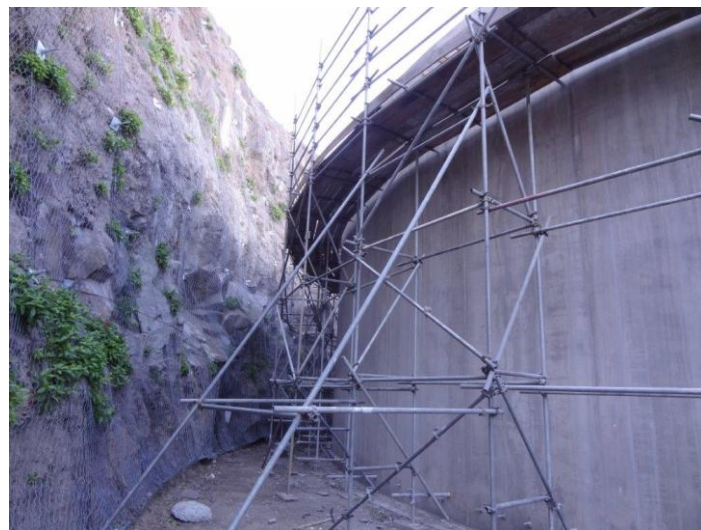
Photograph 3: McCormack’s Bay Reservoir Rock Fall Protection

The McCormack’s Bay reservoirs are located on a platform cut into a hillside. Rockfall and instability in the cut slope above the reservoirs presented a significant hazard which needed to be mitigated prior to external reservoir remediation works (Refer No. Photograph 3) and localised filled areas on the access road on the downhill side of the site required extensive retaining works and restricted access to the site.

The lessons from McCormack's Bay are the need to inspect and assess the geological conditions, and visualise the likely performance of cut and filled slopes during seismic events.

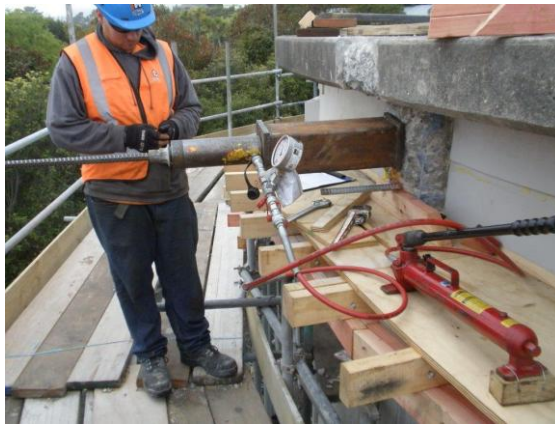
Photograph 4: Upper Balmoral Reservoir Testing Anchorages for Ring Beam

A similar method was used to reinstate the Upper Balmoral reservoir roof/wall connection where the failure mode was roof tee beams punching through the wall (Refer Photograph No's 4, 5 and 6).

In both cases the retrofit design was made difficult due to the lack of sufficiently strong components in the perimeter of the roof and strength limitations in the top of the walls. At Upper Balmoral these difficulties were overcome by core drilling holes into the ends of the radial prestressed tee roof units and epoxy grouting Reidbars into them thereby providing anchorage for the ring beam. However the wall section was not strong enough to resist the horizontal seismic load from the ring beam in bearing against the wall, requiring the transfer of the load to the pilasters and from there via shear to the base of the wall.

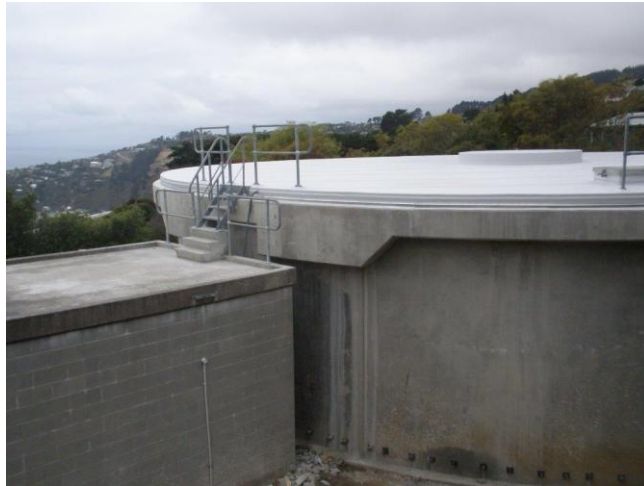
Photograph 6: Upper Balmoral Reservoir Ring Beam and Roof Membrane

Damage at the roof to wall joint and cracking in thin concrete roof toppings increased the risk of contamination. Christchurch water is not normally chlorinated but given the extent of damage in the water supply system the decision was taken to chlorinate.

Due to the difficulty of repairing the extensive cracking in roof toppings, membranes were installed on Upper Balmoral (refer Photograph No. 6) and McCormack's Bay reservoirs. Membranes were also installed on the Huntsbury Stage 1 and 2 reservoirs even though the topping was 200mm thick. In the case of Huntsbury this allowed the roof slabs to be poured in large pours which was critical to achieving the programme. If programme had not been a consideration extensive jointing with PVC waterstops could have been contemplated with the advantage of reduced maintenance.

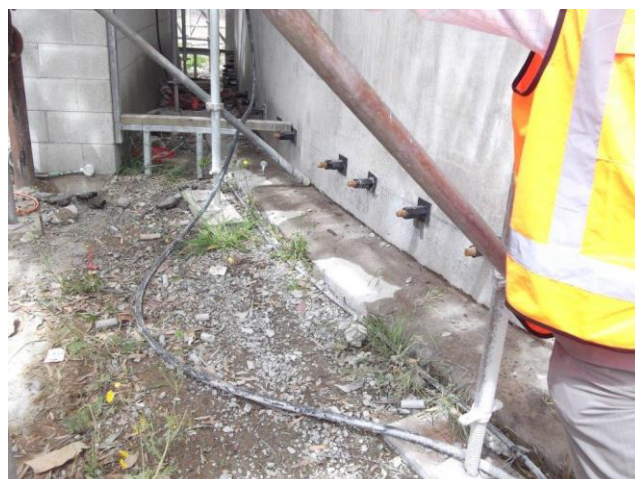
Photograph 7: McCormack's Bay Shear Connection Wall to Floor

Calculations using 2011 seismic design loadings indicated a lack of shear connection strength at Huntsbury, McCormacks and Upper Balmoral. In each case there had been floor slab damage. The repair method adopted consisted of new reinforced concrete floor slabs (Huntsbury and McCormacks) and a shear connection between the floor slabs and the wall. This connection consisted of Reidbars installed through cored holes in the wall and anchored into a beam above (and connected into) the floor slab within the reservoir (Refer Photograph No's. 7 and 8).

The key lessons on connections are to resolve the seismic resistance philosophy for the structure at the outset, and to provide adequate strength and watertightness in the connections. The adequacy of these connections rely on detail and need to be considered at concept design stage to ensure the design of wall, roof and floor slab sections is compatible to accommodate them. The roof to wall detail has the added complexity of providing for temperature expansion and contraction.

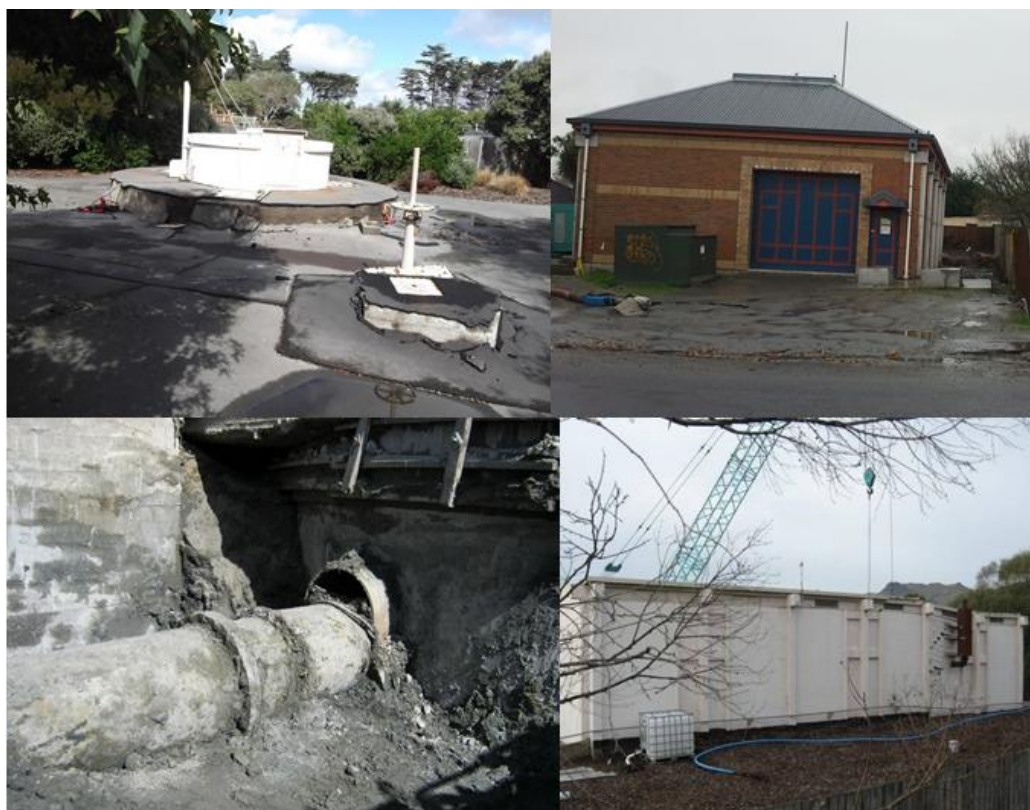
Photograph 9: Pump Station Earthquake Damage

Structural damage to the pump stations was generally a result of settlement, with some damage to above ground structures. There were some water pump stations buildings that suffered substantial structural damage requiring a full rebuild. Photograph 9 below shows typical damage to wastewater pump stations from top left, small pump station next to the Avon River, Pump Station 36, Pump Station 15 and pressure main connection PS15.

The most typical and troublesome were failures at the pipe connections to the structures. These failures were caused through ground settlement which also reversed the grade of some gravity inlet pipes. Repairs to the discharge pipes were often impeded due to the depth of the pipe requiring significant temporary works and dewatering.

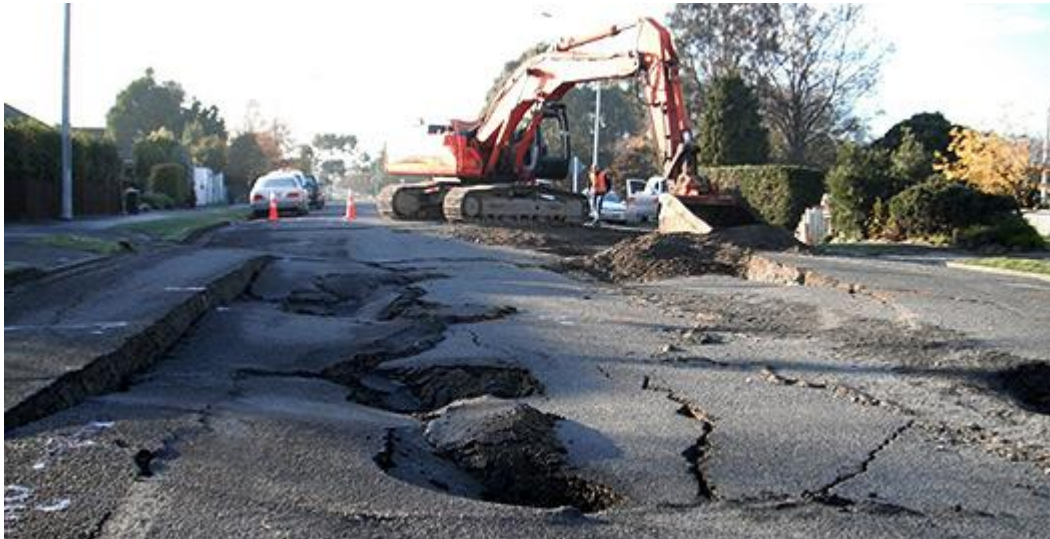
Photograph 12: Woodham Road Trunk Main Failure

The Trunk sewer immediately upstream of PS1 was a 1500mm x 1500mm box culvert. This failed in the 13th June 2011 earthquake resulting in the collapse of Woodham Road (Refer Photograph 12). Prior to the collapse assessment at the pump station had included the survey of the upstream trunk sewer, this indicated a severe dip in the trunk main. On review of the as-built drawings (circa. 1957) the dip had existed since construction and survey indicated the dip had increased by approximately 400mm. It is assumed that all or the majority of the increase occurred in the February earthquake. This highlights the importance of the construction phase, and continued assessment over the lifetime of an asset. In this case a fault in construction had occurred, the trunk main functioned but the resilience had been compromised.
