UNDERSTANDING SERVICE PIPE RESILIENCE

*Jonathan Morris¹, Philip McFarlane¹, Shaun Cook², Matthew Hughes³.
1 Opus Environmental Division, 2 Opus Research, 3 University of Canterbury.*

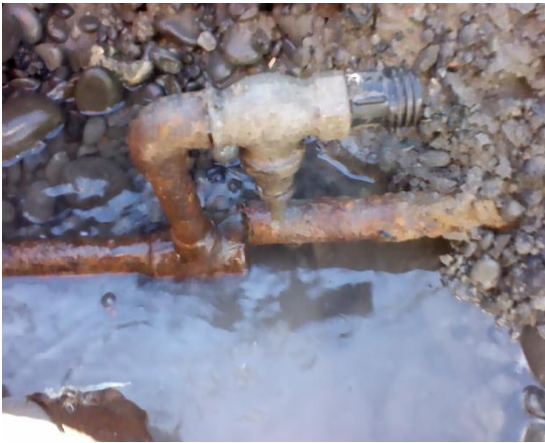
*Figure 1. Complex geometry and mixed materials (Citycare).
The low image quality is due to use of a camera phone.*

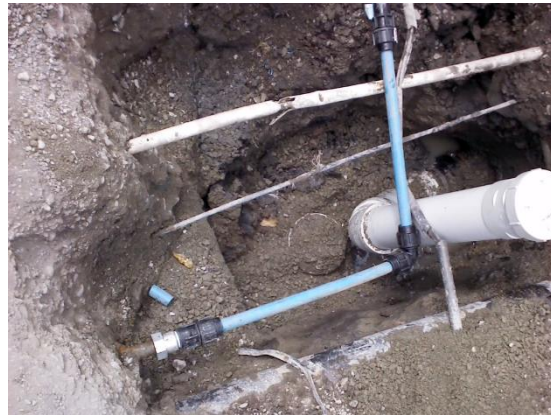
Figure 2. Complex geometry and multiple systems and materials (Citycare)

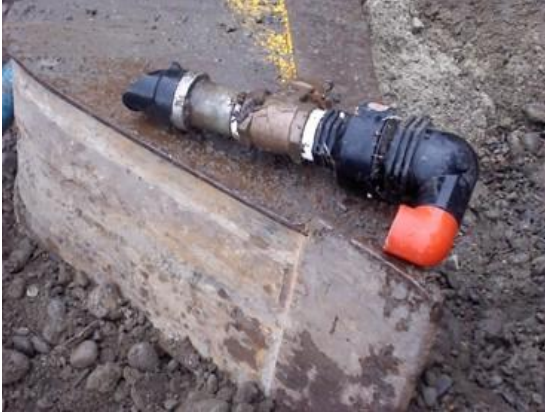
Figure 3. Fractured injection moulded compression fitting elbow showing mixed materials (Citycare).

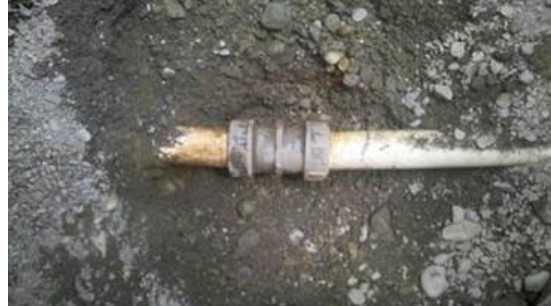
Figure 4. Leaking PE or PP bodied compression fitting on PVC pipe, Masterton. (Citycare).

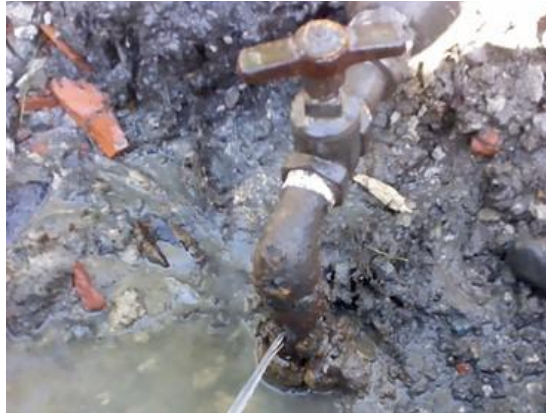
Figure 5. Perforated copper pipe leaking next to stop tap. Citycare.

Photographs of damage service pipes taken after earthquakes show a variety of damage. In PE and PVC pipes, the fitting itself may be broken or the pipe deformed in tension, bent or compressed and in other cases the joint leaks without failing (Figures 7 to 10). Metal service pipes also showed fracture at threaded joints and leakage where corrosion product that was formerly blocking a perforation had been dislodged (Figure 5).

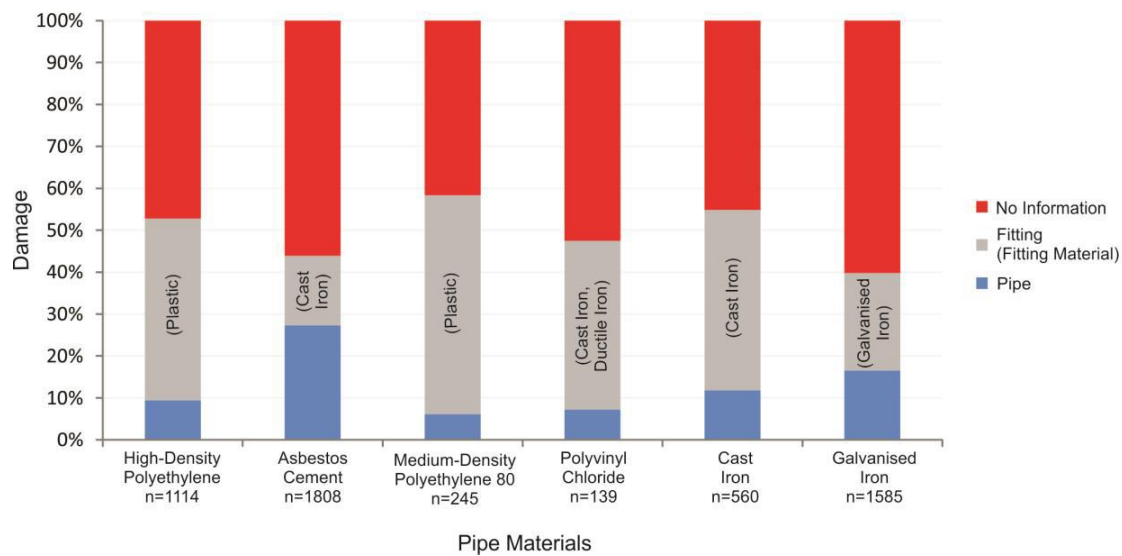
In addition, information collected during a major emergency is often incomplete, sometimes because records are poor but mostly because repair teams have more pressing priorities and are working under some of the most demanding conditions imaginable (Tromans, 2004). Cubrinovski's work (Cubrinovski et al, 2014) notes that around 21% of 6,094 damage repair records for pipes of all sizes specified pipe damage, 35% specified fitting damage and the remaining 44% contained no useful information (Figure 6).

Figure 6. Major damage categories for different pipe materials through the Canterbury Earthquake Sequence over the period 4 September 2010 to 30 June 2012. The dominant fitting materials used for each pipe material are noted in parentheses. (Figure 19 from Cubrinovski et al, 2014)

In the case of the PE pipes, of which many are service pipes, the proportion of pipe failures against fittings failures is much lower than the average for all materials, although there is still a high proportion of incomplete records.

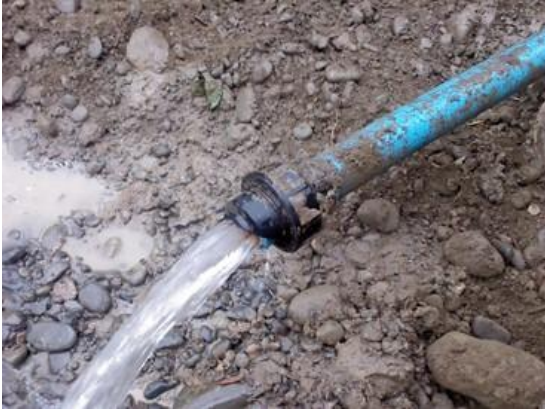
Figure 8. Fractured threaded fitting (Citycare)

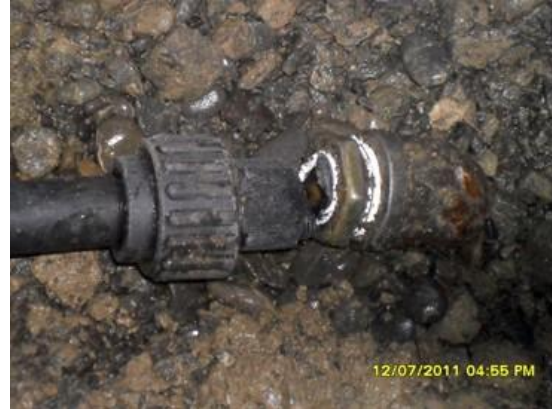
Figure 9. Leaking compression fitting assembly (Citycare)

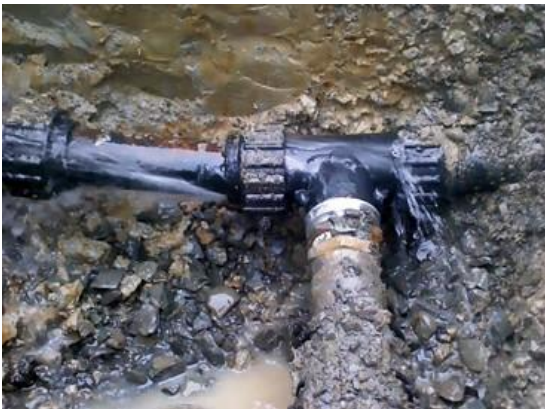
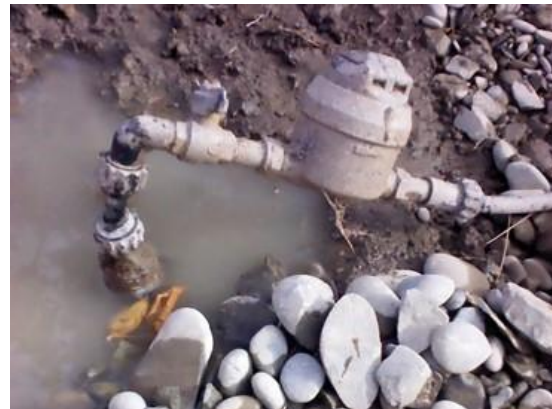
Figure 10. Damaged compression fitting assembly (Citycare)

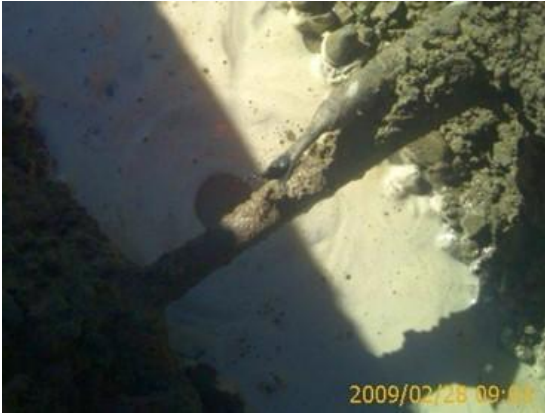
Figure 11. Tensile failure of black PE service pipe with hyper-extension in Christchurch following one of the seismic events (Citycare). Note that the date on the camera setting is clearly incorrect as it predates the first of the events.

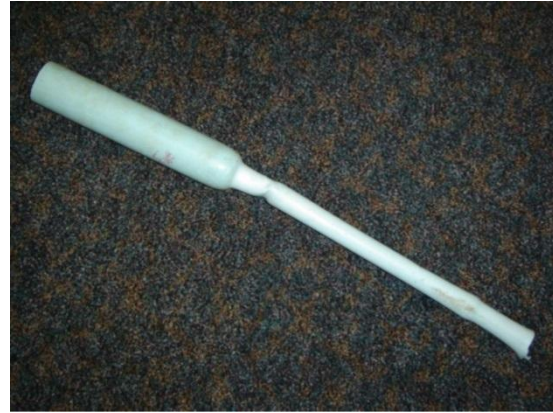
Figure 12. PE100 telecommunications cable duct yielded and hyper-extended to failure. (Frank O'Callaghan, Iplex)

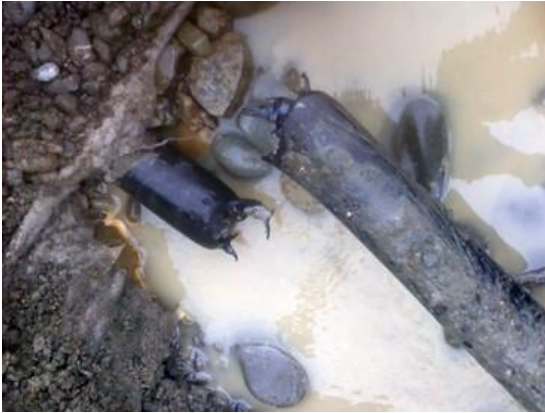
Where was tensile failure in PE pipes and ducts, (Figure 11 and Figure 12), not all of these showed hyperextension (Figure 13). The initial explanation was that the presence of water constrained the ability of the PE to deform freely, reducing the effective ductility. The ability to accommodate deformation can also prevent fracture in compressive or bending failures (Figure 14).

Figure 13. Tensile failure of black PE pipe without gross extension.

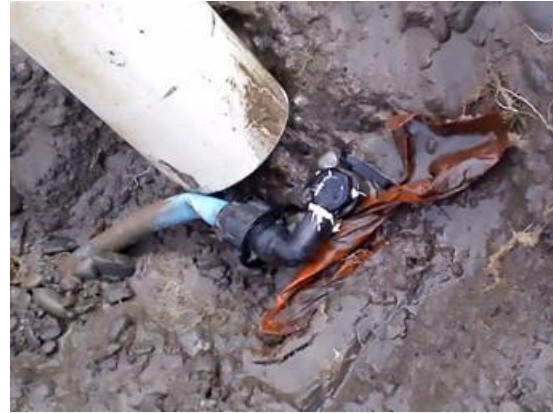
F14. Severe bending in PE80 service pipe. Despite being effectively closed off, the pipe has not failed.

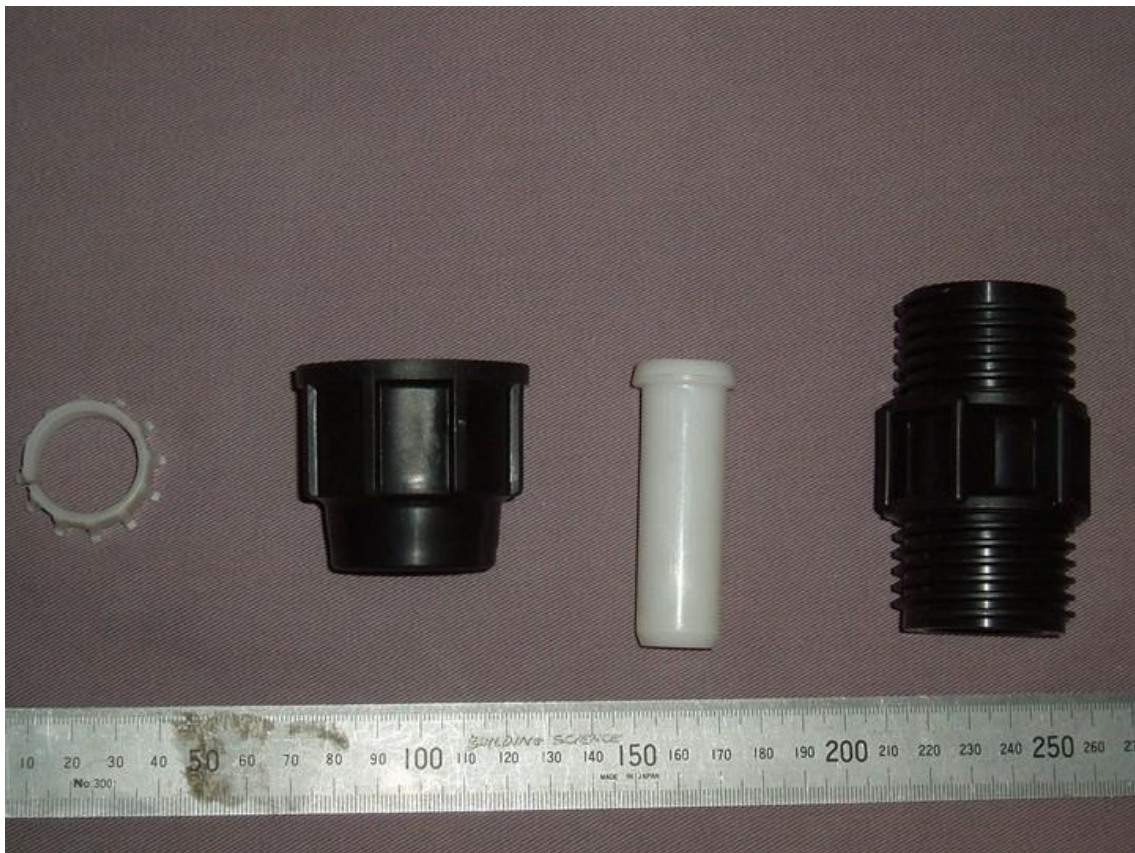
The initial tests all resulted in pull out of the pipe from the fittings. A quick inspection showed that these had been supplied without inserts (Figure 14). Further enquiries revealed that there was widespread confusion over the difference between an insert and a grip ring. Inserts were obtained and installed and while the peak loads were similar, there was no further pull out from the fitting.

*Figure 15. Components of a Plasson DN 25 straight coupler.
From left: grip ring, Collar, insert, fitting body.*

Service pipe fittings can be made fully end load resistant simply by using an insert. These are readily available from suppliers at minimal cost, and are easy to install. There is minimal increase in installation time and their use may possibly result in a marginal reduction through making it easier to achieve a seal on the pipe.

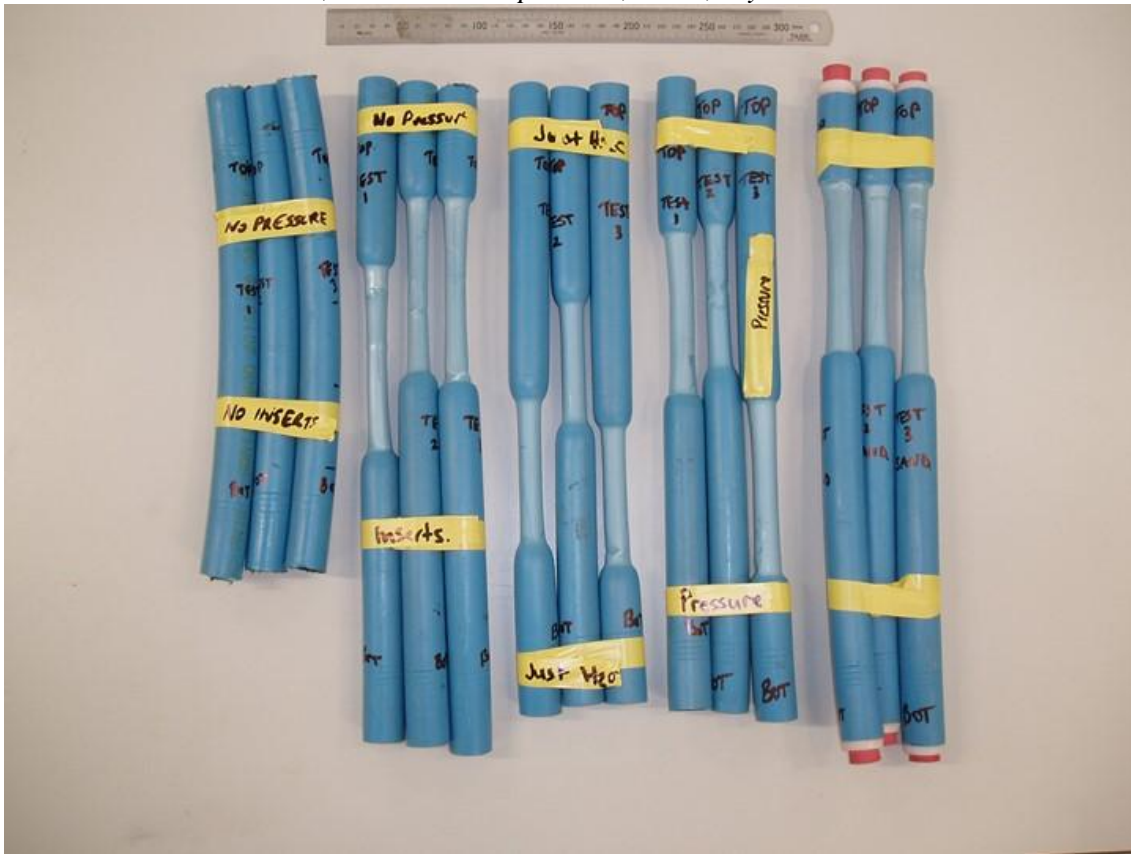
- Testing with standard fittings without inserts resulted in failure of the joint, and all pipe samples pulled out of the coupling.
- Testing with standard couplings and inserts resulted in drawing down of the PE pipe, and the connection remained sound – the fittings with inserts were fully end load resistant;
- When filled with water, the PE pipe drew down, and there was no leakage;
- When filled with water under pressure, the pipes drew down and there was no leakage. The reduction in diameter was slightly less than in the other tests.
- When filled with sand, the PE pipe drew down but the reduction in diameter was less than in the other cases.

Figure 16. DN25 PE80 service pipe assemblies after testing. The top as tested is next to the 300 mm ruler. From the left: No insert, empty pipe; Insert, empty pipe; Insert, water but no pressure; Insert, water at mains pressure; Insert, dry beach sand.

The peak loads for all tests were similar at around 4 kN, except that pull out occurred between 2 and 4 kN. The presence of water under pressure and the dried beach sand resulted in a smaller reduction in diameter where draw down occurred but did not change the form of failure or the peak load.
