SEISMIC PERFORMANCE OF PLASTIC PIPE SYSTEMS IN 2010/11 CANTERBURY EARTHQUAKES

Bill Noell, Water Services Infrastructure Lead, Pattle Delamore Partners

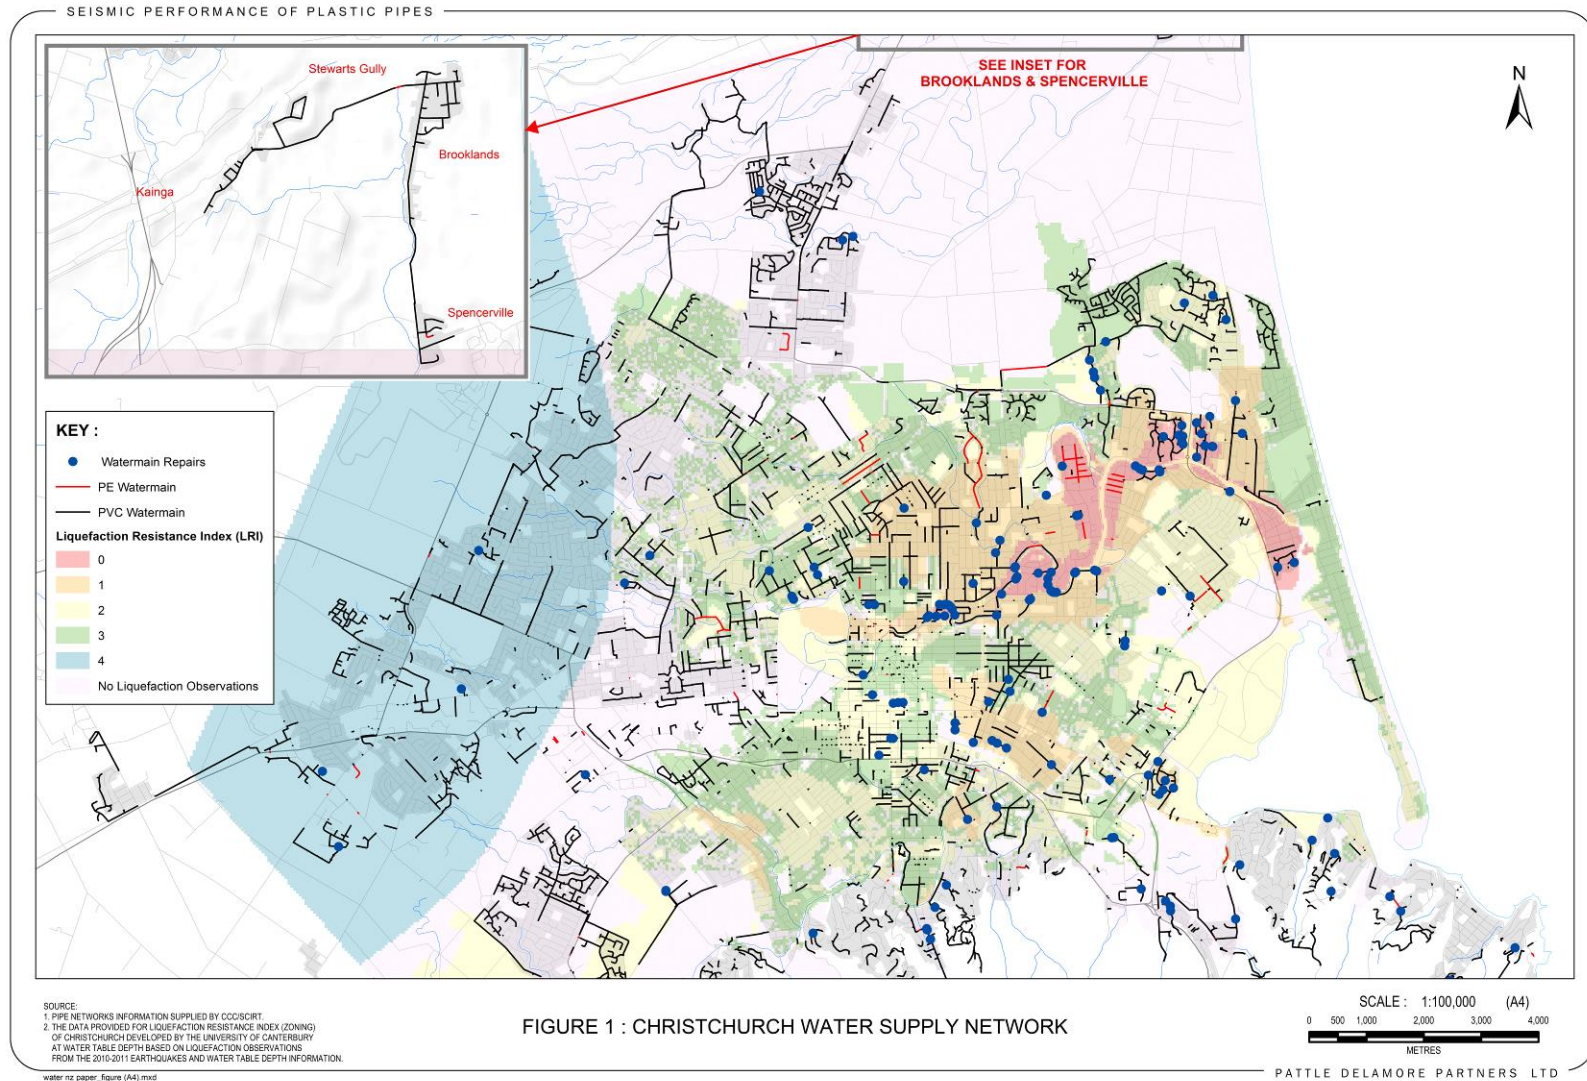
Figure 1 Water Supply Mains Repairs

The highest failure rates occurred in LRI zones 0 & 1 and in pipes installed before 1986.

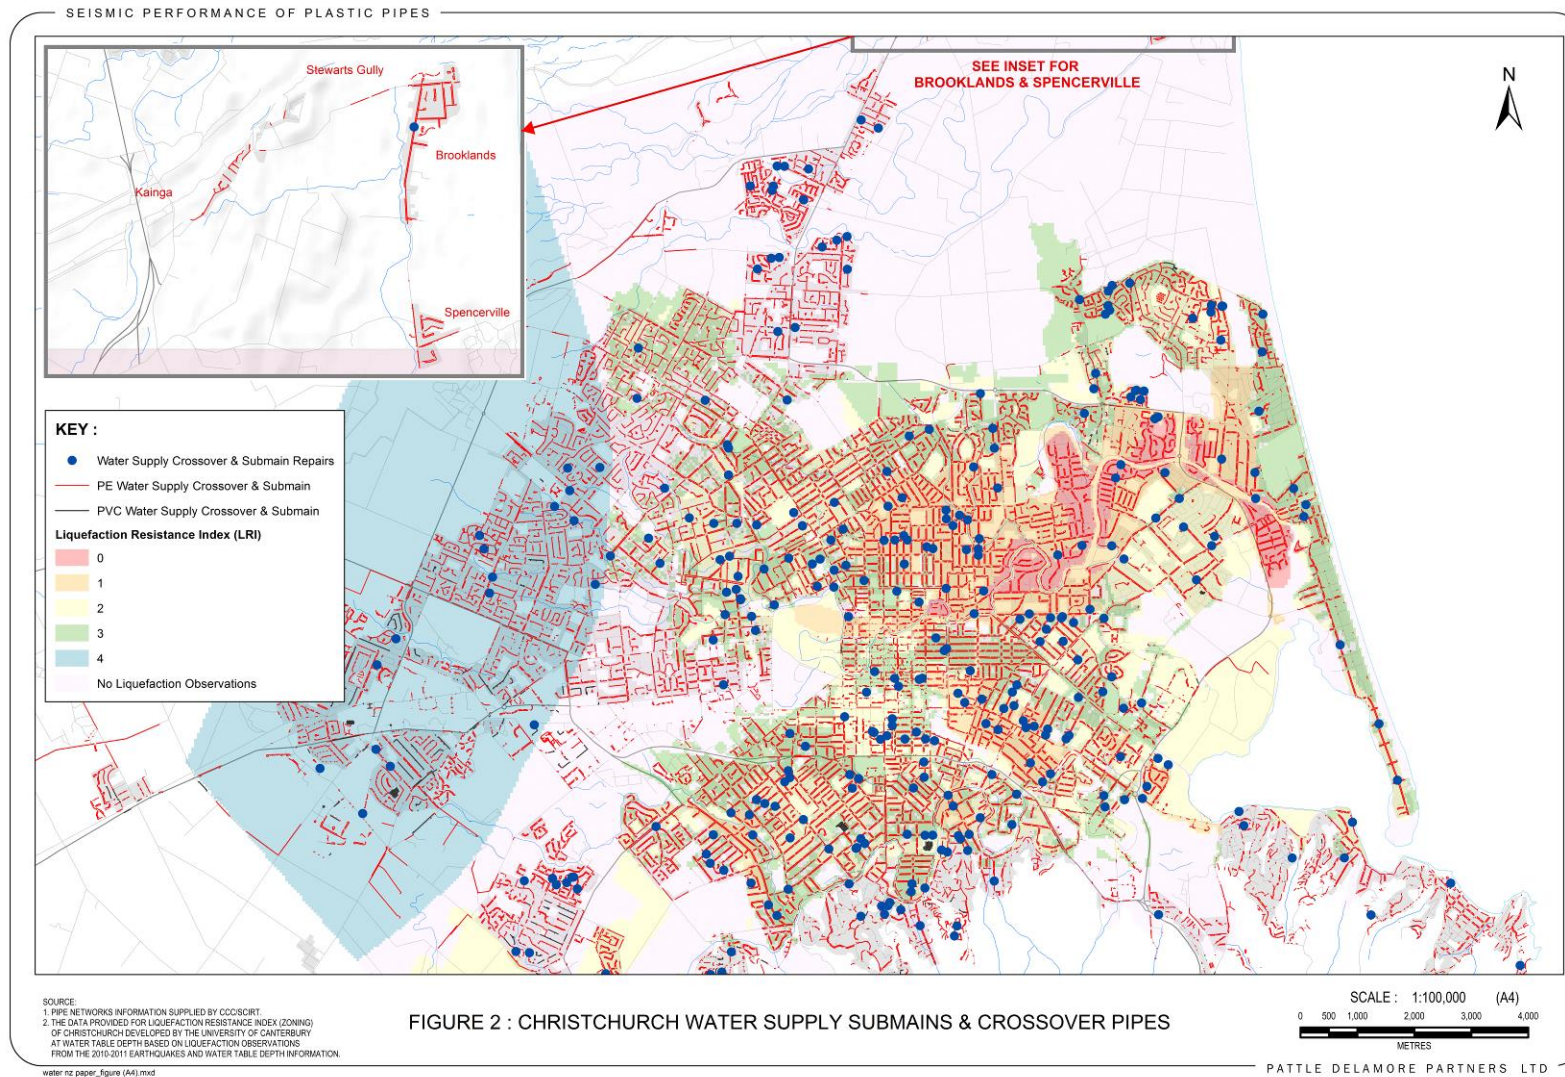
Figure 2 Water Supply Sub-mains and Cross Overs Repairs

Polyethylene has been used extensively for sub-mains and cross over water supply pipes throughout Christchurch and the polyethylene sub-main and cross over failure rates were considerably higher than the PVC sub-main and cross overs failure rates, with higher failure rates observed in older pipes and in heavily liquefied areas.

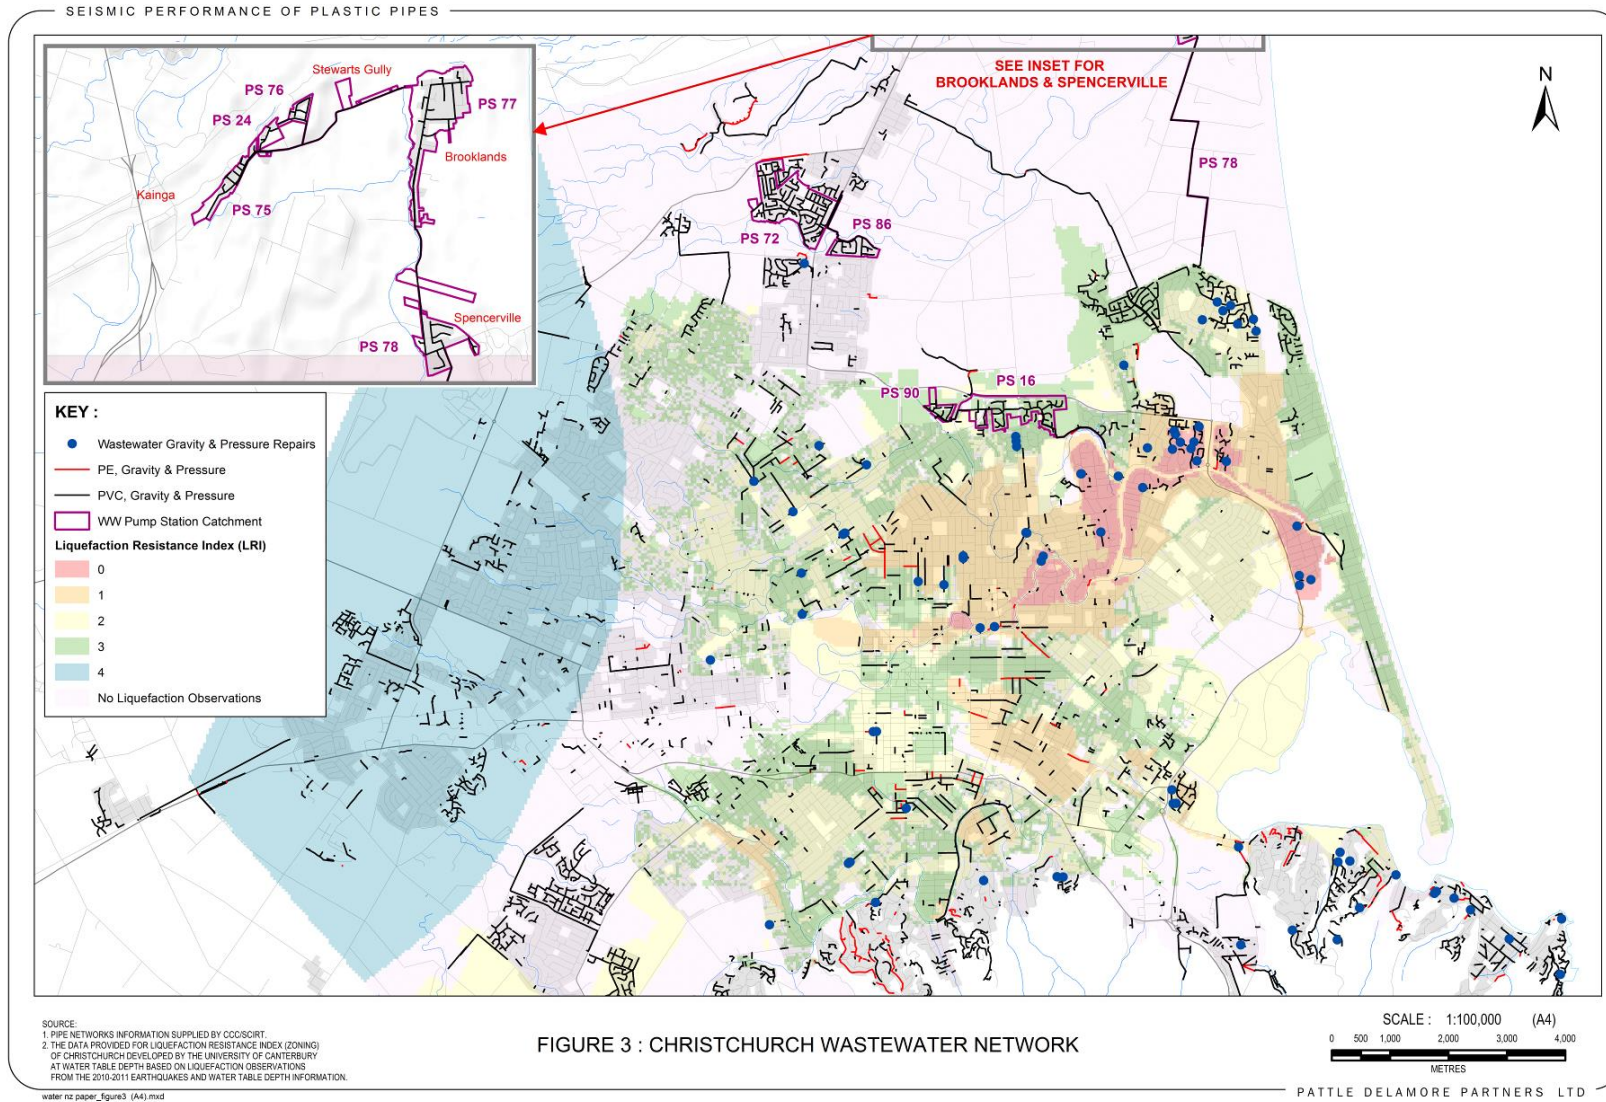
Figure 3 Wastewater Main Repairs

Four wastewater pumping station catchments in northern Christchurch constructed solely with PVC gravity wastewater pipes (as shown on Figure 3) were selected to examine changes in pump hours pre and post-earthquake in order to assess possible changes in infiltration rates due to the earthquakes. Unfortunately, there are no polyethylene wastewater sub-catchments to allow full comparison of the operational performance with catchments of PVC or other pipe materials. Pump station operational records were reviewed to confirm no changes occurred with the pumps.

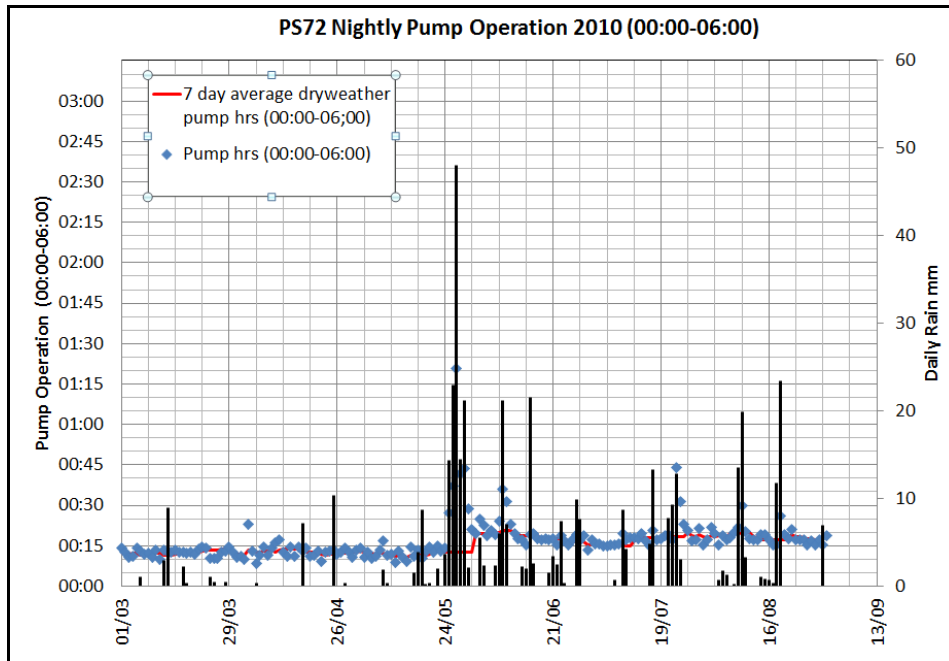
Figure 8: PS72, 2010 Operation

Figures 8 and 9, show that the variation in nightly pump operation for 2010 and 2013 in PS72 catchment. Peak groundwater levels were similar for the two years, but there was approximately 20% more rainfall for the period investigated in 2013 compared with 2010. Figure 8 shows summer night time dry weather pumping times of between 10-15mins in 2010, which increased to between 20-25mins in 2013 in Figure 9. Winter dry weather night time pumping times were typically 15-20mins in 2010 as shown in figure 8, and these increased to approximately 25mins in figure 9.
