ASSET MANAGEMENT – NOT JUST ABOUT LONG TERM PLANNING

Robin Walker (Opus International Consultants)
Bilyana Podrumac (Waipa District Council)

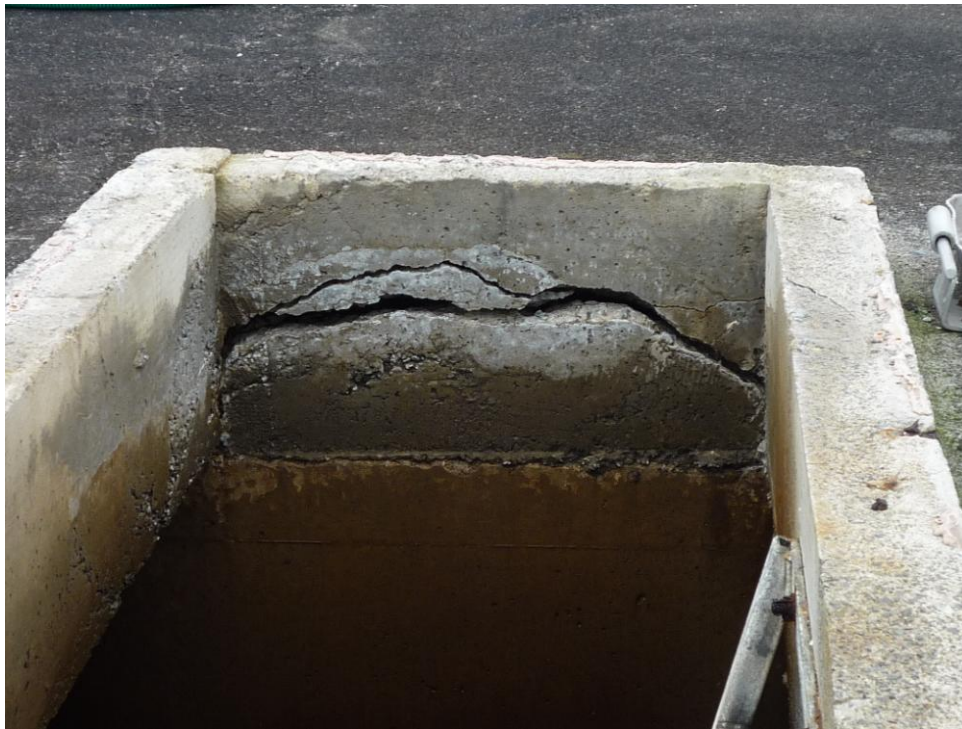
Karapiro 1 – There is a very large crack (≈ 10 mm) in the upstand around the centre roof access hatch, The recommended action being to undertake detailed inspection to determine cause of crack and identify most appropriate remedial repair.

Also there is evidence of minor water ponding on the roof. It appears that a thin screed has been added to the roof. The screed has spalled in one location. Saw cuts, in a square pattern, have been made and filled with sealant. Any significant ponding on the roof can add significant weight to the roof resulting in greater displacements increasing the area of ponding leading to progressive failure.

Photograph 2, crack in access upstand

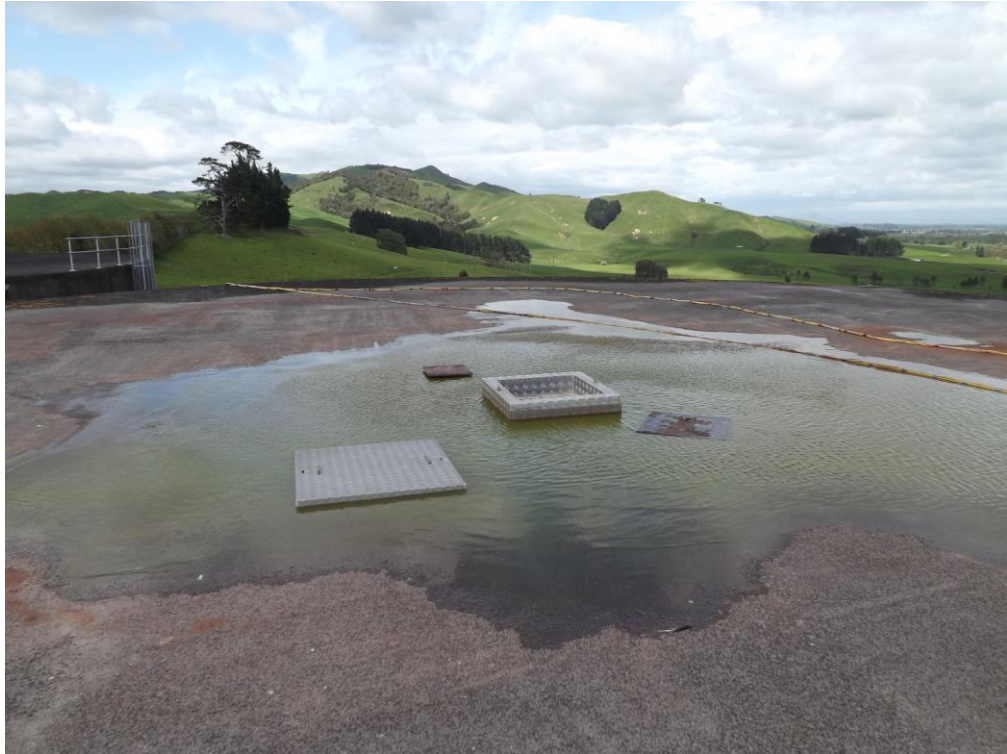
Karapiro 2 - The reservoir currently has significant water ponding on the roof . The depth of the water during our inspection was 55 mm near the centre hatch. This depth would increase following rain events. It is likely the original roof did not have sufficient fall. With time settlement of the internal columns and foundations has likely occurred together with displacement of the roof slab. The water ponding adds further weight which can lead to additional settlement and progressive failure of the roof. Further, ponding can lead to contamination of the stored water.

Photograph 3 of roof ponding Karapiro 2 at time of survey

Once reservoir 1 was back in service Karapiro 2 was taken out of service but not emptied as the roof was in good condition. To alleviate the surface ponding and hence extra roof loading a roof drain was installed by another innovative means namely installing internal pipework from an inflatable dingy.

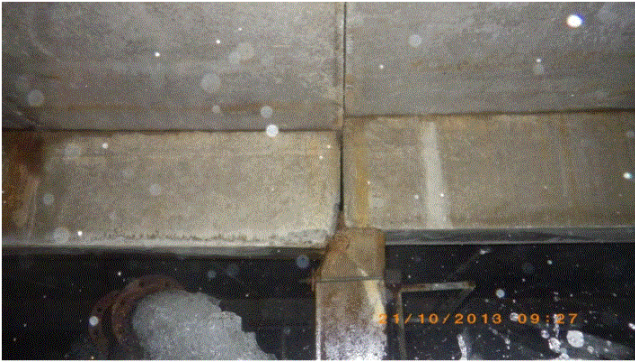
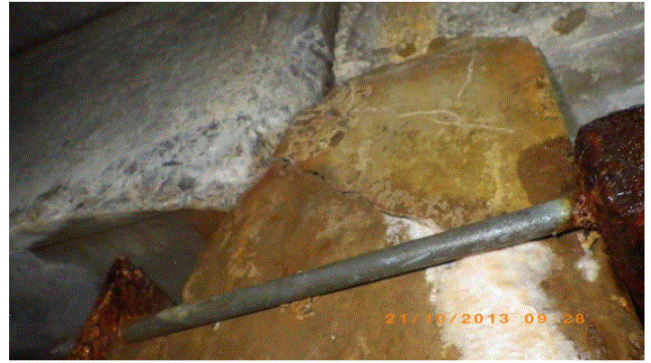
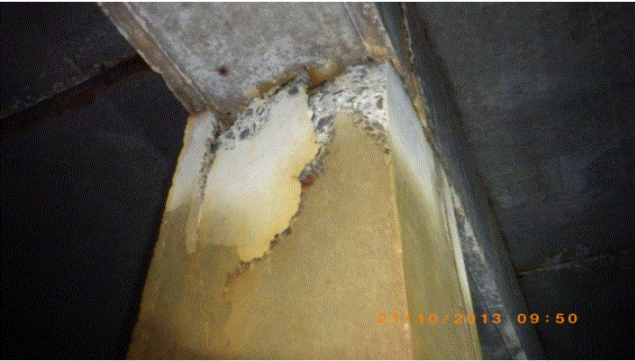
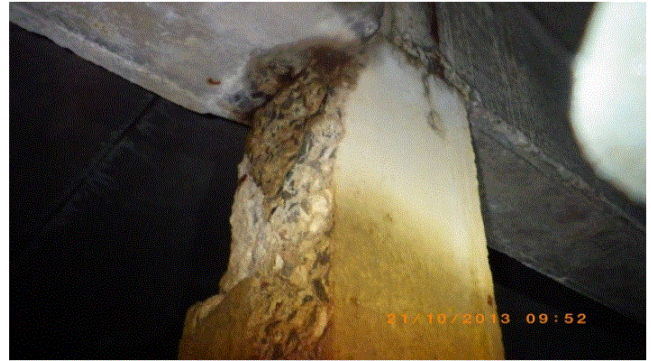
Photographs 4, Internal views of Karapiro 1

The 2013 report was very clear and definitive in that it concluded very significant and immediate structural issues with Karapiro reservoir 1 roof in particular. The internal beams being misplaced off the column supports in parts and some column tops being significantly damaged. The prognosis for Karapiro 2 being that the internal supports were of a different type to 1 and in much better condition. The observed external ponding probably being due to localized and minor beam settlement.

The column tops in Karapiro 1 were repaired and enlarged such that the roof beams could not fall from them but no attempt was made to raise the beams just to support them in their present position. An interesting observation during the repairs were several small holes in the roof which were obviously a previous attempt to get rid of the roof ponding.

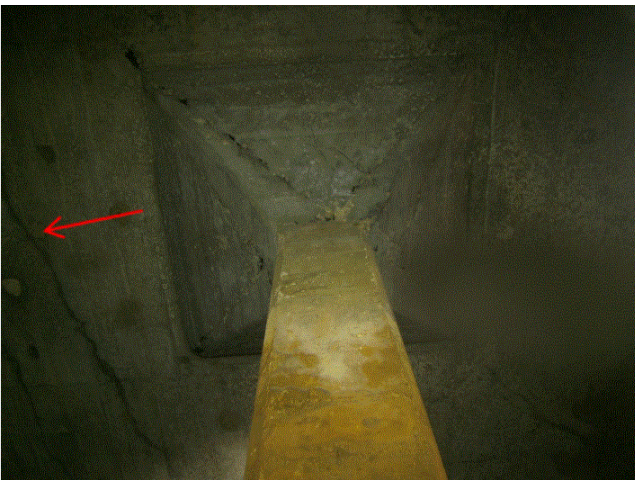
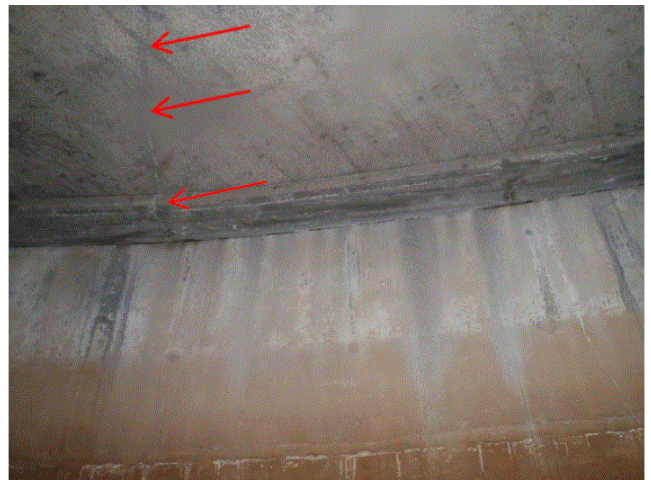
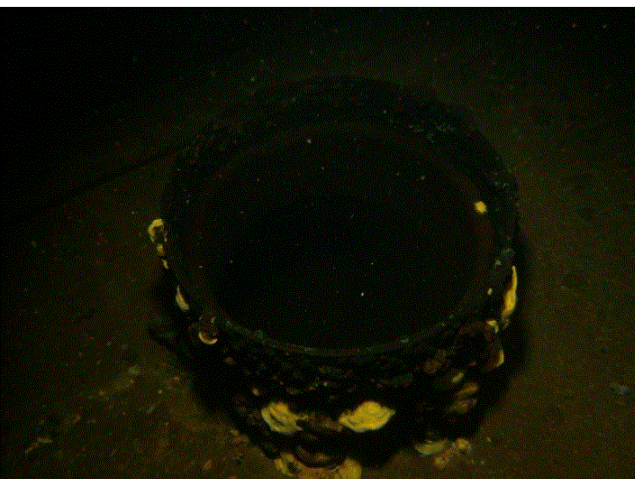
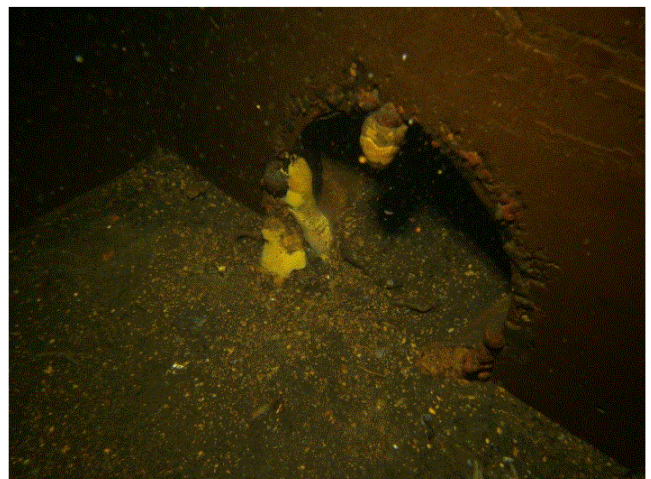
Photographs 5, Internal views of Karapiro 2
