# **FIGHTING AN UPSTREAM BATTLE - THE BARRIERS TO IMPLEMENTING THE FISH PASSAGE GUIDELINES.**

*Colin Jermyn (Stantec New Zealand)*

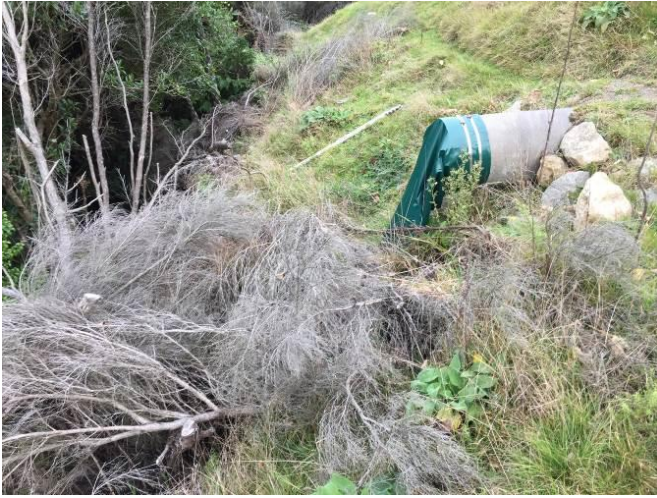
Figure 2-3 Perched outlet

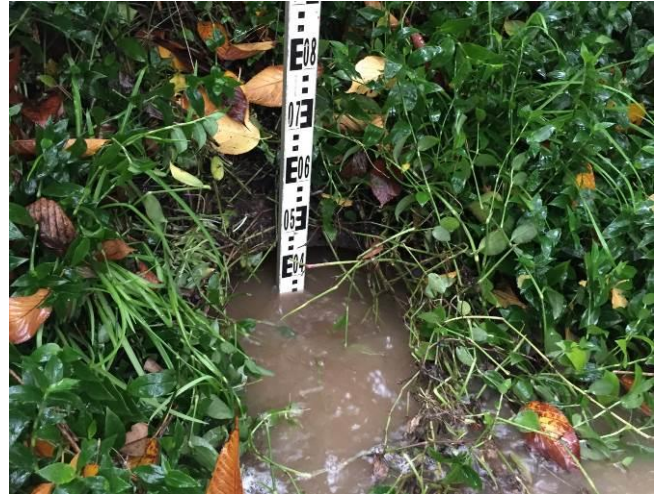
Figure 2-4 Insufficient hydraulic capacity for design flows demonstrated by submerged inlet during typical rainfall event

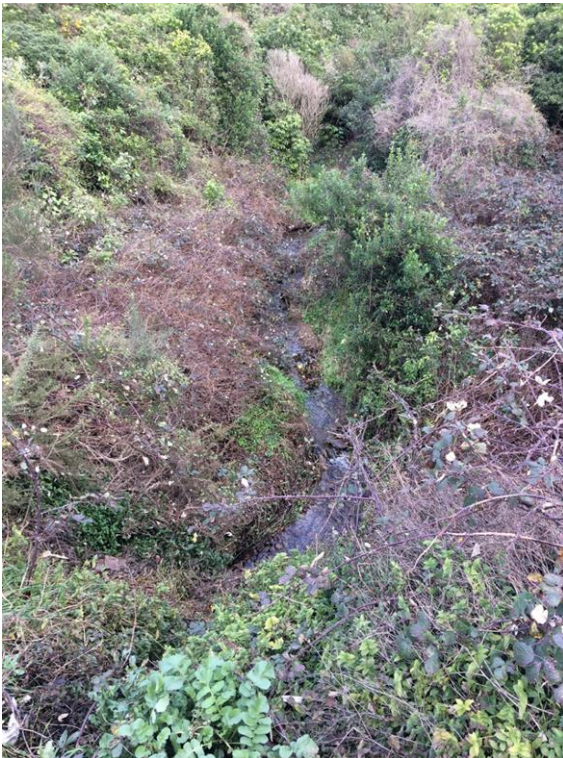
*Figure 4-1 Upstream channel*

This culvert is an existing 45m long DN900 RC pipe across SH58. The culvert has an upstream catchment of approximately 80ha. The pipe appears to be in good condition with no structural issues noted. The culvert has been constructed at significant depth (up to 10m below road level). Access to the upstream side is also particularly difficult due to steep slopes and heavy vegetation. The pipe has hydraulic capacity for a 1 in 70 year storm event (including climate change) without surcharging onto the carriageway. This does assume an upstream water depth of over 6m. The invert of the culvert is at stream bed level.

Given the size, depth and accessibility of a new culvert to meet the current standards versus the relative improvements which would be achieved, it is not considered reasonable to upgrade this culvert. As the existing culvert is less than 1.2m diameter, mussel spat ropes can be installed to facilitate fish passage through the culvert.

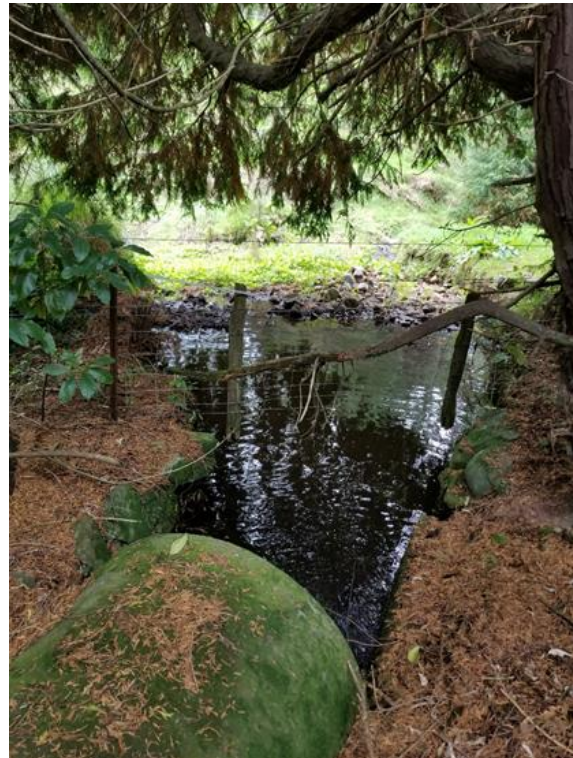
Figure 4-2 Existing outlet

The existing culvert does not meet the requirements of FPGs and P46, however the true performance is well above average on the network, i.e. no vertical jumps, 100 year capacity (excluding climate change) without surcharging onto the carriageway.

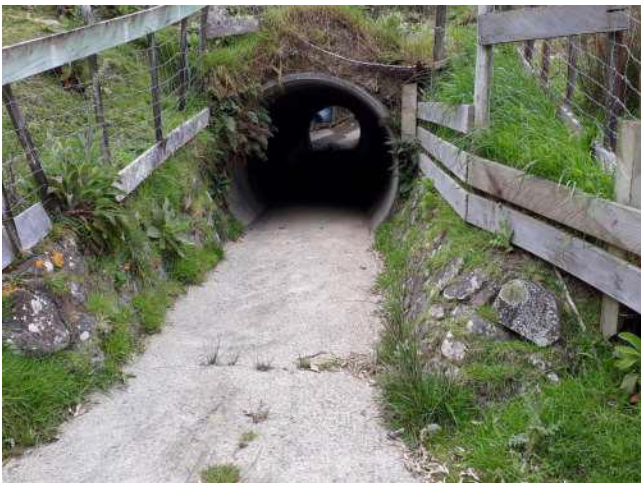
*Figure 4-3 Main culvert*

This culvert is an existing stock underpass with a small diameter pipe below the main culvert to convey typical flows. The main culvert is 20m long, 1.m diameter with a flat base. The low flow pipe is 40m long, 200mm diameter, The main culvert is in good condition, the low flow pipe is steel which has significant corrosion where visible. The pipe appears to be broken along its length as water is not existing at its outlet but rather through the substrate below.

The main culvert meets the requirement of P46 and has suitable design life remaining. The system is a barrier to fish passage upstream. Provision of fish passage would require construction of a fish ramp at the outlet and replacing the existing low flow pipe or constructing a new fish friendly channel within the main culvert. As the main culvert is currently used as a stock underpass, any changes to its use as an underpass would significantly impact the landowner. These works also offer no improvement to the safety or resilience of SH58. Given the habitat availability upstream, a rock fish ramp is proposed at the vertical jump between the Pautahanui Stream and the culvert outlet. Consideration had been given to installing a spat rope in the pipe however further inspections of the pipe are now required based on the apparent damage.

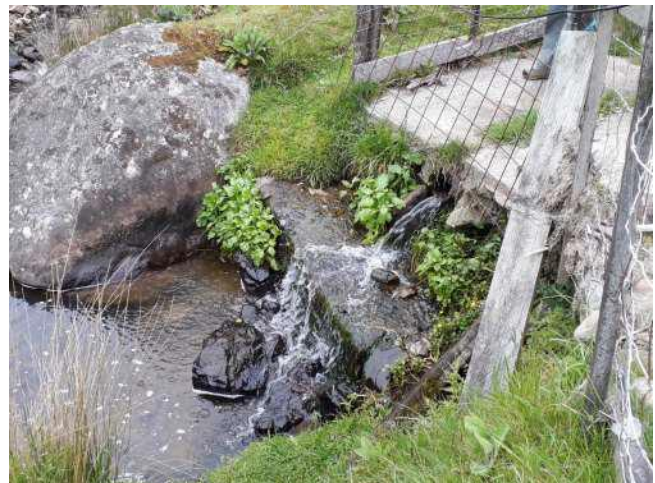
The pipe is fully perched and the apron also presents a barrier to fish passage. The current configuration does not provide fish passage.

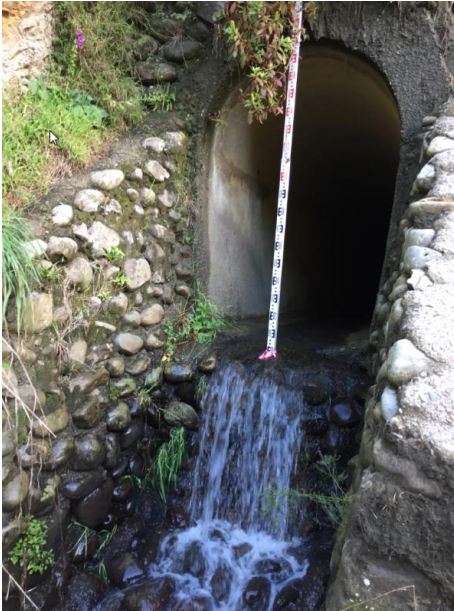
There is a 900mm drop from the outlet into a stone-lined concrete channel.

*Figure 4-5 900mm step at outlet*

Remove existing vertical jump which acts as a significant barrier to fish passage upstream

The proposed solution involves construction of a new fish ramp at the outlet to remove the 900mm step between the outlet and the bed immediately downstream. Improvement works along the base of the culvert (installation of spat ropes or baffles) pose installation and maintenance challenges, given the long, tortuous nature of the culvert.

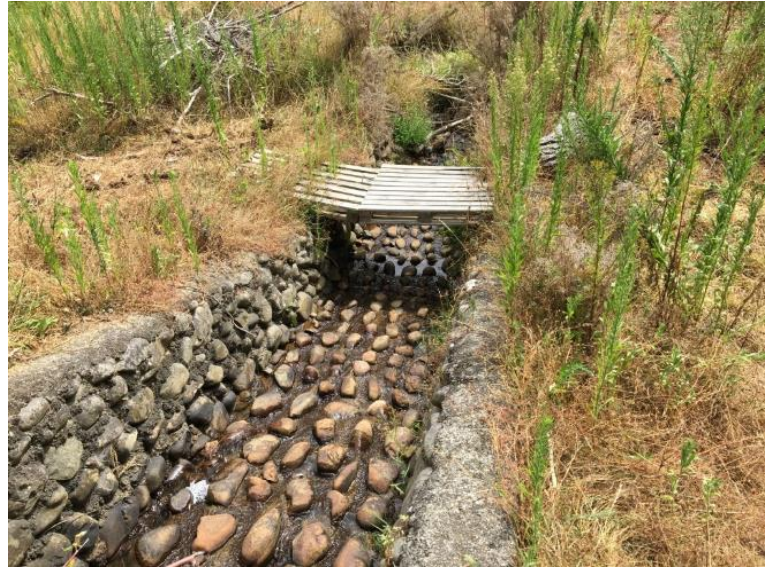
*Figure 4-6 Existing downstream stone lined concrete channel*
