BETWEEN A ROCK AND A HARD PLACE: SUMNER ROAD STORMWATER REBUILD

A.Pratt (Beca Ltd)

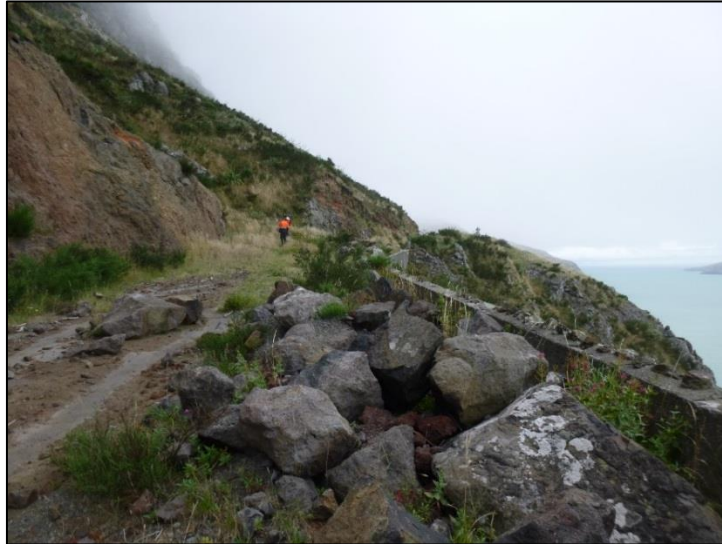
Figure 1: View of rockfall damage to Sumner Road (early 2016)

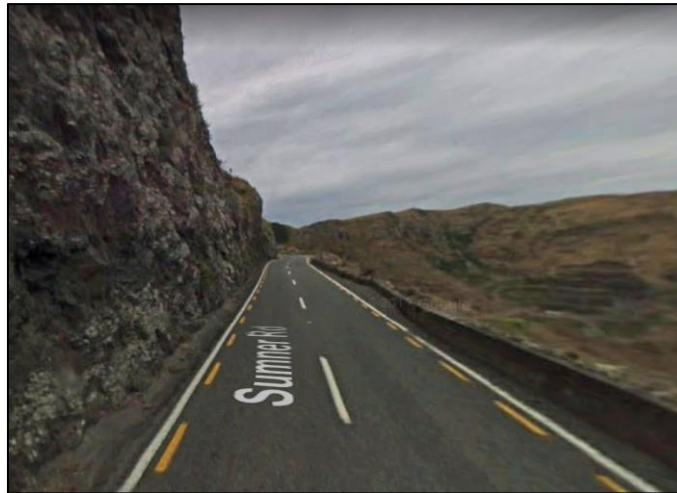
In addition, an old rock wall (see Figure 5). on the outside of the road, for much of the upper part of the road and parts of lower section, acted to contain flows and concentrate discharge over the edge

Figure 5: Typical view of the upper part of the road with cliff and hand formed channel on the left and rockwall on right (sea side). (Source: Google Streetview).

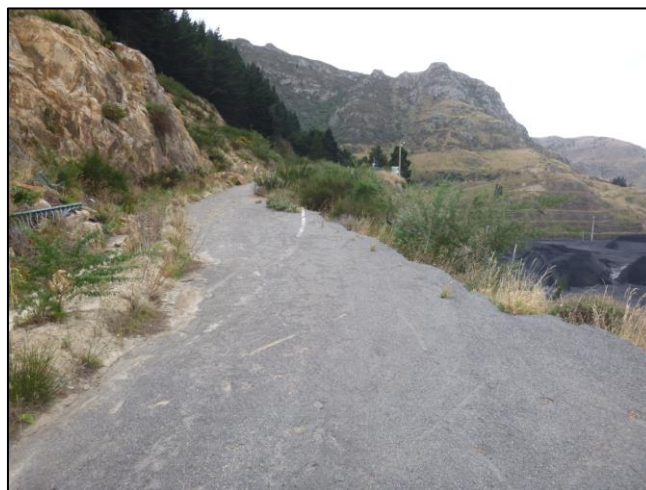
The bottom half of Sumner Road traverses a mixture of steep rocky terrain (Windy Point) and slightly flatter loess covered slopes. Rockfall damage to the road was less frequent in this section but damage to the numerous retaining walls was widespread (see Figure 6).

Figure 6: Damage to the road near Windy Point due to a slip removing a retaining wall below the road
