WATER SENSITIVE DESIGN PERFORMANCE OVER THE PAST 10 YEARS: A ROAD MAP TO THE FUTURE.

L. Norman (ACH Consulting Ltd., T Acharya (ACH Consulting Ltd) and A. Choureemootoo (ACH Consulting Ltd.)

ABSTRACT

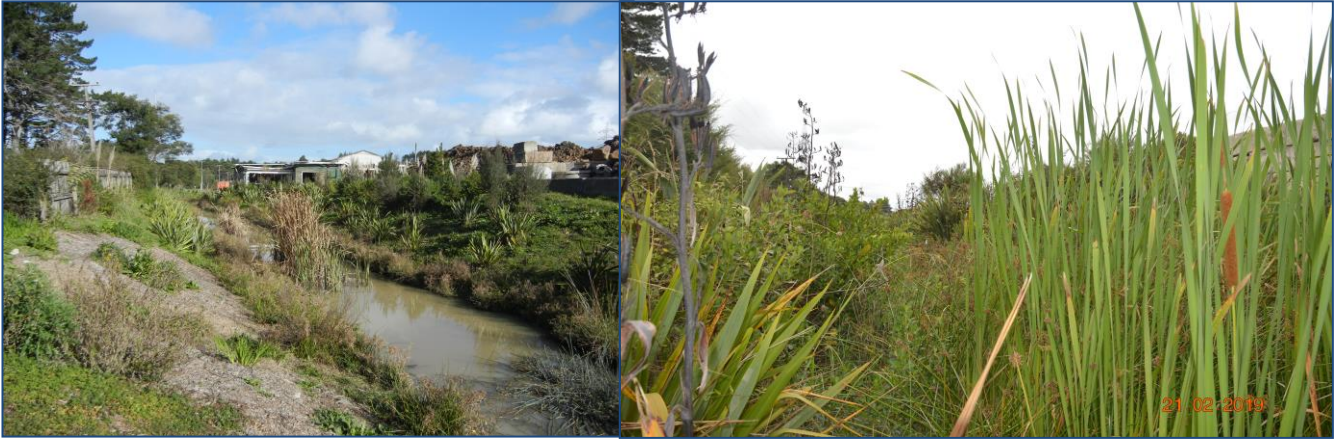
maintained since they had been installed. Photos from 2012 indicate the need for maintenance at the time. Current photos from 2019 show the first wetland to be completely degraded and the second one to require significant maintenance. Pest species are prevalent in Wetland 1 and the main outlet is blocked with sediment. The forebay is also completely silted in.

Photograph 1 & 2: Wetland 1 2012 (3 years after commissioning) and present.

The current property owners have been spoken with and are now in the process of putting together a working plan to restore the wetlands. It is hoped that the group of property owners will continue to maintain the wetlands once the restoration has occurred.

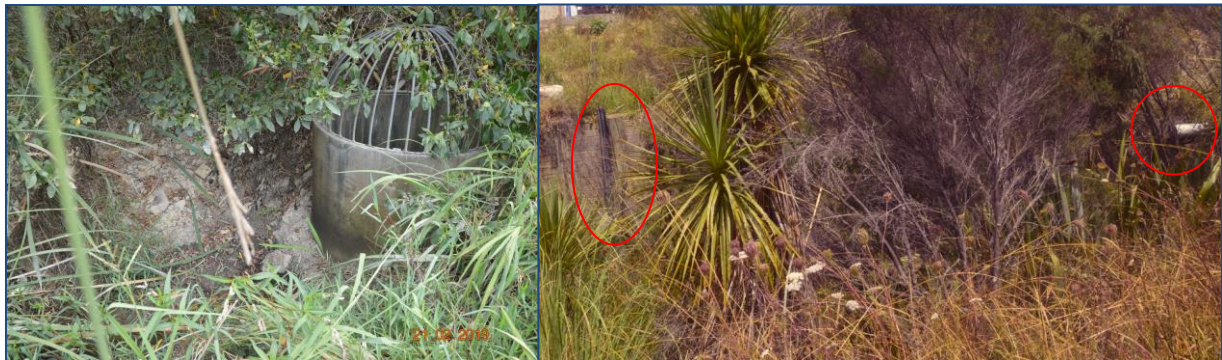
Photographs 3 & 4: Outlet for wetland 1 & 2 informal connection to wetland 2, 2019

Wetland 2 had two informal connections which were allowing the stormwater to bypass the forebay area completely.

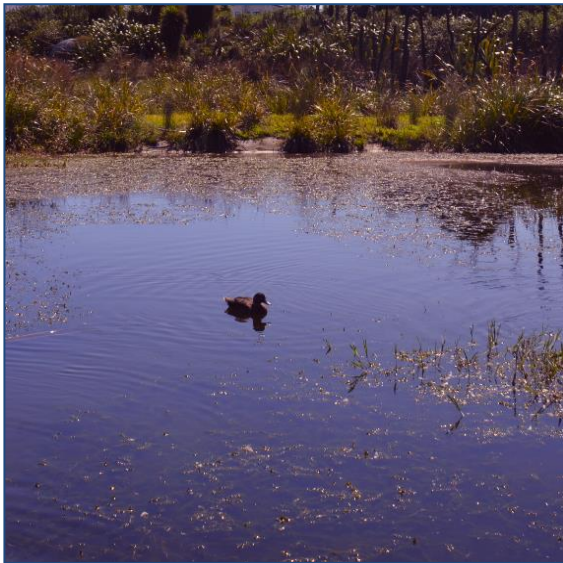
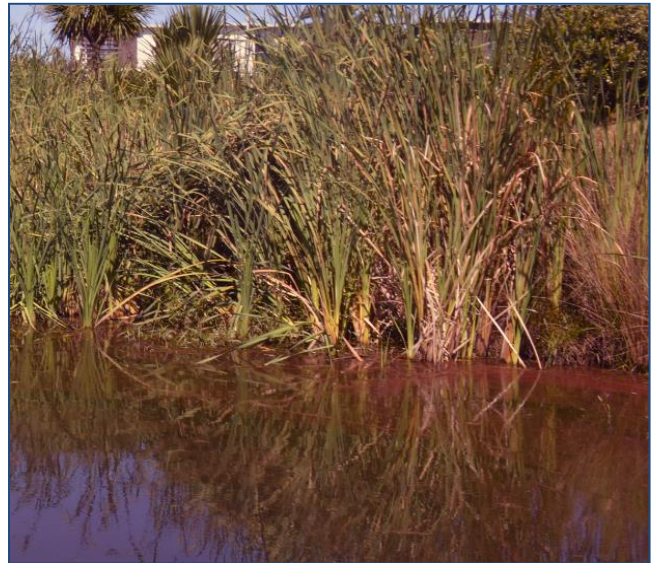
Photographs 5 & 6: Wetland 5

Wetlands 3, 4 and 5 are located in larger residential subdivisions. The wetlands have some plastic rubbish in them. All three of these wetlands are accessible for maintenance and have walkways to provide amenity value to the surrounding community. Signage has been provided to educate visitors on both the habitat and treatment value. However wetland 5, the oldest of the three wetlands, while still being in good condition in terms of functionality, is in need of maintenance. In the deeper wetland pool, Oxygen Weed (*Lagarosiphon major*) is pervasive and the downstream area has an unidentified sheen over the water.

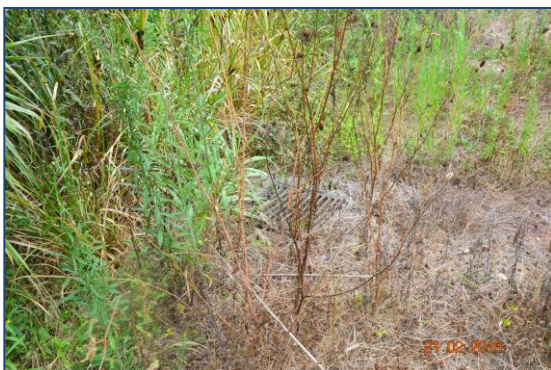
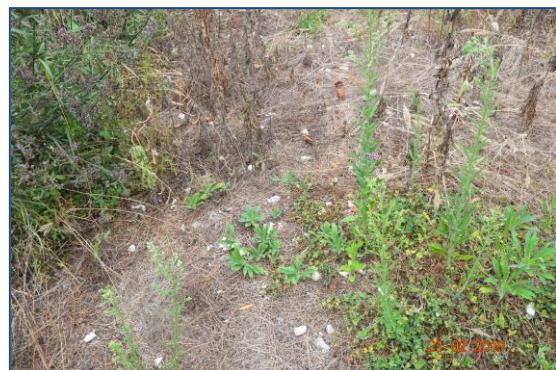
Site visits to four different swales that were designed to provide treatment and convey surface flows into the stormwater network, provided varying results. Swale 1 was nearly nonexistent due to a lack of both maintenance and knowledge. During the visit to the property the occupiers of the commercial property had no knowledge of the swale. The swale was a condition of consent and designed to provide treatment of the stormwater runoff prior to it reaching an unnamed creek at the bottom of a gully.

Photographs 7 & 8: Swale 1 behind commercial development

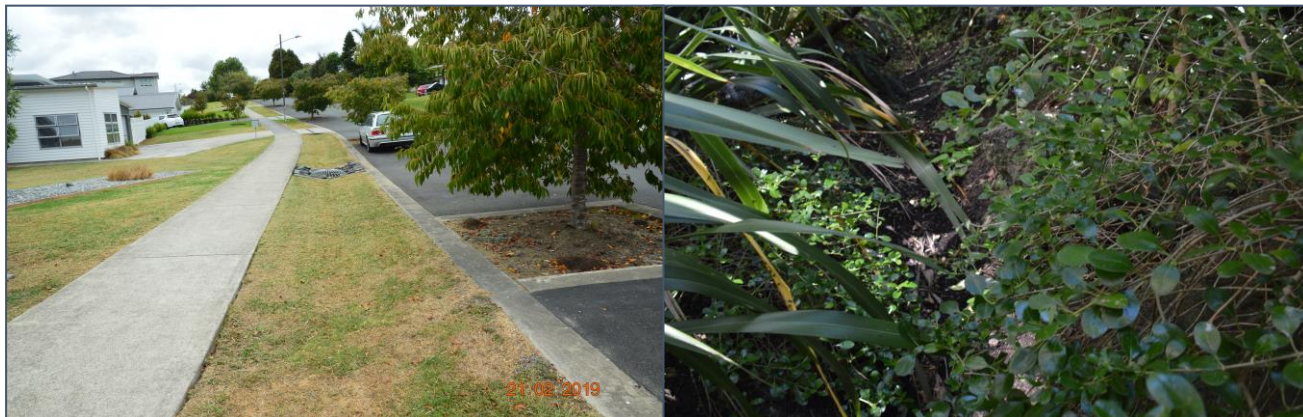
Swale 2 is currently in good shape but is located in a residential subdivision and requires maintenance. The scruffy domes in some sections of the swale have been grouted in and then damage has occurred due to vehicular loading.

Swale 3 was in excellent condition. In this instance the owner was on board with the design and has expressed that he feels the swale adds amenity value in providing an island of bush in the middle of an urban area. The swale was clean and free of rubbish.

Photographs 9 & 10: Swale 2 Residential Subdivision & Swale 3 single lot bush swale

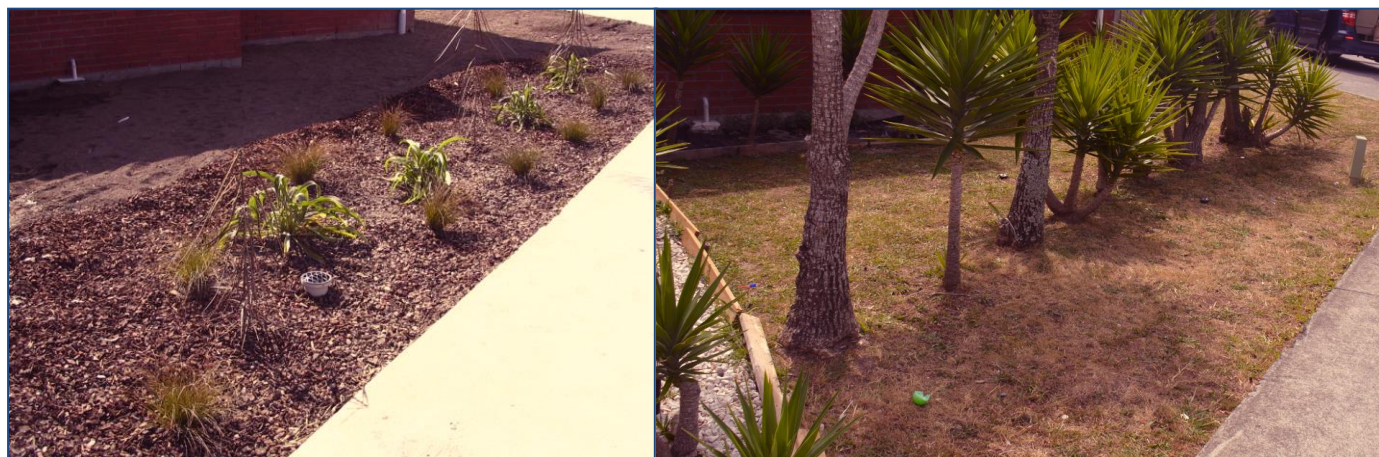
Of the 8 raingardens visited 5 had been completely removed or paved over. The raingardens were part of the Land Use Consent conditions for a 5 lot subdivision. They were designed to provide treatment and detention for the shared driveway entering the infill subdivision. The raingardens were located on the individual lots so that each owner was responsible for maintenance. None of the initial owners currently own the property. Moreover, the requirement for the raingarden to be maintained, or the fact that there was a raingarden on the property, was not included in the consent notice on the title. The consent notice states that treatment and hydraulic neutrality must be provided.

Photographs 11 & 12: Raingardens when completed & 2019

Given that the raingardens were deemed compulsory by the Council's development engineer at the time of the subdivision, the failure for the information to appear on the consent notice is a regulatory failure. The fact that some of the raingardens were paved renders the assets not only useless but a contributing factor to increased runoff and contaminate loading.

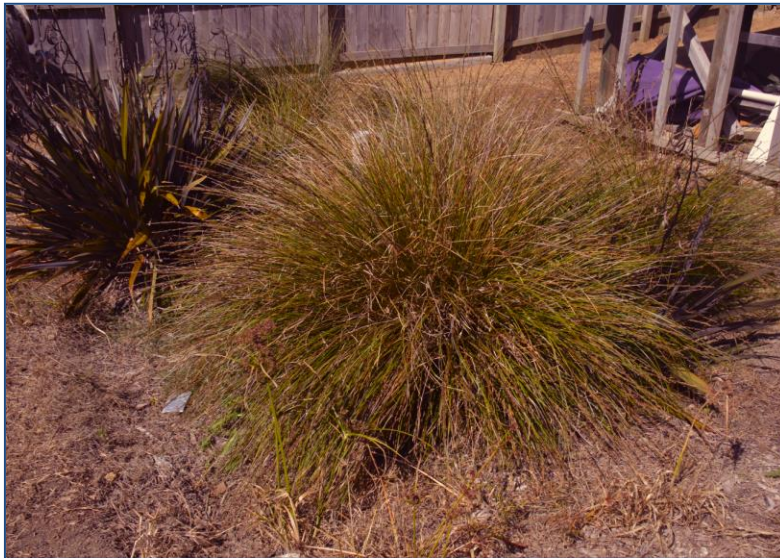
Photographs 13: Raingarden 6

Raingarden 6 is in good to fair condition however the overflow pipe has not been cut down to the required level and sticks up out of the ground about 700 mm. Additionally, during the site inspection the owner stated that they had no idea why this asset was required to be located on her property and was finding it difficult to maintain. In further discussion, the owner stated that the Oioi made it an eyesore and was causing the maintenance difficulties. As a result of the site visit an extensive list of planting options was given to the owner, who is now engaging a landscape company to help upgrade the asset so that it provides amenity value to the property.

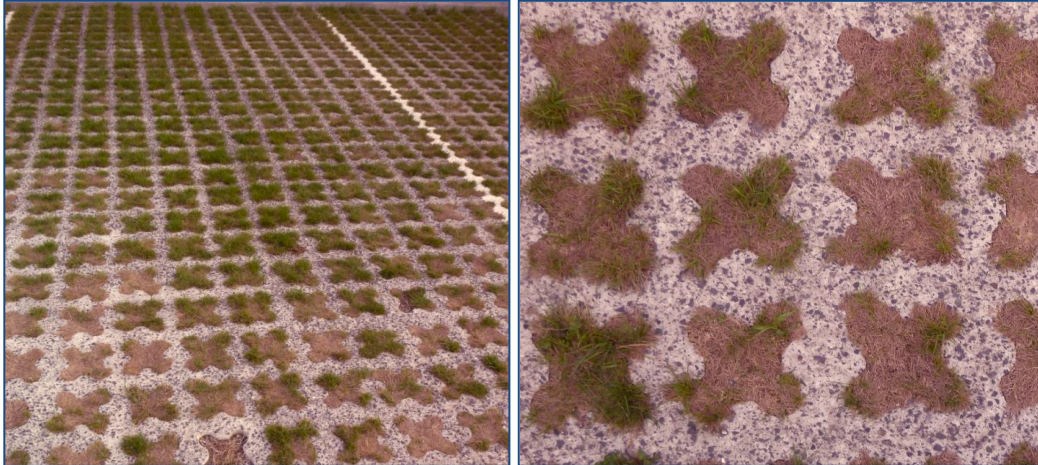
Permeable paver site 1 is in a parking area serving a commercial building. The permeable paver used here is Grasspave™ which is poured in situ with steel reinforcement and forms to allow for grass planting within the pavement. The pavement has been in service for 3 years and traffic loading consists of 30-40 vehicle movement a day Monday – Friday. The grass component of the pavement is showing signs of stress due to summer heat; however it is likely to rebound once the rain begins again.

Photographs 14 & 15: Permeable Paving 1, Grasspave™

The property owner was questioned regarding the pavement. The permeable pavement was required as part of the consent. The owner is pleased with the product in terms of permeable paving, and feels the steel reinforcing makes it practical for commercial properties. The owner stated that the pavement is a good idea but that permeable pavement in general still requires more thought in terms of the base course. It seems to be functioning as designed and produces no runoff during small steady rainfall events but does in larger events.

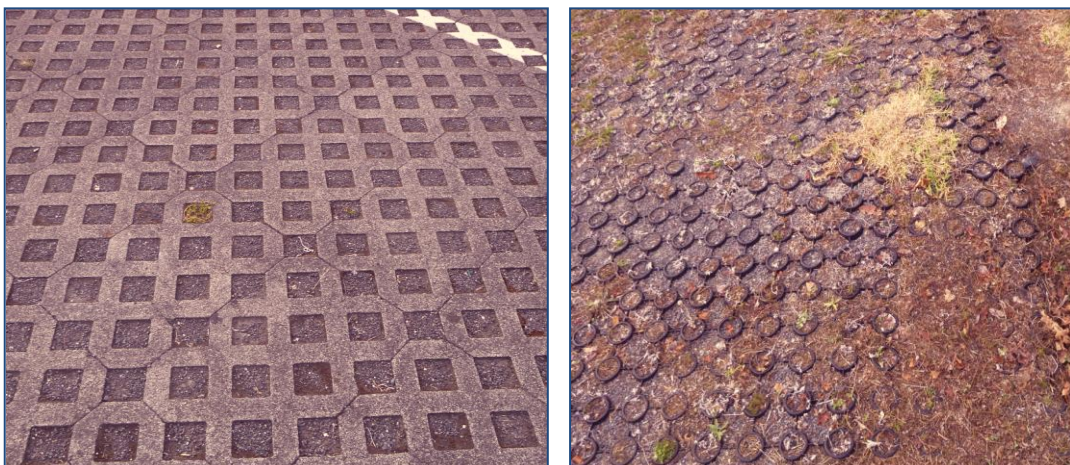
Photographs 16 & 17: Permeable Paving 2

Permeable paver site 2 receives most of its traffic on the weekend. The site uses two types of permeable pavers; plastic mat and Gobi blocks. The Gobi blocks have been filled with pea gravel. The pea gravel, when new, allowed the water to flow through but did nothing in terms of thermal loading. Now the pea gravel is visibly clogged. The plastic planted mat is sparsely planted and both pavers are in need of maintenance. Neither the plastic pavers nor the Gobi blocks are performing as designed.

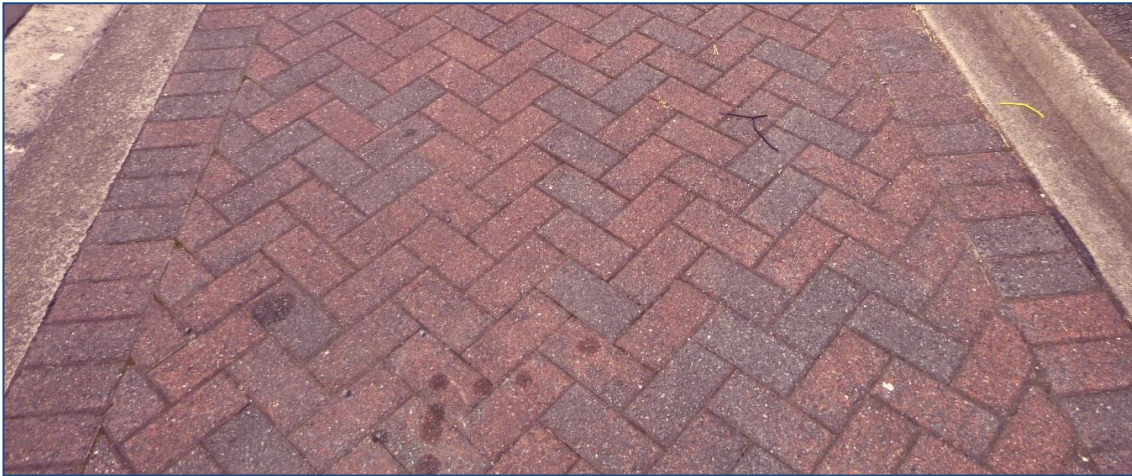
Photographs 18: Permeable Paving 3

Permeable paver site 3 was completed to provide parking in a subdivision. The pavers used here allow water to flow between the pavers. The gaps have not been maintained and are clogged with dirt and grease. The pavers are not operating in accordance with the design.

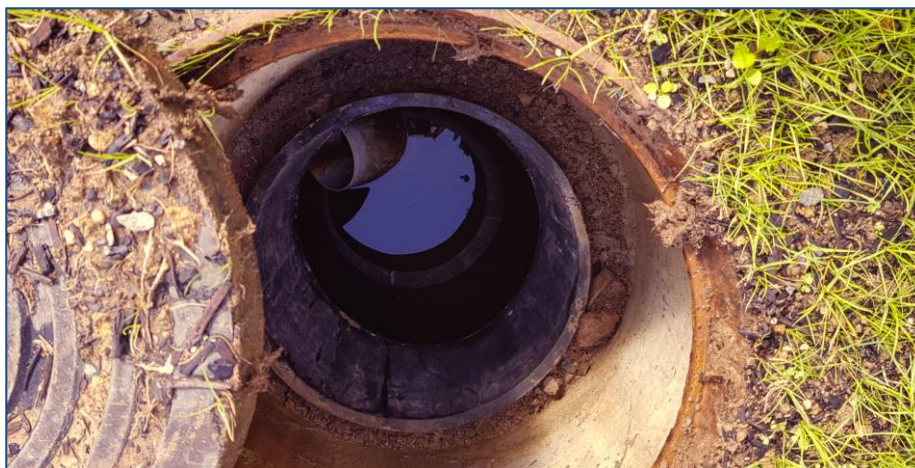
Photographs 19: Underground Tank 6

Tank 6 was the only underground tank that was accessible during the time of the research. The remaining underground tanks had their lids buried far enough in the ground that the screws holding on the lids were not accessible without destroying part of the lawns. Tank 6, located in a large (10+ ha) commercial subdivision was currently full and in overflow. The tank has been maintained within the past 6 months. The tank was a requirement of the underlying consent that each property provide 17 m³ of detention storage draining down over a period of 24 hours. The design drawings and calculations show that this required an 11 mm orifice be installed in the bottom of the tank. It takes a small amount of debris to clog the orifice and confined space entry training to be able to perform any maintenance on the tank.

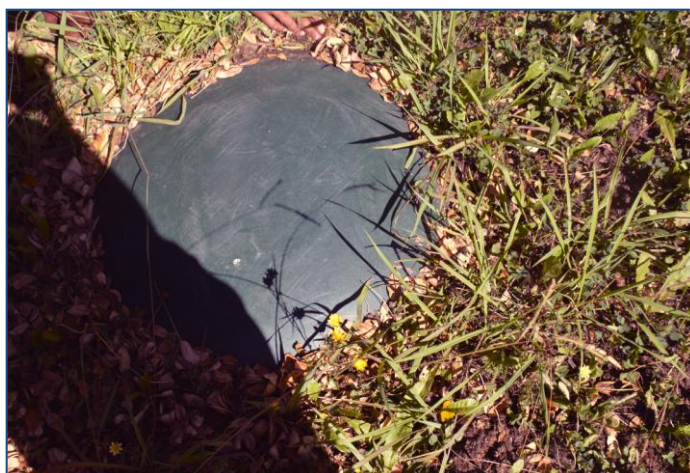
Tanks 7-19 are underground tanks located on a residential subdivision. The properties are all rental properties with a single owner. As part of the subdivision the 7000 litre underground detention tanks were installed to prevent any increase in peak flow into the combined sewer network. The design drawings indicate that each tank has a 45 mm orifice situated at the bottom of the tank. The tanks do not appear to have been maintained for some time as the lids are partially buried in the front gardens. Considering the tanks have been in the ground 10 years, and are unlikely to have had any maintenance, it is likely that all 13 tanks are in overflow.

Photographs 20: Typical Underground Tank 7-19

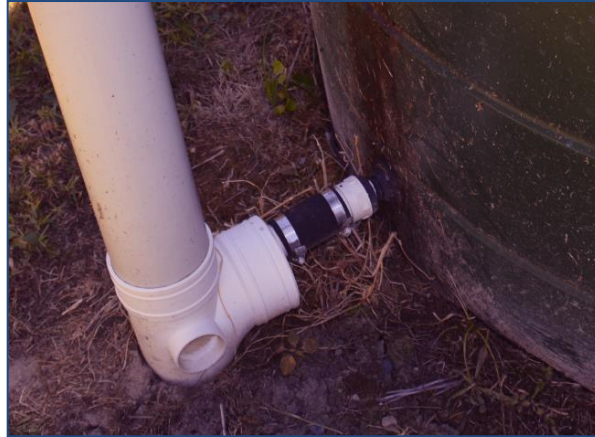
In terms of SMAF (Stormwater Management Area–Flow 1 & 2) mitigation, the detention/retention scenario generally results in an orifice smaller than 10 mm placed at the bottom of the detention volume on a residential site. The stormwater orifice will become quickly blocked and fail to provide the detention component of the SMAF mitigation requirements and thus the intention of the rule is not achieved.

Photographs 21: Difficult to maintain stormwater tank

In regards to stormwater tanks, which have the potential to be a useful tool industry professionals need to develop a removable orifice fitting which allows for easier maintenance. Underground tanks need to have a smaller easy to remove inset lid which completely lifts out the orifice manifold and allows for it to be quickly and easily cleaned. The current design of underground tanks results in Confined Space Entry Training being required for basic maintenance to occur. If there is to be any chance of tanks being maintained the clearing of a stormwater tank orifice needs to be as easy for the property owner as mowing the lawn even for an underground tank.
