WATERNZ CONFERENCE Sarah Millar; Janan Nirainjanan

Öpōtiki District Council workon Private Laterals

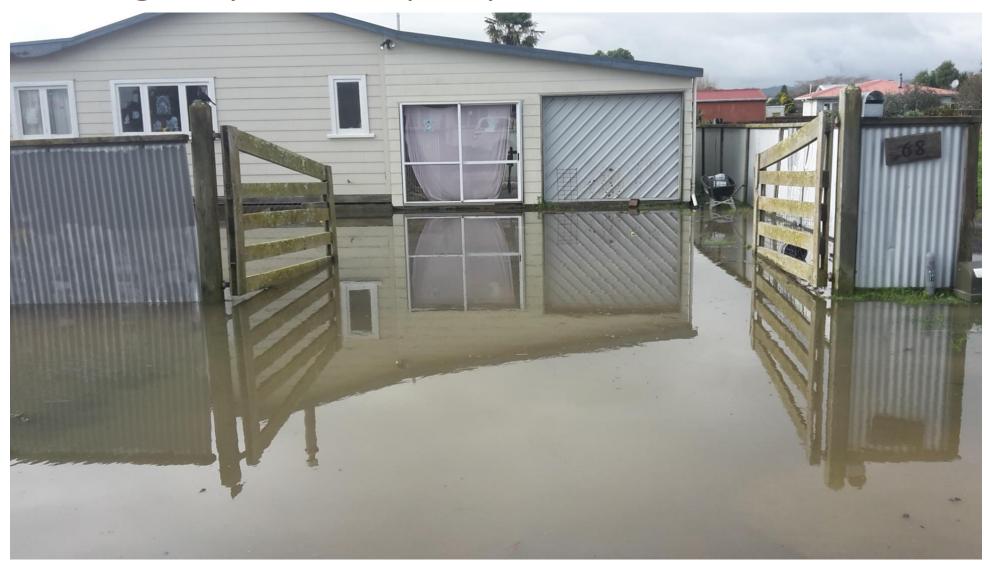
Flooding in private properties

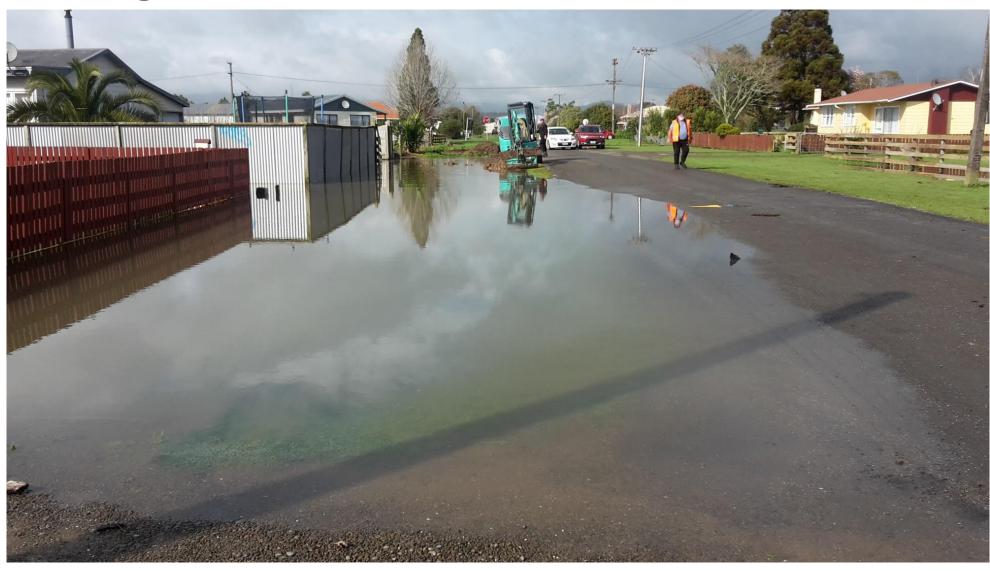
Flooding

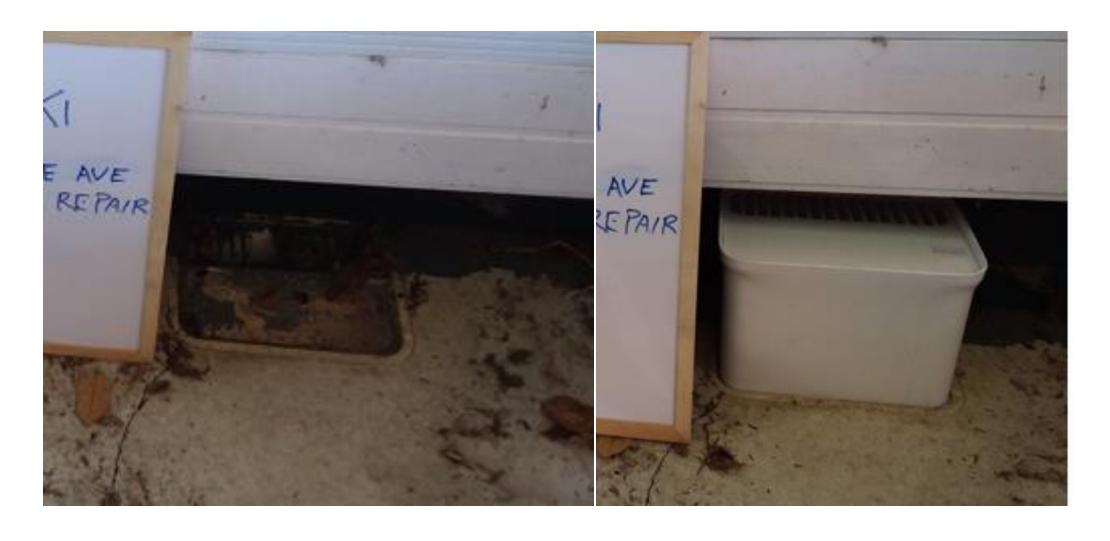
Damaged Earthenware Lateral
