# NON DESTRUCTIVE PIPELINE CONDITION ASSESSMENT – HUTT VALLEY MAIN OUTFALL PIPELINE

*S.J. Hutchison*

*R.J. Mascarenhas*

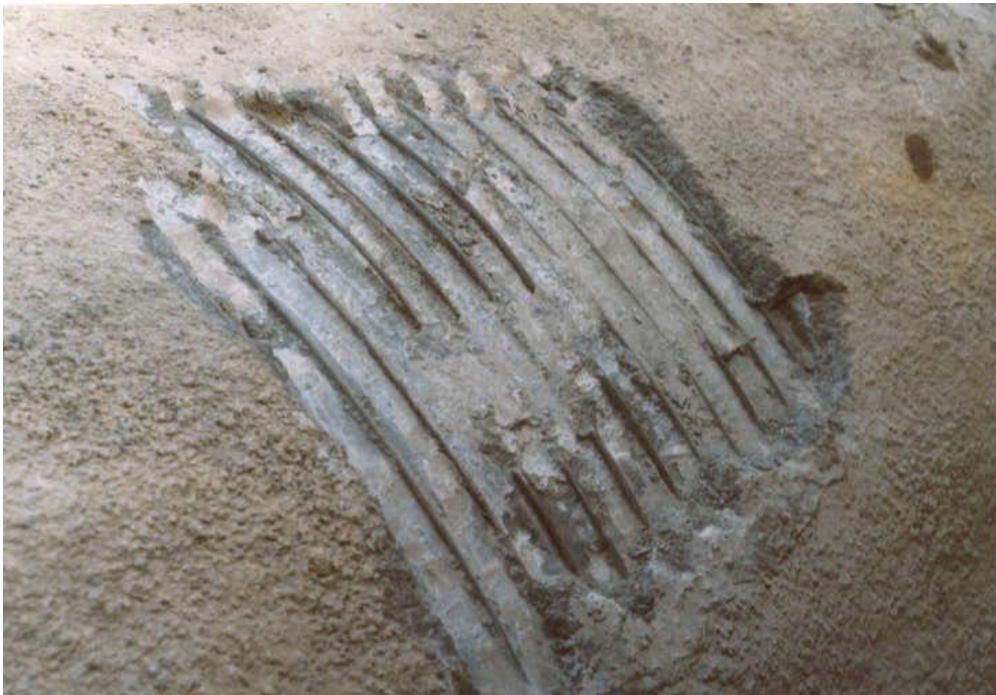
Catastrophic failures occurred in two pipes in one of two short tunnels in the southern end of the pipeline in 1978. These failures were mainly due to severe corrosion of the prestressing wire, although internal corrosion was also a factor and accidental over-pressurisation may have occurred. The corrosion of the prestressing wires was caused by contact of saline groundwater dripping onto the pipes in the tunnel. In 1995 the annular space of these tunnels was filled with concrete to remove the risk of further wall failure in the tunnels.

This failure raised the concern over possible, albeit slower, corrosion of the prestressing wire due to groundwater conditions. Condition survey work in 1989 and 2003 has found areas of prestressing wire corrosion in five of 44 inspected pipes, however only one of these was significant. One of the pipes inspected also had extensive delamination of the protective shotcrete that was a separate concern.

*Photograph 1: View of exposed and corroded prestressing wire*

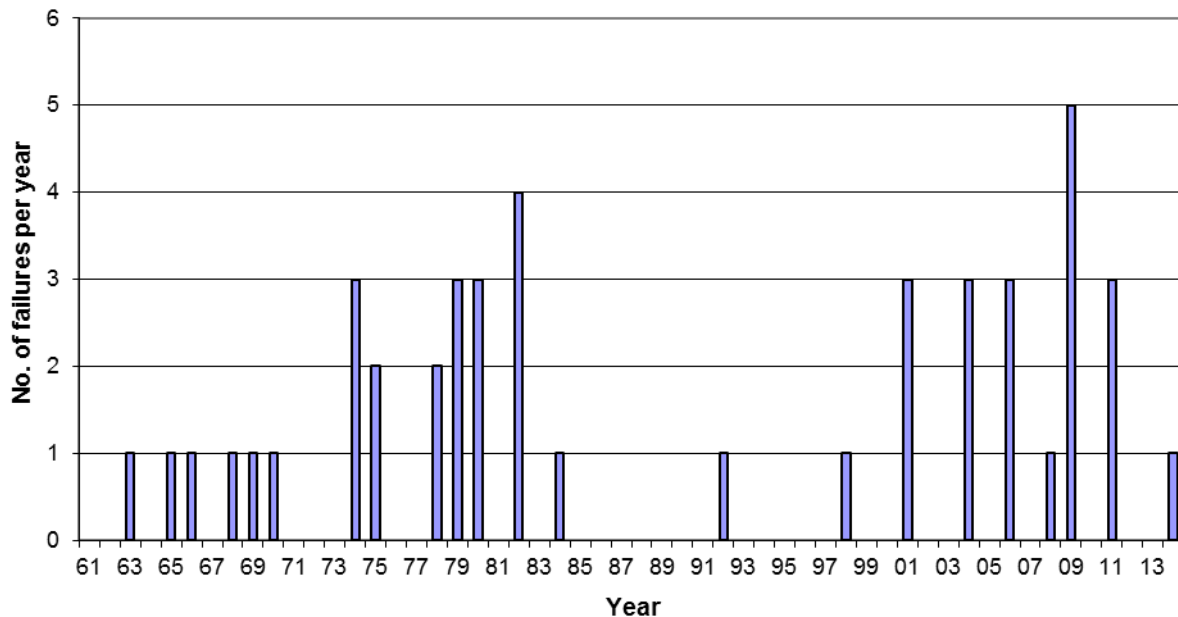
Figure 4: Pipe joint failure histogram from 1962 commissioning to July 2014

Prior to 2009 there had been 36 joint failures in the 47 years of operation of the pipe. The frequency had varied, with an obvious reduction in failures from 1982 due to the installation of new pumps and variable speed drives controlled by new computer control system in 1981 which limited the rate of change of pressure in the pipeline. There are several contributing factors to these joint failures, including pipe settlement, unsatisfactory original installation tolerances, internal pressure fluctuations, ingress of tree roots and loss of integrity of the rubber ring due to loss of elasticity and general degradation with age.

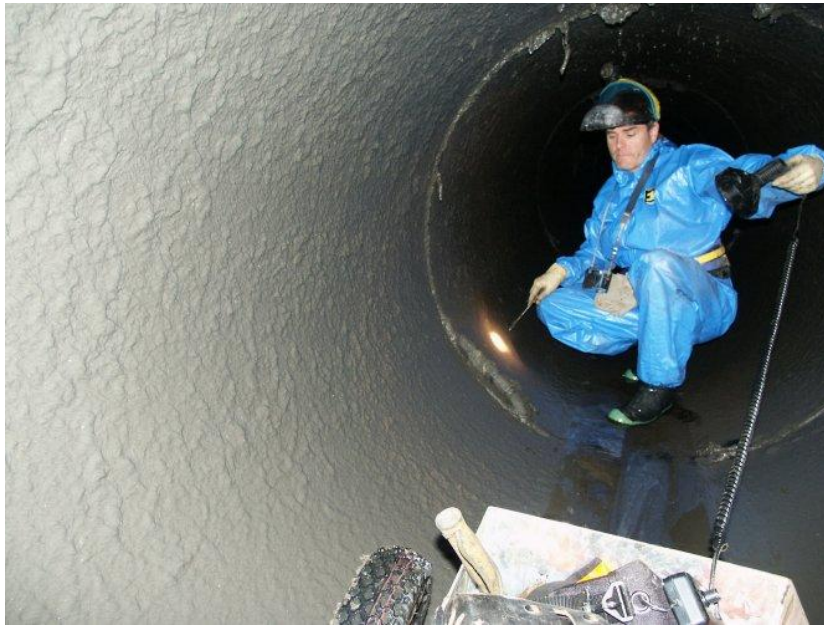
Condition inspection of rising mains is inherently difficult as there is seldom any redundancy to allow the pipelines to be taken off-line. In the case of the Main Outfall Pipeline treated effluent has to be diverted from the Seaview wastewater treatment plant into the lower reaches of the Waiwhetu Stream from where it flows into Wellington harbour. Resource consents were obtained for an internal condition inspection of the pipeline in 2004. The previous inspection had been in 1991 and the key finding in 2004, using methods of that time, was that most of the pipeline was in good condition and no further deterioration had occurred. The remaining life of the pipeline was assessed as being unlikely to be less than 15 years based on about two joint failures per year being reasonably acceptable to the community.

*Photograph 2: Internal condition inspection 2004*
