# DAM BUSTERS! – THE DECOMMISSIONING OF THE HISTORIC RESERVOIR CREEK DAM

*M. Roberts, MWH NZ Ltd.*

## ABSTRACT

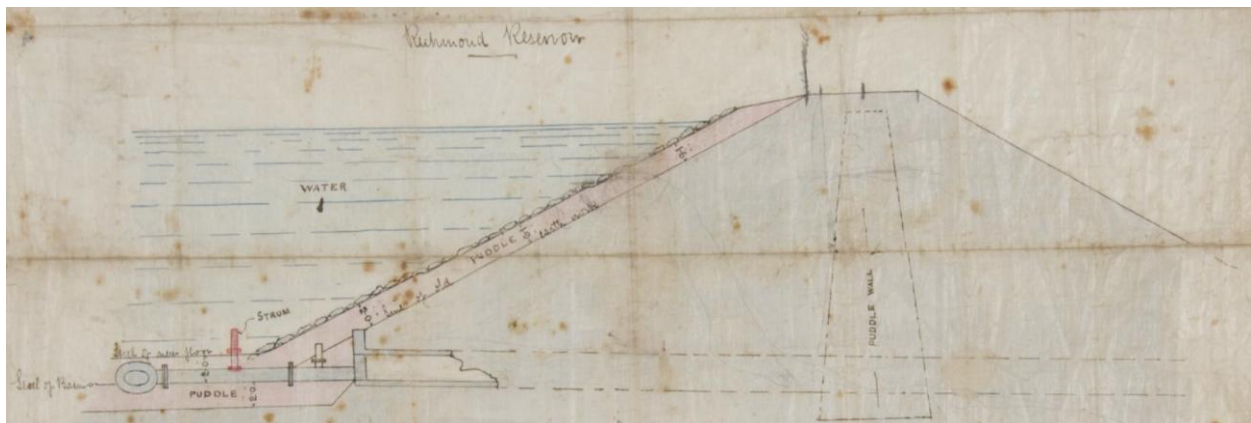
From shortly after the time it was first constructed, the dam leaked and from historical records it appears the dam has leaked in some capacity ever since (Figure 2). The dam was repaired several times and the crest height extended. The original dam was constructed to contain a 12 foot head of water with an estimated storage of 1,200,000 gallons. Later, the spillway was raised to 20 feet to enhance water storage. The last repairs to the dam were carried out around 1970 when a deep trench was excavated and backfilled with clay (2006, Tasman District Council).

*Figure 2: Jickell's plan dated 18/11/1925 appears to show puddle and boulder additions to inner face of embankment and basin, requiring relocation of “strum” or strainer.*

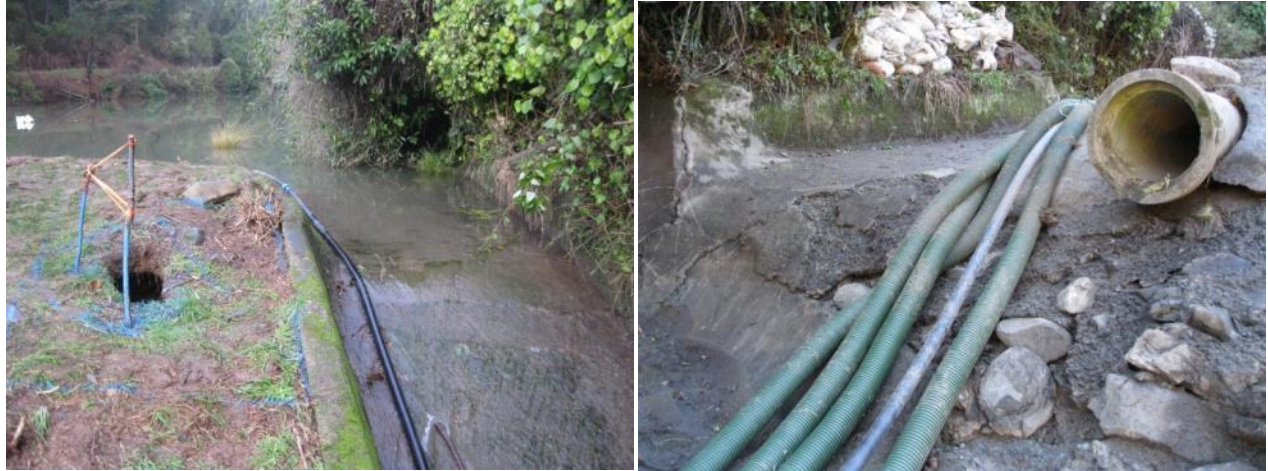
Following a high rainfall event in June 2010, an assessment by MWH identified a sink hole (Photograph 2, left), in the crest of the dam, the Council together with MWH and the maintenance Contractor, Downer, lowered the water level in the dam and removed the old high level outlet pipe (Photograph 2, right) which

*Photograph 2: (left) the sink hole discovered in 2010, (right) the high level outlet pipe.*

was adjacent to the spillway. The area was then also sealed with selected backfill and a newly formed spillway section added (Photograph 3).

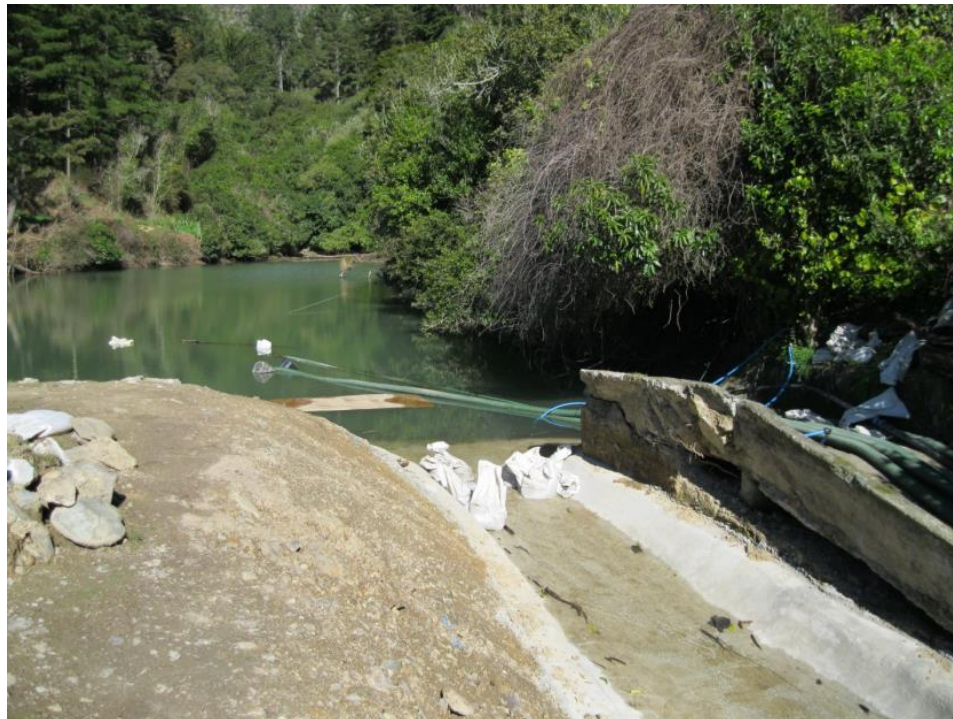
*Photograph 3: Construction of the new low level spillway section.*

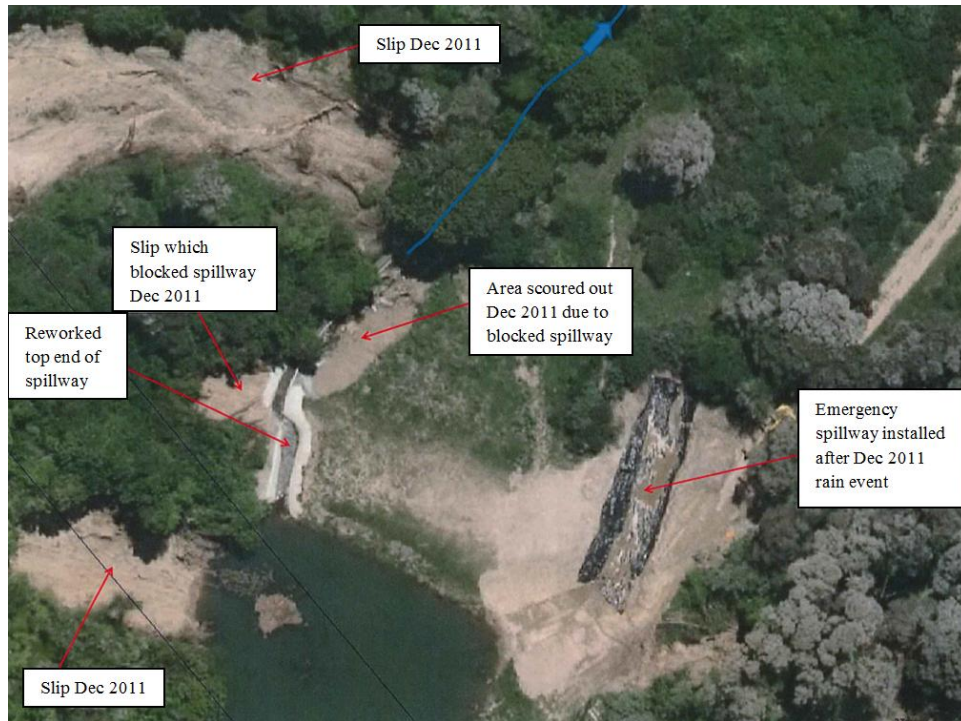
The December 2011 storm event delivered 280 mm of rain in 48 hours to the Richmond township, with other areas of the district receiving over 500 mm. As a result, the dam suffered several slips on the western slope above the dam. The debris from the slips blocked the spillway and the overtopping water scoured the front face. Following the event, a second emergency spillway was excavated through the east side of the dam crest to accommodate flows for any future high rainfall event (Figure 4 and Photograph 4).

Figure 4: Aerial photo showing the slips and scours which occurred during the 2011 high rainfall event.

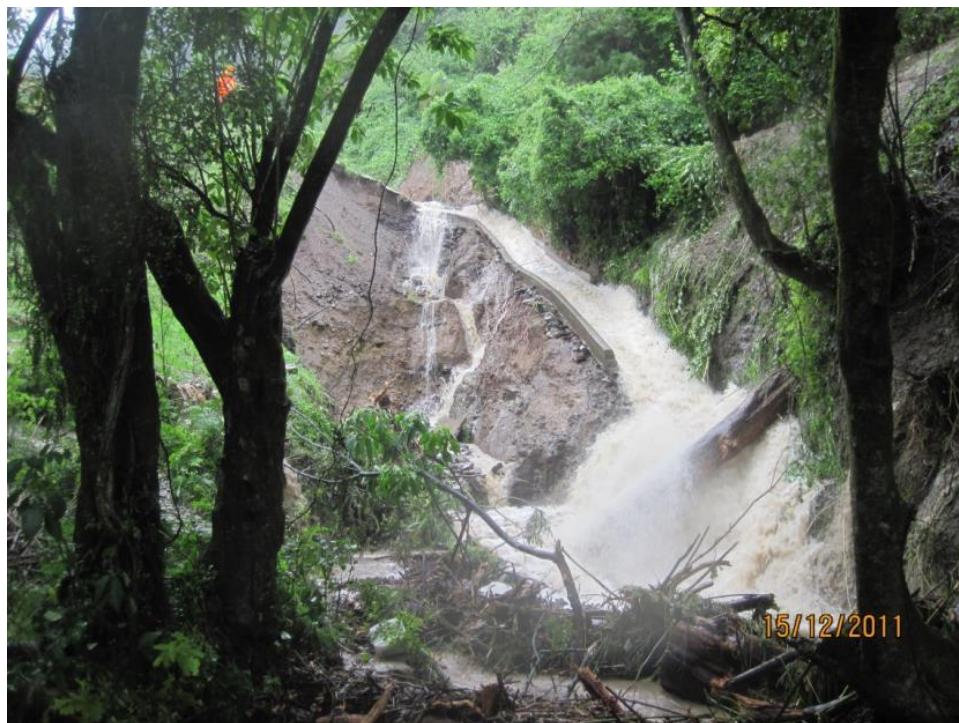
Photograph 4: Toe of the dam - taken during the December 2011 event.

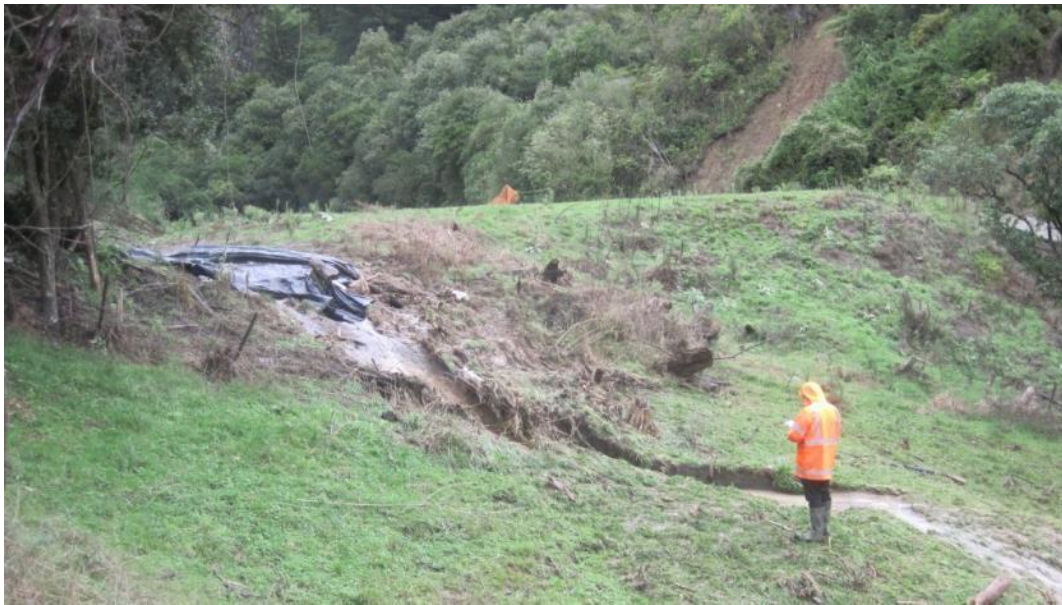
*Photograph 5: the front face of the dam in 2013 before decommissioning. The photograph was taken in a high rainfall event when the emergency spillway was flowing.*

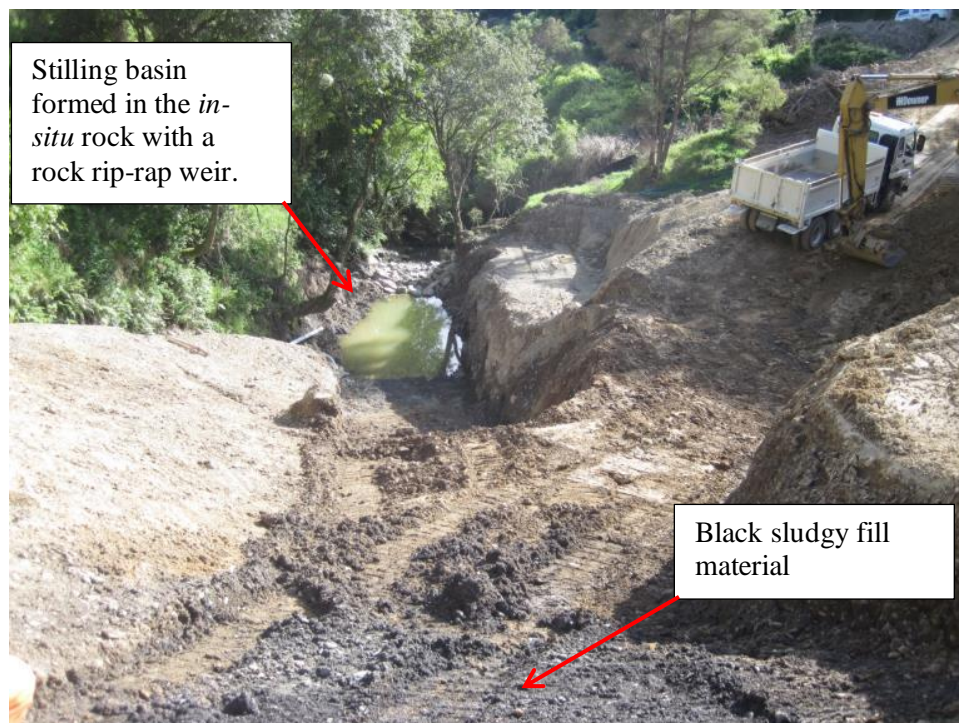
*Photograph 6: The beginning of the excavation for the spillway.*

As the excavation continued, the fractured rock was no longer present and the *in-situ* dam material now encountered was a black sludgy silt material (Photograph 6). This material was excavated to approximately 1 m below the underside of the new spillway. As it continued to be a very soft unsuitable foundation material, it was stiffened by pushing a layer of 150 mm rock into it until the material bound up to form denser foundation material. This was then overlaid with a compacted well graded crushed gravel material to the level of the spillway.

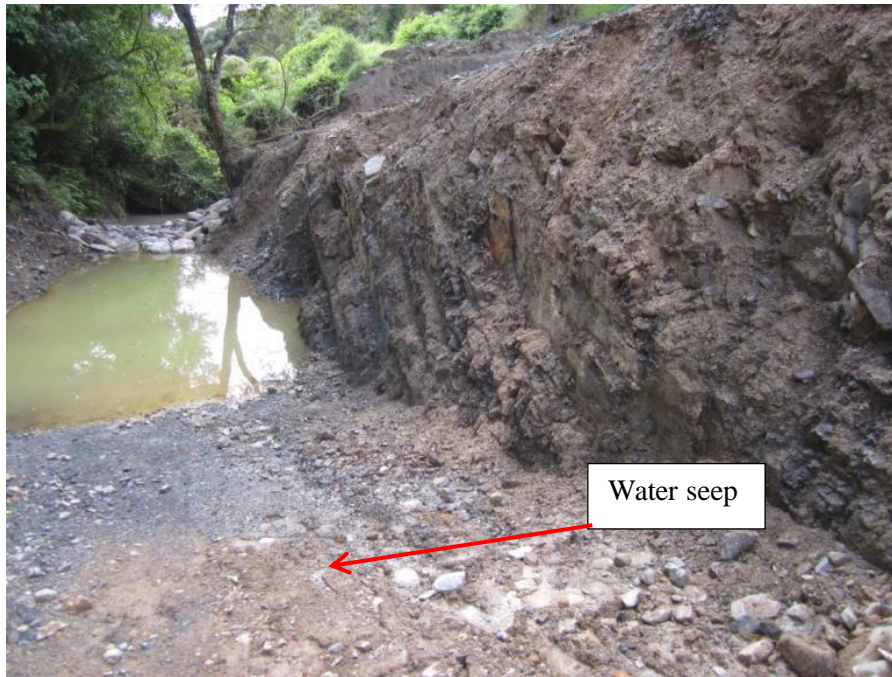
*Photograph 7: shows the fractured rock at the stilling basin with water seeping through the rock in the foreground.*

As the Contractor worked upstream from the stilling basin the fractured rock continued and it was found that water was seeping through fractures directly below the new spillway. To address this, a series of subsoil drains were installed to help relieve the hydrostatic pressure from beneath the new spillway.

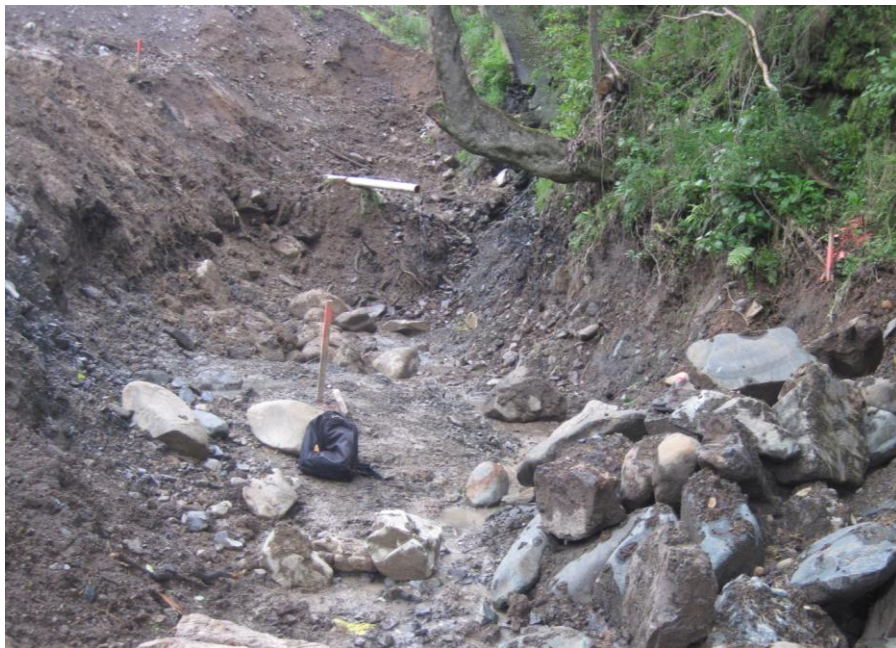
Soon after the start of excavation, an old 6 inch diameter cast iron pipe was discovered protruding from the dam face. The pipe was continually leaking water at a low rate. It was assumed that this was the old scour pipe.

*Photograph 8: Leaking cast iron scour pipe with PVC extension (from previous remediation work).*

Access to the inlet of the scour pipe was not possible as it was buried beneath the silt below the water in the reservoir. Therefore, decommissioning the pipe would be too difficult. To overcome this, the pipe was cut and joined with a new PVC pipe which was aligned to the side of the spillway discharging into the stilling basin. This was again encountered further up the excavation and again connected to with a PVC pipe to ensure any leaks would not flow into the dam material (Photograph 8).

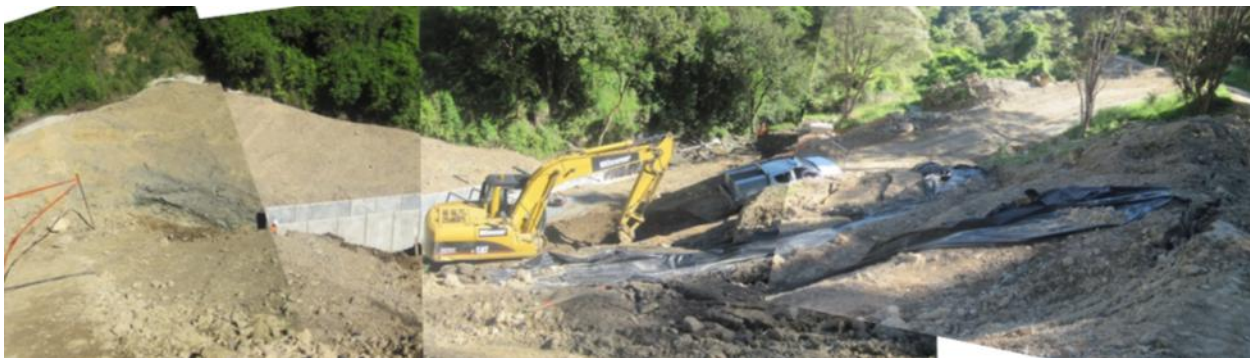
The formation of the access track to the stilling basin meant that part of the dam toe had been removed and stockpiled material at the top was surcharging the face of the dam. Exacerbated by wet weather and the vibration from construction machinery, the face of the dam started to slowly creep forward. This slow creep is known as a 'greasy back' and the foreman on site had experienced this before. The creeping slip material was moving as a single block of soil was and protruding out from the cut face at the base. In addition, cracks were also appearing at the top. The material was moving tens of millimeters per day. Some of the surcharging stockpiled material was moved from the top and polythene plastic was laid over the cracks to reduce water ingress from rain (Photograph 10). The foreman regularly evaluated the rate of movement as the construction continued. Once several panels were in place the excavation at the toe of the dam could be backfilled with the surcharging stockpile material, retaining the material above and the 'greasy back' stopped moving.

*Photograph 10: The site with over half the panels in place. Note the polythene in the foreground protecting the slope from water ingress.*
