A CASE STUDY ON THE SEISMIC PERFORMANCE OF WASTEWATER PIPELINES FOLLOWING THE VALENTINE'S DAY EARTHQUAKE

Miao (Melanie) Liu (Beca Ltd), Marcus Gibson (Beca Ltd), Kelly Tang (Beca Ltd), Greg Preston (UC Quake Centre)

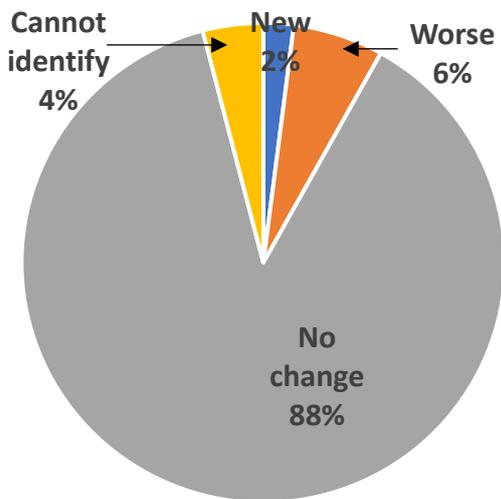
Figure 3. Percentage of lateral related defects

A total of 99 wastewater lateral structural defects were observed within the selected pipelines, of which 88% had No Change to the severity of defect. The percentages of New and Worsening lateral issues were 2% and 6%, respectively. Around 4% of lateral defects could not be coded due to the defects being obscured by water.

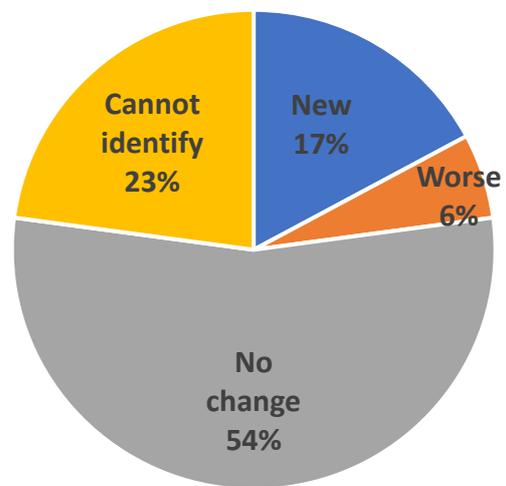
Figure 4. Percentage of pipe related defects

A total of 35 pipe related structural defects were observed. The pipe related structural defects included cracks within pipe walls (longitudinal and circumferential) and deformed pipes. 19 defects, accounting for 54% of the total

observed, did not record a change in severity of the defect. The percentages of New and Worse defects were 17% and 6%, respectively. Approximately 23% of pipe related defects could not be coded due to either defects being covered by water or poor video quality.

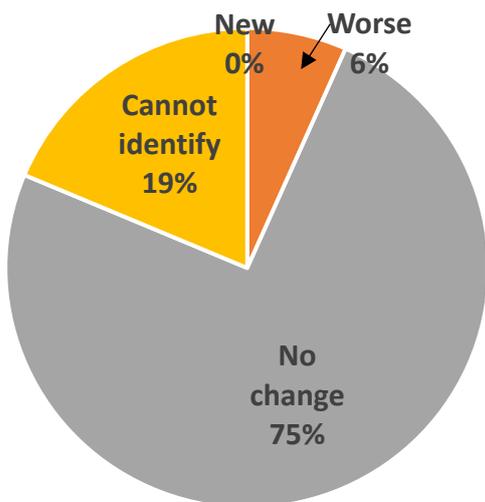
Figure 5. Percentage of pipe joint related defects

There were 75 pipe joint related structural defects observed within the selected pipelines, of which almost 75% had No Change to severity of the defects and 19% could not be coded due to defects being covered by water or poor video quality. Approximately 6% of the defects had a Worse condition in the post-earthquake CCTV footage. There were no New joint related defects identified.

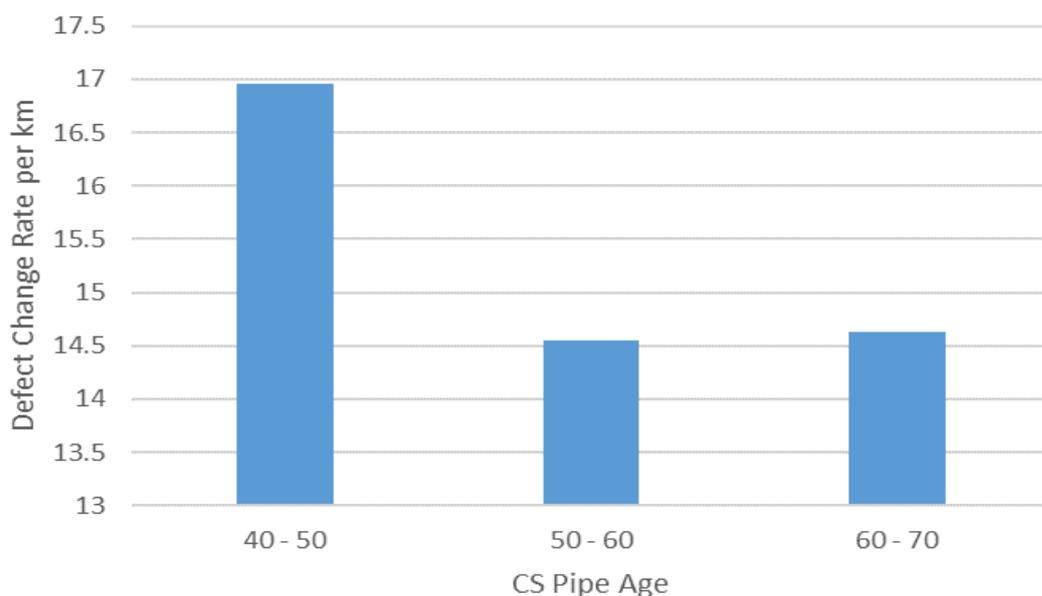
Figure 6. Defect change rate based on pipe age

No clear relationship between pipe age and pipe performance was identified in this study. PVC pipes in this study were laid between 2002 and 2004; CS were between 1954 and 1975 (Figure 6).

- There is no clear relationship observed between pipe age and pipe performance for CS pipes.
