ARE YOU PREPARED FOR NATURAL HAZARDS? – A LESSON IN RESILIENCE PREPAREDNESS

Tracey Mitchell (NewPlymouth District Council)

1. INTRODUCTION

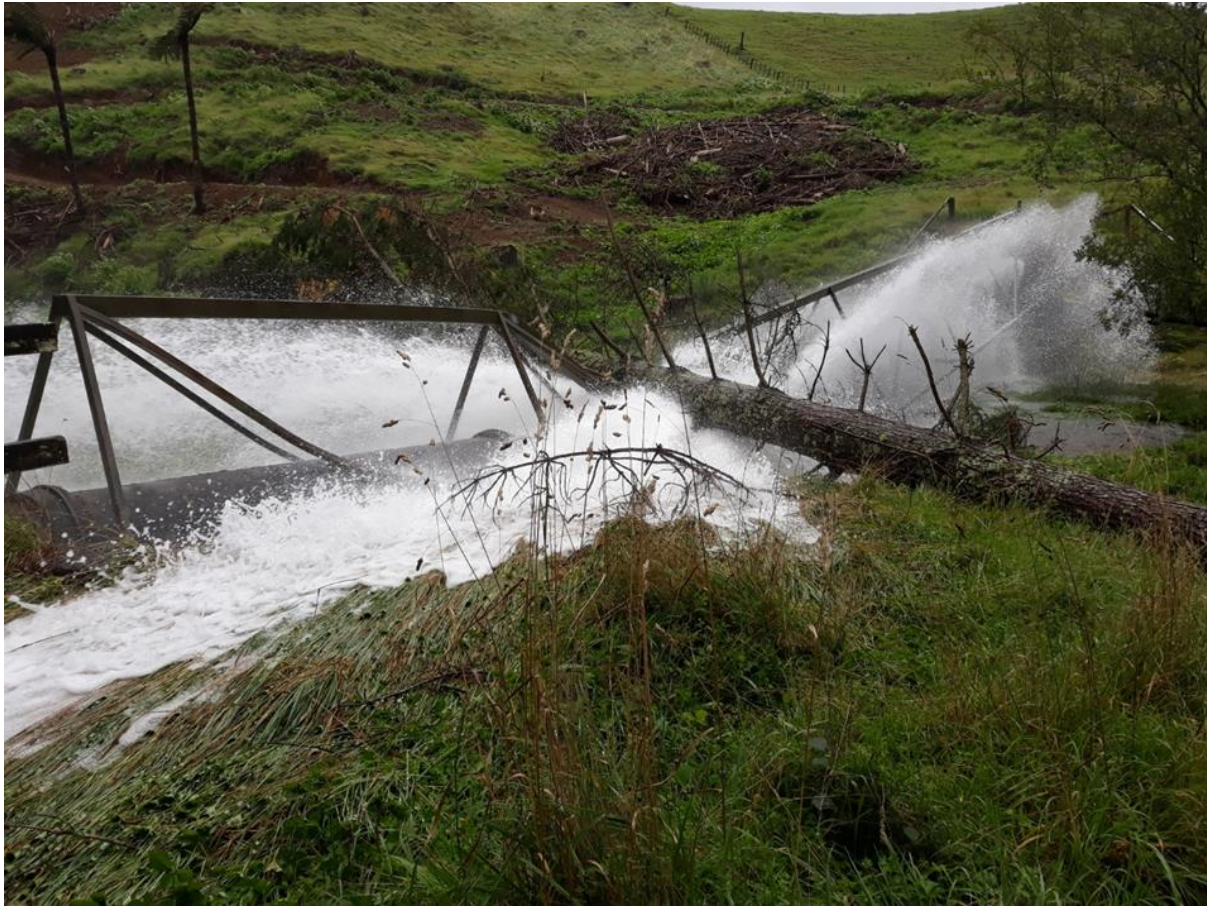
The resulting damage to the pipe bridge and water main caused water to drain out of the reticulation network between the New Plymouth Water Treatment Plant and the Mangorei Reservoirs with water from the Mangorei reservoirs flowing back towards the pipe break.

With the water main ruptured, the majority of the city and outlying areas to the East were at risk of running out of potable water.

Photograph 1: Discovery of broken Pipe Bridge and water main

Our maintenance contractor mobilised to evaluate the damage to the pipe bridge and feeder main and to start the necessary repairs. We closed reservoir valves to stop treated water flowing back to the broken main and started up our emergency response team.

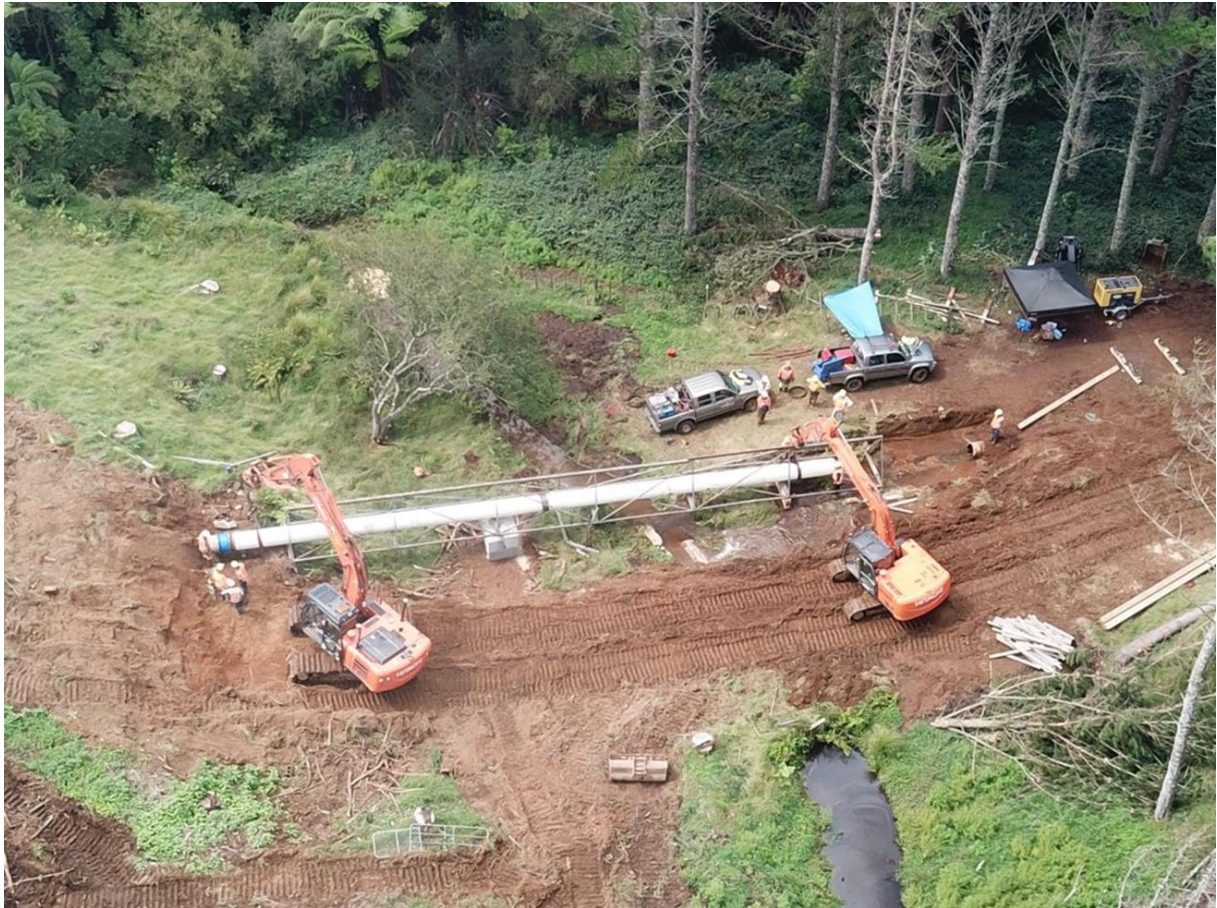
Photograph 2: Contractors repairing Pipe Bridge and water main

We got lucky! Our maintenance contractor and local suppliers were able to use their contacts to source the pipe and fittings needed. The pipe and fittings arrived 27 hours after the main break was first discovered, and this was just in time for the wind to die down and the rain to stop the following morning, making it safe to work in the forest and lay metal to get machinery in and make the repair to the pipe and bridge.

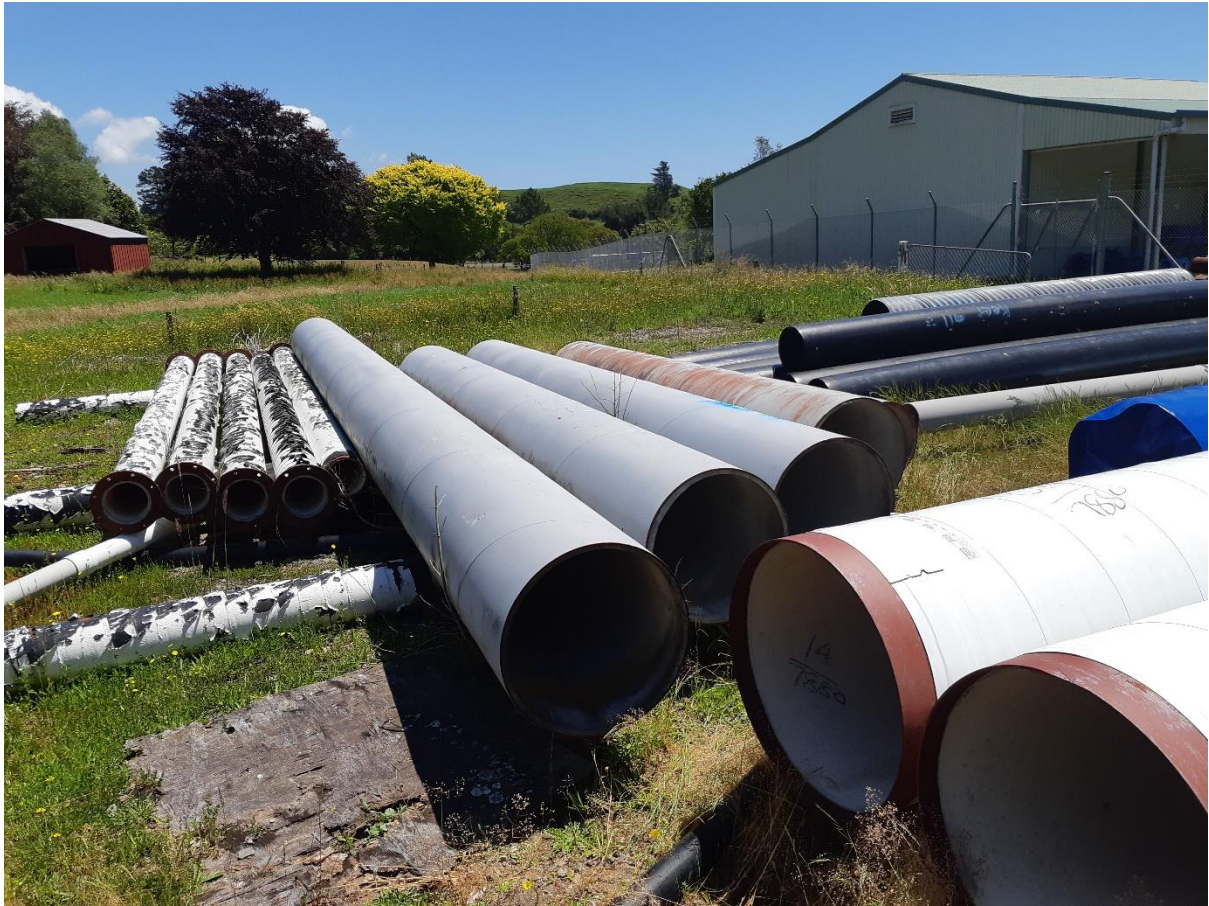
- Spare pipe had been held in stock for an extended period of time and its condition had deteriorated considerably.
- Spare pipe was made of asbestos cement which was brittle and not able to self-support with the damaged/temporarily repaired bridge.
- Asbestos cement pipes also pose a health risk if it becomes friable when left exposed to the air and not buried.

Photograph 3: Condition of existing stored pipe

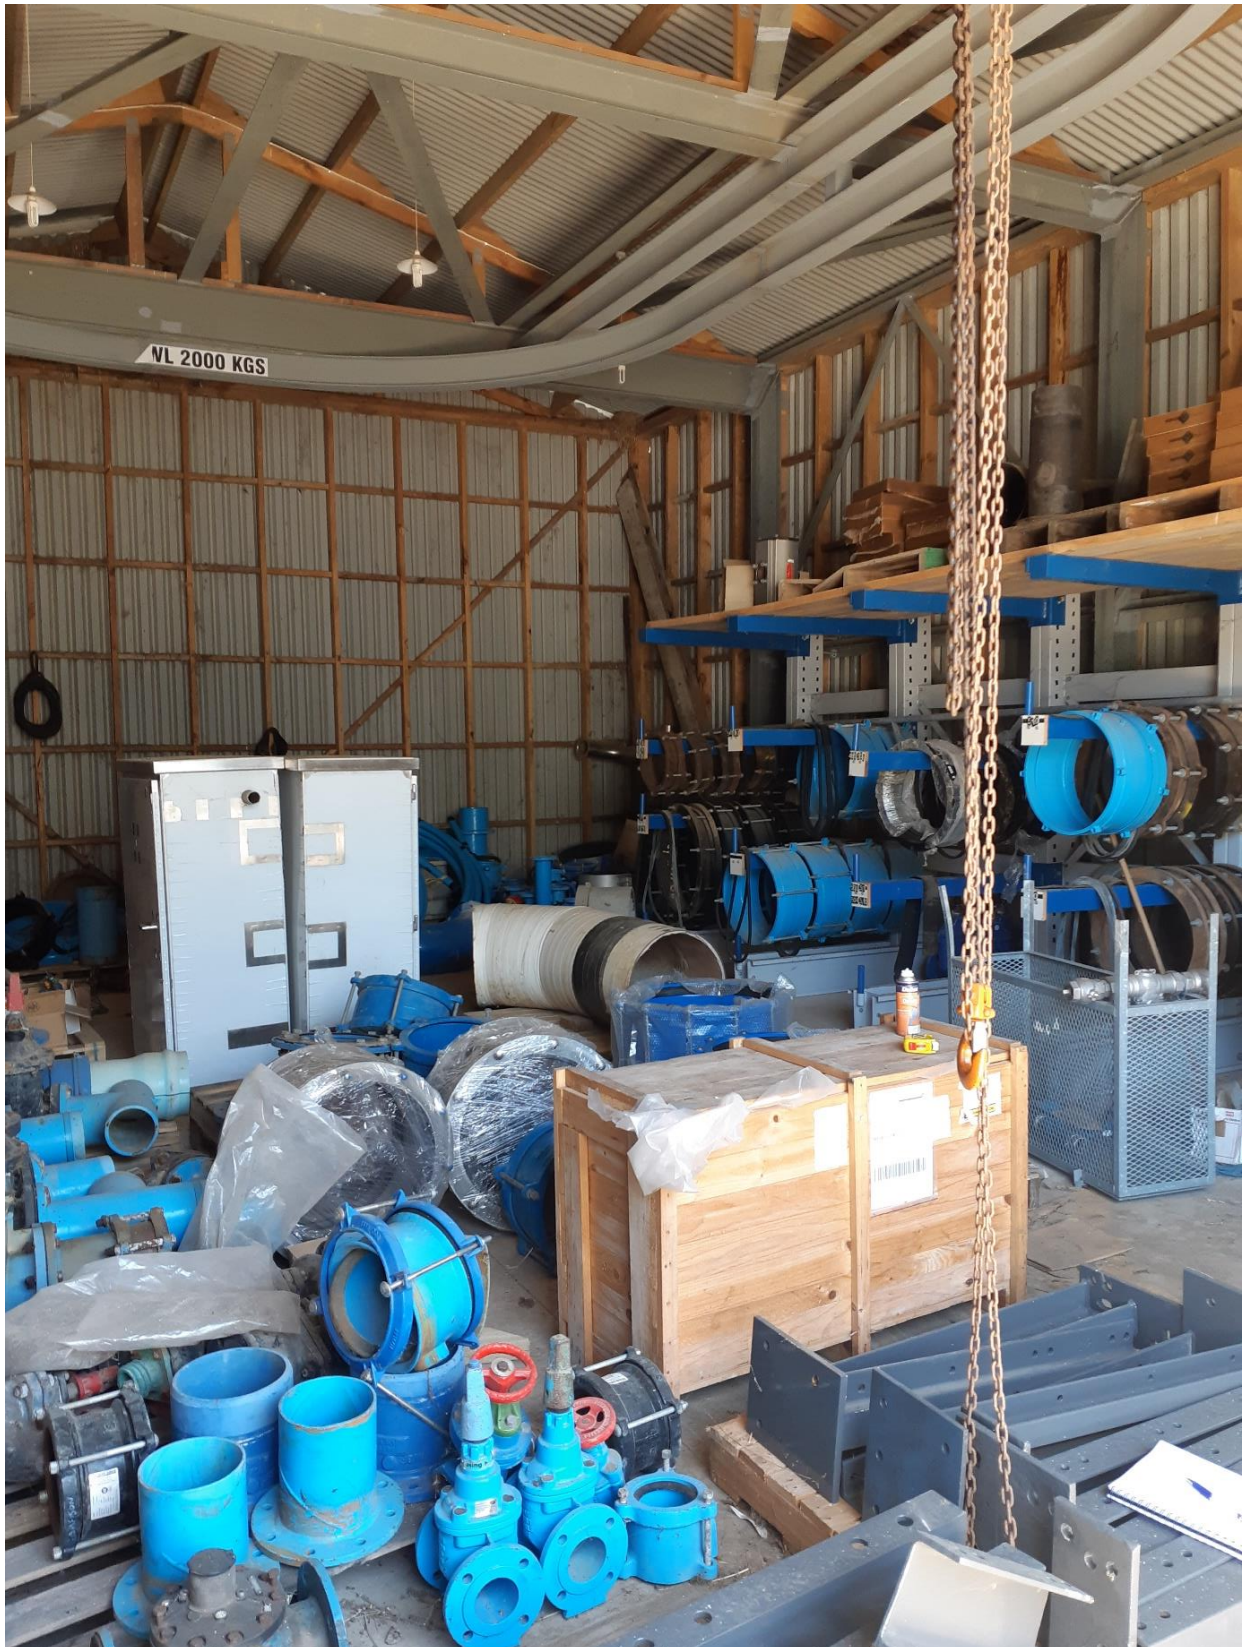
A comprehensive stocktake was undertaken. This involved cleaning out the fittings shed which had become a convenient place for keeping odds and sods that we may need one day, but no idea when. The shed had to be put into some sort of order first to get access to all the fittings. I found pipe stored on three different sites (just by asking around) as it had been assumed all pipe was stored at the Water Treatment Plant.

Photograph 4: Spare fittings Storage Shed – before
