GET THOSE TURD TAXIS OFF OUR STREETS! – A STORY OF SLUDGE PIPELINE REPAIR IN WELLINGTON

Elliot Altham

1 MT ALBERT SLUDGE LINE REMEDIATION

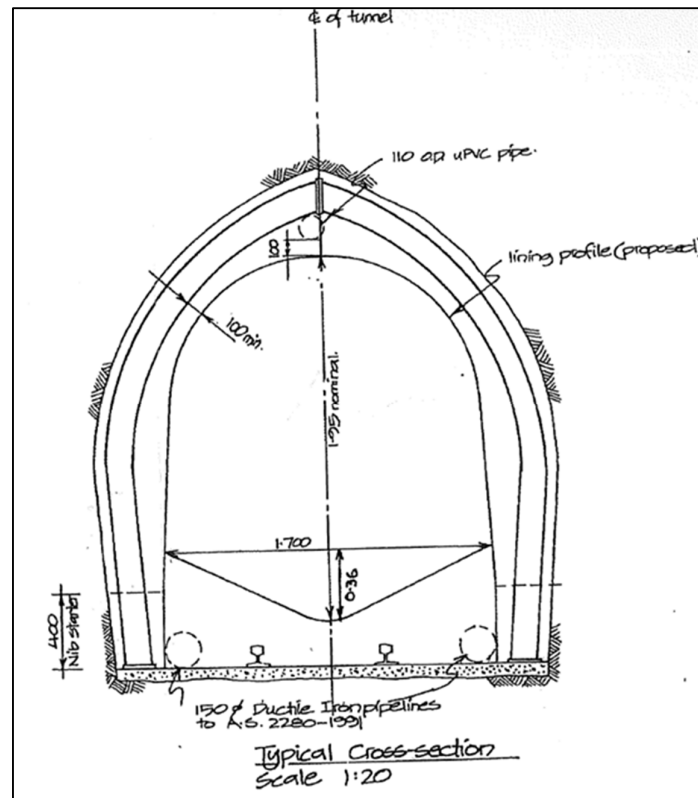
Figure 2: Tunnel Cross Section

The initial investigations carried out identified the failures had occurred within the 1.7km wastewater tunnel that runs beneath Mount Albert, between Kilbirnie and Island Bay. The tunnel has access points at each end only; these being Adelaide Road, Island Bay and Queens Drive, Kilbirnie. The tunnel transfers wastewater gravity flow from west to east towards the WWTP, with the sludge pressure pipelines cast in the tunnel benching, pumping sludge from east to west towards Carey's Gully (refer Figure 2).

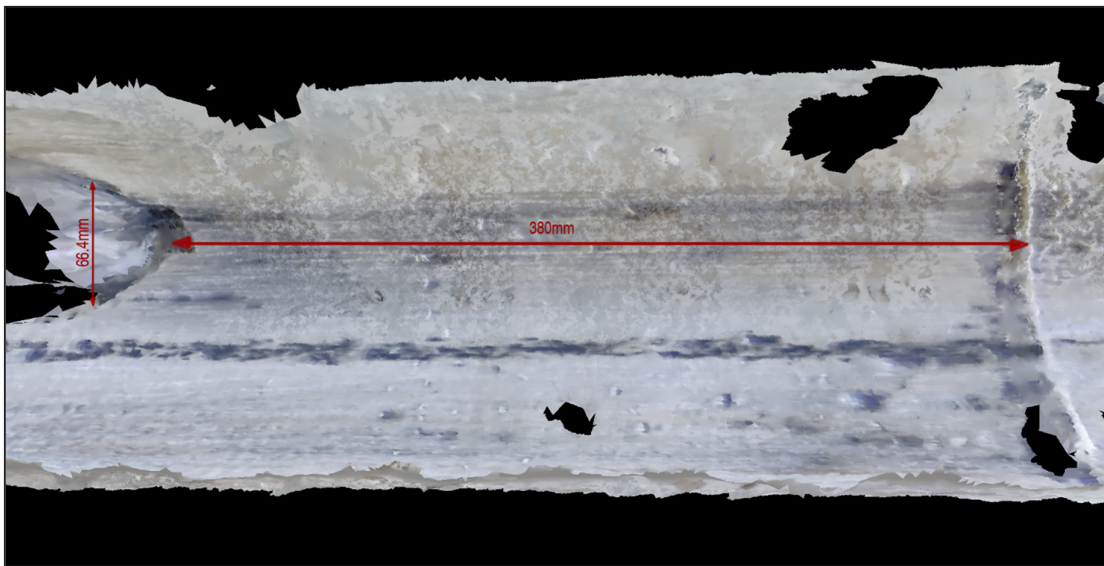
Figure 3: Post processing of CCTV footage to identify burst size and pipe features.

- Northern line – burst in the pipe wall approximately 235m from Adelaide Road
- Southern line – burst in the pipe wall approximately 170m from Adelaide Road.

The footage identified significant water ingress to the pipe and post processing of the footage was used to determine the burst widths to be approximately 65-70mm.

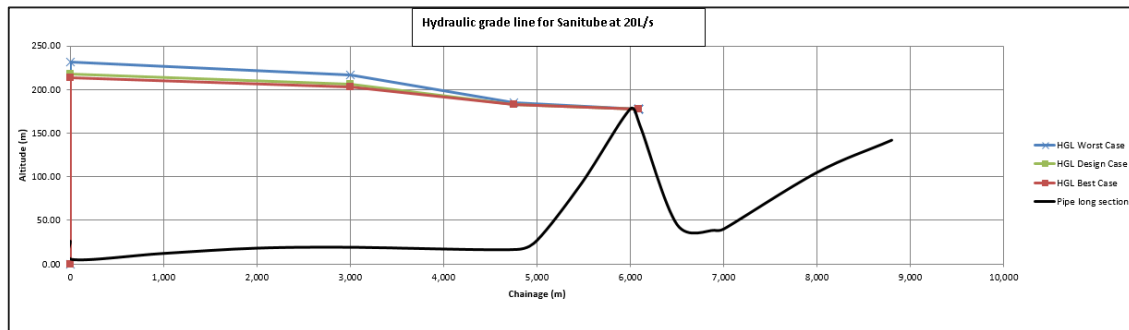
Figure 4: Hydraulic Grade Post lining

To deliver the required 20 l/s design flow an approximate 1 bar increase in system pressure upstream of the tunnel is required. Post-lining HGL's are shown in Figure 4.

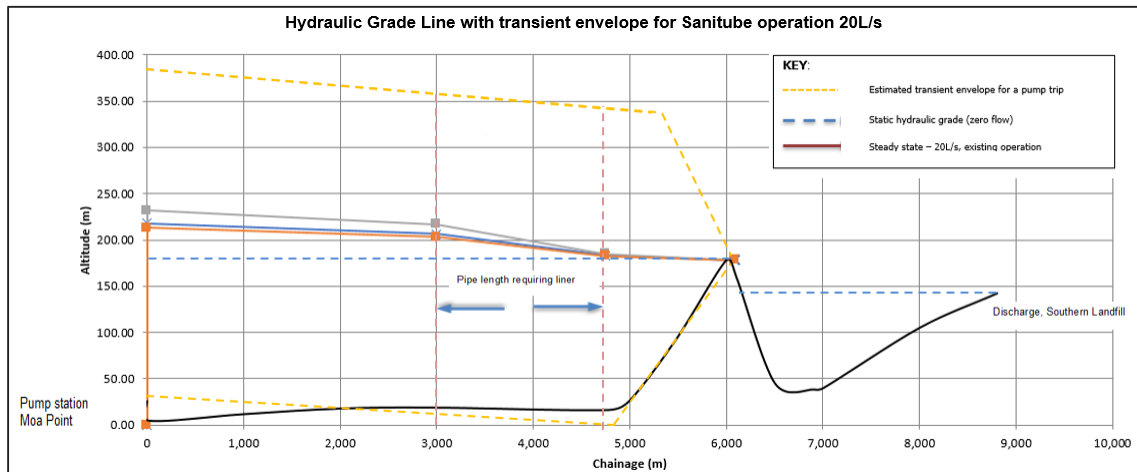
Figure 5 - Transient Envelope with Sanitube Liner

A Joukowsky head calculation was completed to estimate the transient pressure envelope for the lined tunnel section of the pipeline assuming a pump trip scenario. The calculation provides a conservative estimate of transient pressure and is typically used as a starting point to determine level of risk and whether a more in-depth analysis is required using computer simulation. It also ignores the fly wheels provided at the pump station for transient protection. The maximum pressure rise was found to be 35 bar at the upstream end of the tunnel and this figure was used to set the minimum allowable pressure rating for the liner supply. Please see Figure 5.

It is noted that this is conservative in comparison to transient analysis completed for the original pipeline design.

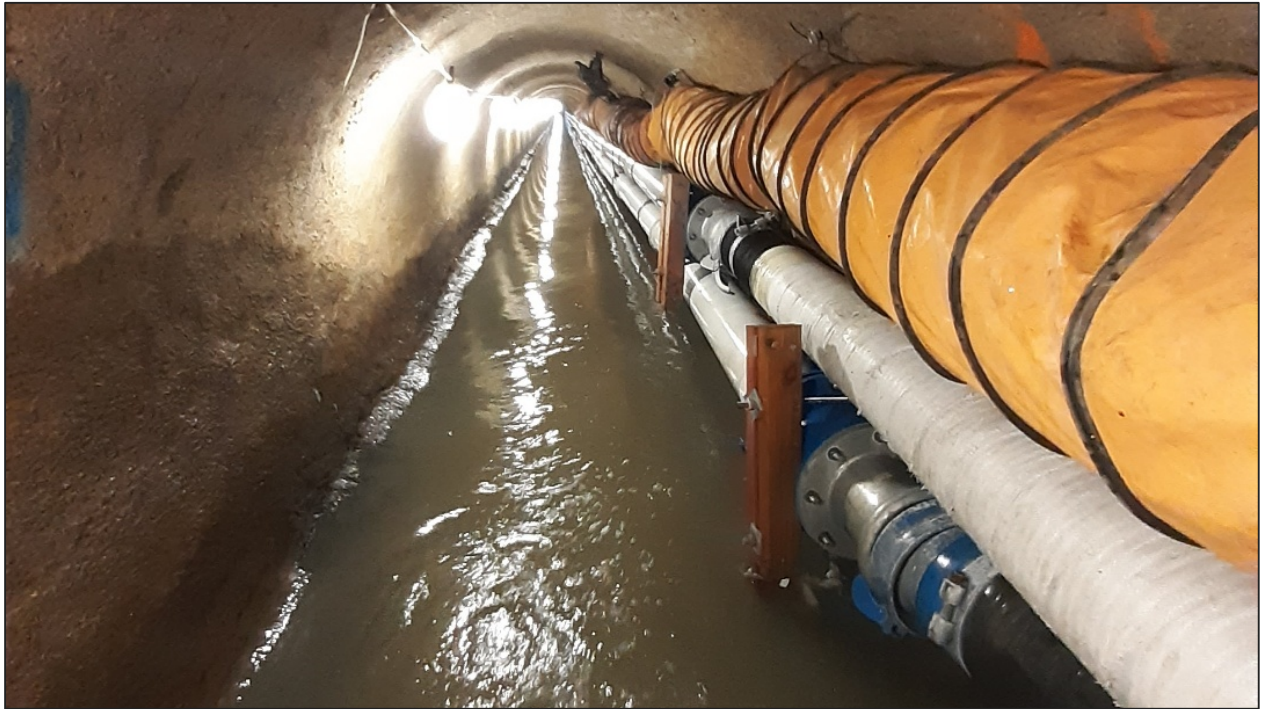
Figure 11: Over pumping set up

A confined space entry was completed in July 2020 with the flow from PS38 being held back to allow assessment of the damage with minimal flow in the tunnel. This identified areas where benching had been fully lifted, tilted and / or cracked. The damage was generally concentrated in the vicinity of the two burst locations and as such is thought to be related to the pipe failures, as opposed to other mechanisms such as seismic movement, or groundwater pressure. The boat survey showed no other notable damage in the remainder of the tunnel beyond the 222m mark.

To enable the repairs an pumping system used whereby sewage was pumped through temporary rising mains installed into the tunnel. A new access chamber was installed onto the DN1050mm incoming pipe to the tunnel to act as a wet well to reduce the number of pipelines required within the access shaft to the tunnel.
