EARTHQUAKE REPAIRS AT CHRISTCHURCH WWTP – CLARIFYING THE SITUATION

Greg Offer¹, Ian Billings¹, Tim Scott²

1. CH2M Beca, 2. Christchurch City Council

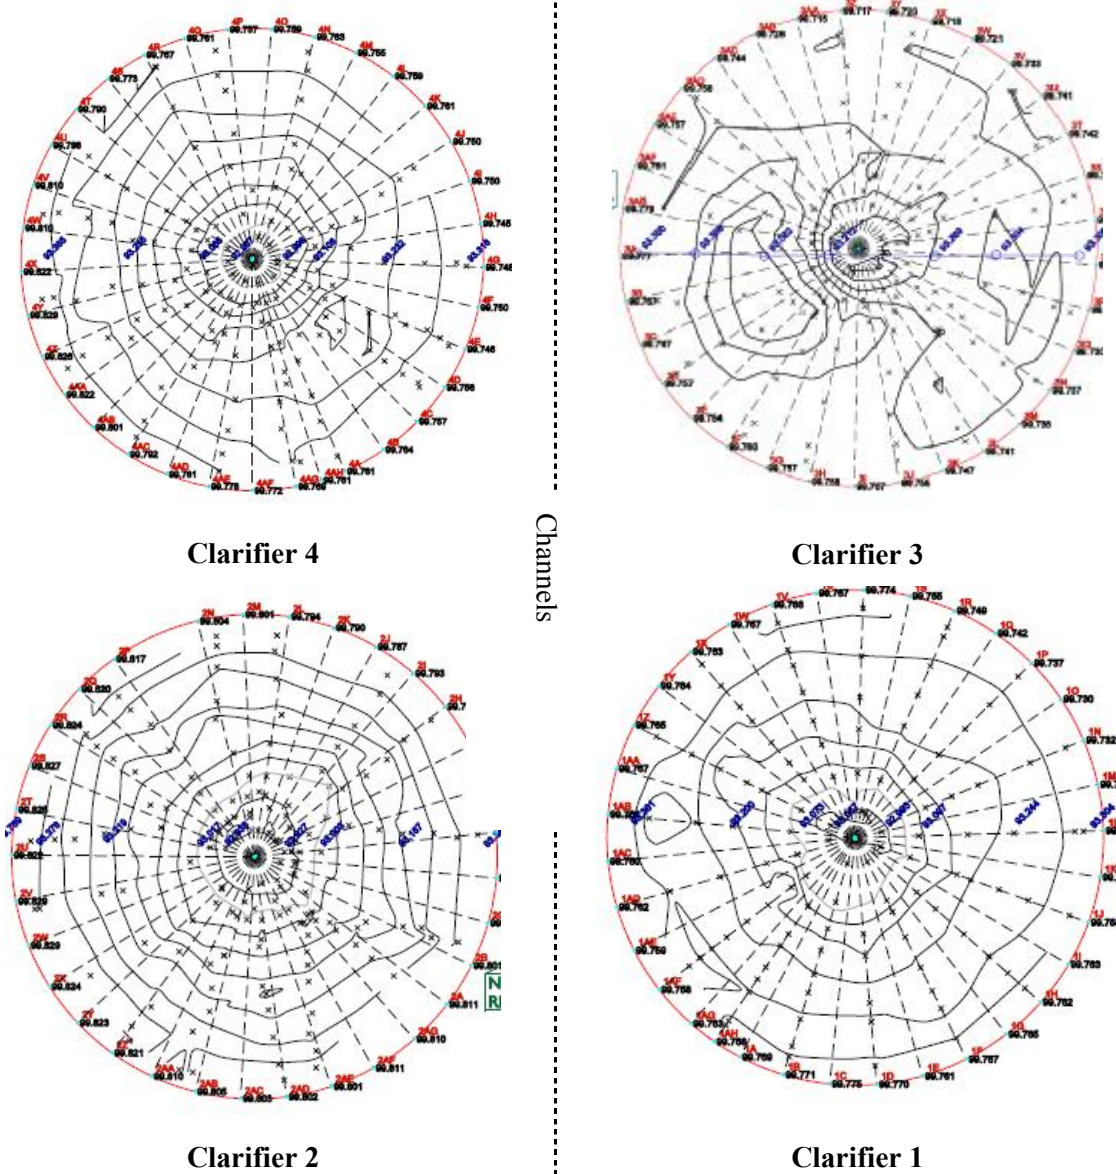
Figure 4: Bathymetric Survey of Clarifier Floors

The bathymetric survey showed that the floors of Clarifiers 2 and 4 appear to be relatively less damaged, with the original floor falls remaining largely intact. The floors on Clarifiers 1 and 3 showed significant deformation, with Clarifier 3 clearly the worst case. This was consistent with observations of the bridge across the centre of the Clarifiers 1 and 3. Based on these results the decision was taken to select Clarifiers 2 and 4 as the first units to be repaired with the objective that they would be fixed and brought back online fairly quickly.

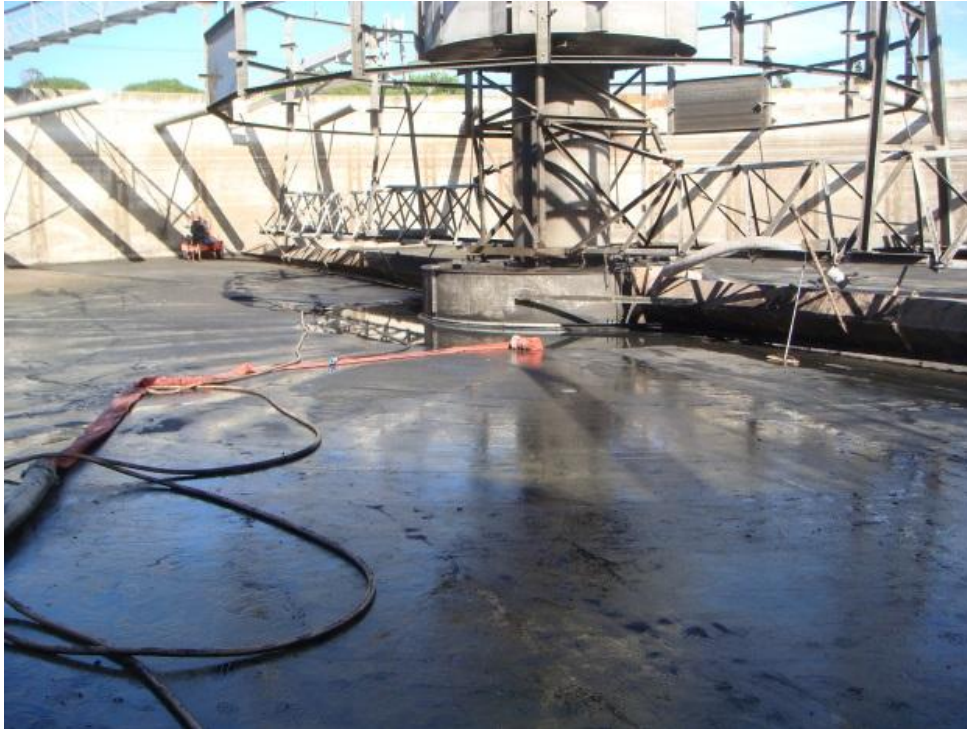
Figure 5: Clean Out of Clarifier 2

Well pointing was installed on Clarifiers 2 and 4 and operated for the 6 weeks necessary to lower the groundwater to a level where the clarifiers could be pumped out. Water and residual sludge was then removed from Clarifier 2 and the internals inspected. Final clean out of clarifier 2 is shown in Figure 5.

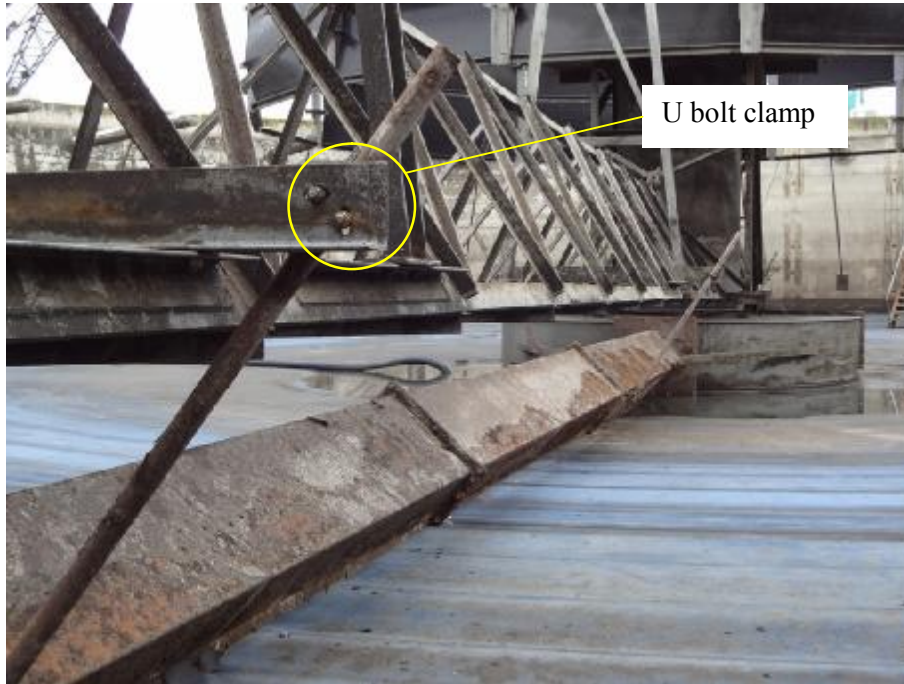
Figure 6: U-bolt scraper support

The dewatering around Clarifiers 2 and 4 had created a groundwater depression zone that extended out across the other two clarifiers. With some local piezo bore measurements to hand the water was carefully pumped out of Clarifier 1 until the top of the scraper support frame was exposed. Inspection of Clarifier 2 mechanicals had identified that the scraper was held up off the floor using simple U-bolts around two pieces of 40mm pipe (as shown in Figure 6).

During the earthquake the pipes slipped through the U-bolts until the scrapers hit the floor. It was speculated that the same thing had probably happened on Clarifier 1. If the scraper arm itself could be attached to a chain hoist and jacked off the floor then Clarifier 2 might be able to run. Two maintenance hands in a dinghy performed this task working up to their armpits in wastewater. The scraper arms were jacked well clear of the floor and the clarifier was able to be restarted (albeit with reduced performance).

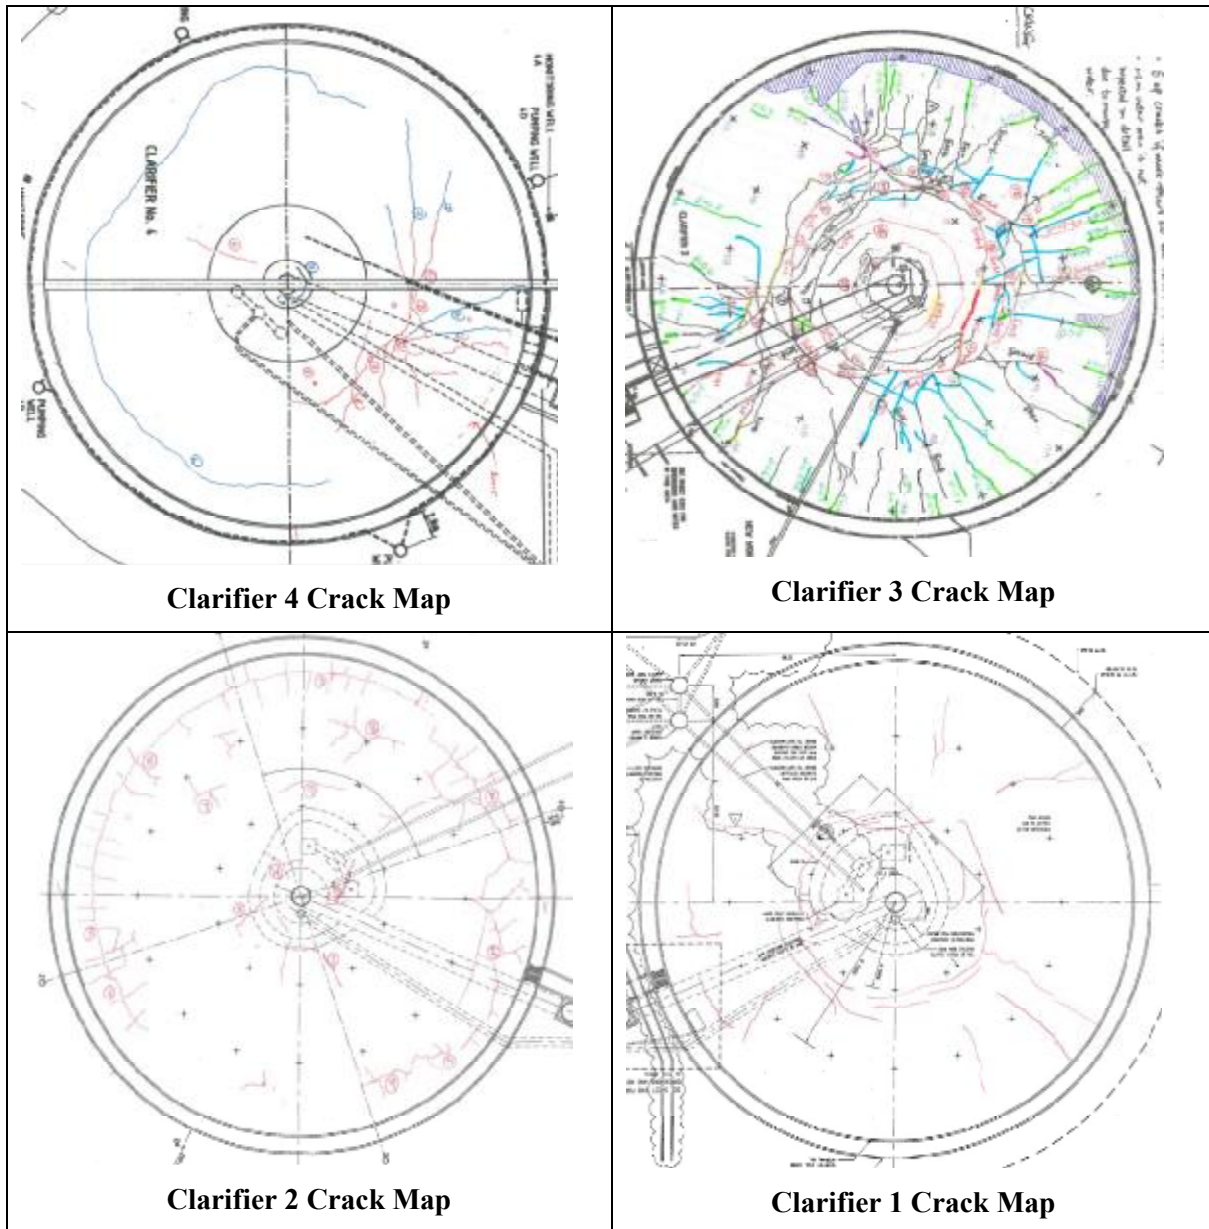
Figure 7 Clarifier Crack Maps

Clarifier 1 survey indicated that the floor suffered uplift of about 90mm and the central foundation had risen about 80mm relative to the walls. The uplift of the slab was distributed reasonably evenly in a circumferential annulus around the mid-point of the slab, with the upward deflection causing a series of circumferential cracks of up to 2mm width at the surface of the post tensioned slab, with minor radial cracking in the outer third attributable to differential settlement around the perimeter.

Clarifier 2 surveys showed no significant floor deformations.

Clarifier 3 floor suffered considerable damage with a maximum uplift of about 600mm and widespread circumferential cracking of the floor slab – many of the cracks being several millimetres in width. The maximum uplift was also over the influent pipe. The central foundation also rose significantly – in the order of 300mm relative to the walls.

Clarifier 4 floor was subjected to uplift of up to 200mm and the central foundation rose about 100mm relative to the walls. The uplift of the slab was mostly confined to the area above the influent pipes where a pronounced local vertical deflection or “bulge” of approximately 100mm was observed. The upward deflection caused a series of cracks of up to 2.5mm width at the surface of the post tensioned slab, radiating outward from the point of maximum deflection.

Crack maps for Clarifiers 1, 2 3, 4 are shown in Figure 7 overleaf.

Crack mapping also showed wide variation in the response of each clarifier to earthquake –imposed loads. There is no obvious rational explanation for the wide disparity in floor cracking and deformation observed. The design of all clarifiers is the same and the foundations of all four clarifiers involved use of the same ground improvement in the form of stone columns to a standard set out and depth. Hypotheses for explaining the differences in behaviour include the following:

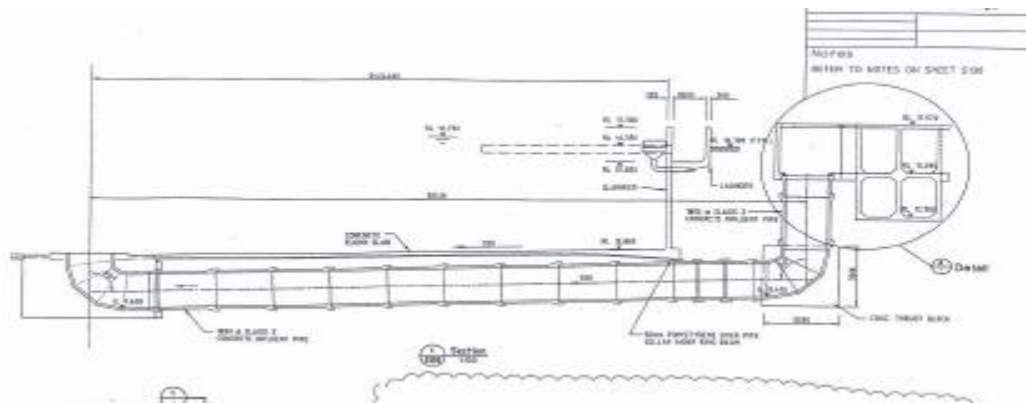
Figure 8: Influent Pipe Cross Section

In addition to investigation of the clarifier structures, the 1800 Ø concrete influent pipes which supply wastewater to the central distribution plenum were also checked. A schematic diagram of the influent pipe is shown in Figure 8.

Hydrostatic head testing of the influent pipes identified significant levels of leakage. A dive survey of the influent pipe on each clarifier was then conducted to ascertain joint movement and settlement. The dive surveys showed that the cumulative gap across all thirteen pipe joints had closed by as much as 120mm, with the cumulative gap along the bottom of the pipes typically less than across the top. The dive inspection also found evidence of spalling at the pipe joints indicating impact damage between the pipe sections.

This simple analysis indicated likely ground movement around the pipe causing shortening with the attendant risk that subsequent seismic events could cause further movement and damage. Any repair solution needed to be capable of accommodating a similar amount of movement – i.e. another 120mm, while retaining the integrity of the repair. Further minor shortening could take place to the point where all joints are closed, but equally, a future event could lead to extension of the pipe. This was an important consideration in the selection of the repair method.

Having taken consideration of the above options it was concluded that the CIPP system installed with a vinyl ester resin binder offered the optimum solution to repair the leaking joints and provide resistance against future seismic events. The CIPP liner system results in what is effectively a new pipe formed inside the existing pipe by using a polyester fabric impregnated with thermo setting resin inflated against the existing pipe and cured with hot water or steam. The thickness of the newly formed pipe was designed to suit loading conditions.

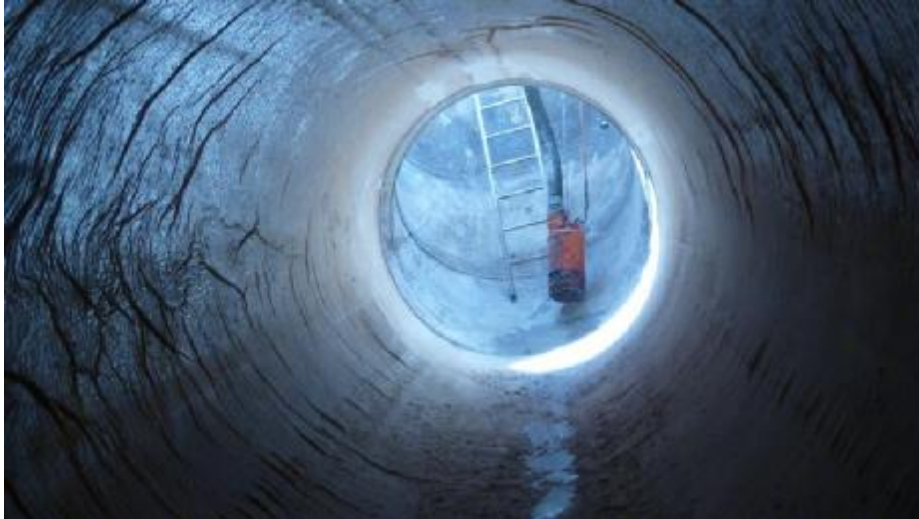
One potential problem with a very thick CIPP liner is that it will not accommodate the sharp bends in the pipe if the liner is installed as a single length. The proposed approach to overcoming this problem on the inlet pipe involved installation of several liner sections including once section with custom made fitted CIPP bend piece. However during the construction phase it was found that a single straight liner was able to fit around the 90 Deg bend with a minimum amount of creasing and this was the finally adopted solution. Some creasing was identified on the straight section of the finished liner on Clarifier 4 and this occurred because the liner ID did not exactly match the pipe ID (refer to Figure 9.). This problem was corrected for the liners on Clarifiers 3 and 1.

Figure 9: Creasing of Liner on Clarifier 4 Influent Pipe

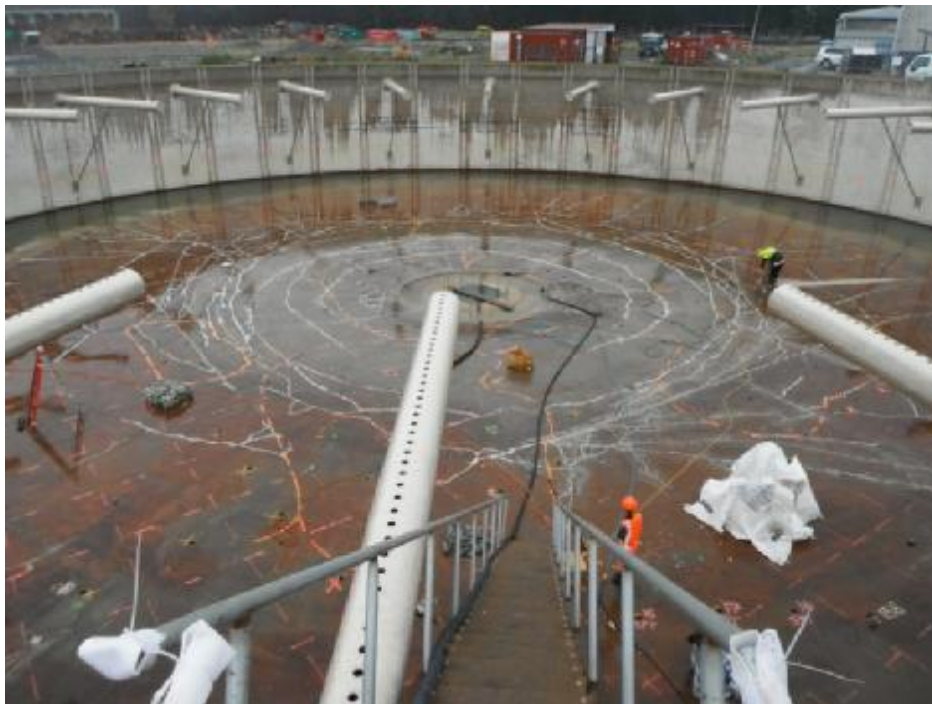
Figure 11: Inverted floor cone on Clarifier 3

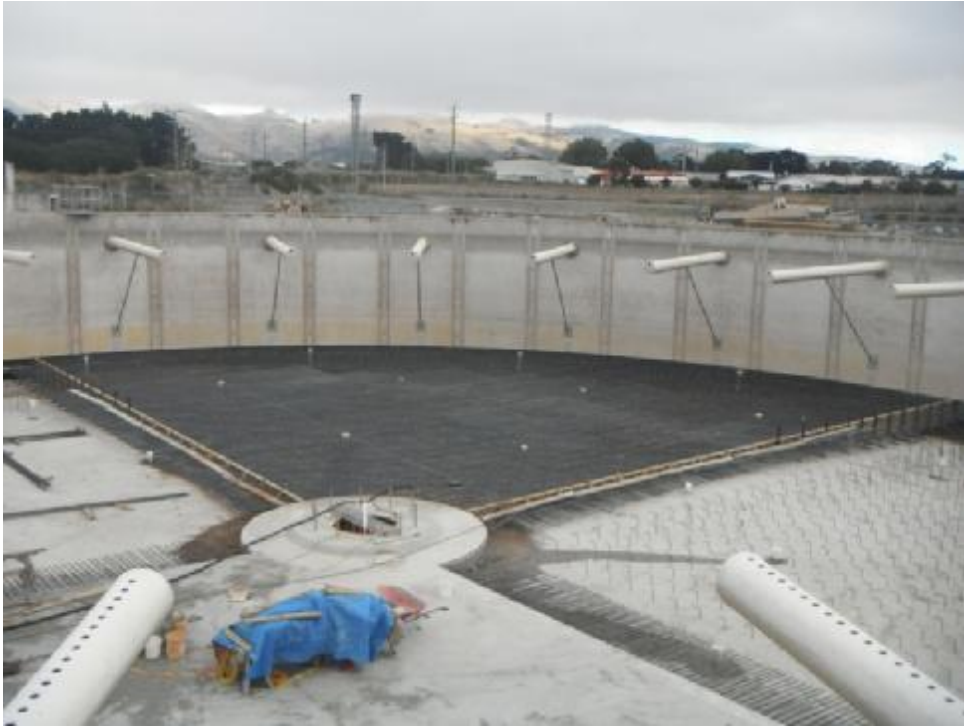
Figure 12: Clarifier 3 repairs showing reinforcing mats

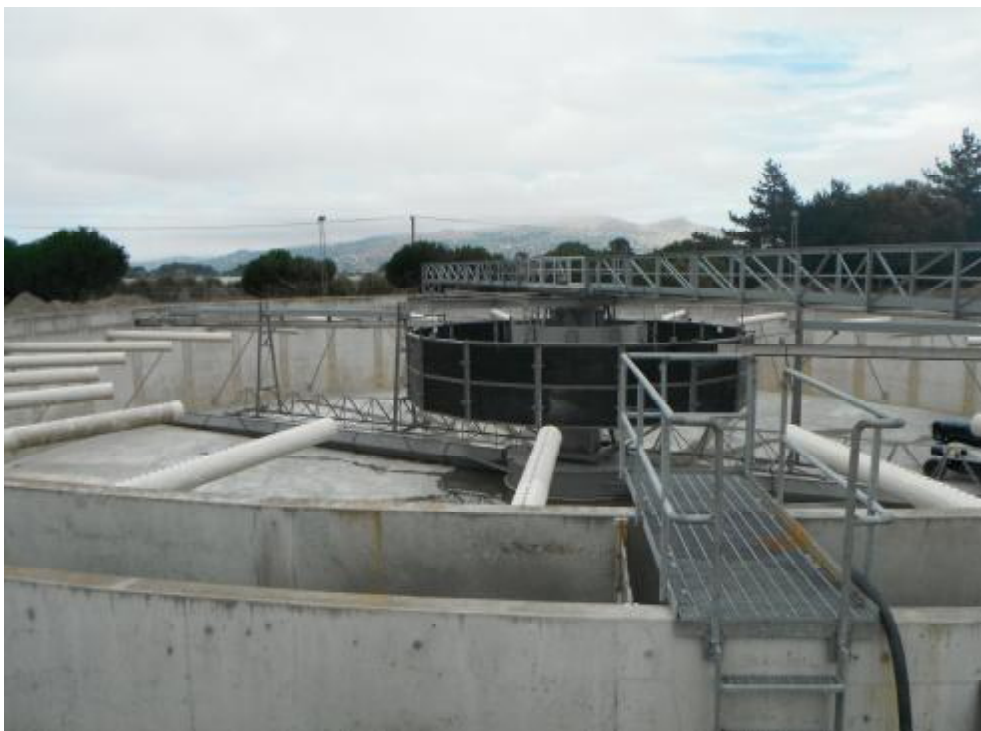
Figure 13: Fully repaired Clarifier 4
