# TOTAL COLIFORMS IN PUBLIC WATER SUPPLIES: CASE STUDIES IN THE PURSUIT OF THE ELIMINATION STRATEGY

*Colin Roxburgh, Water Asset Manager, Waimakariri District Council  
BE (Hons) Natural Resources Engineering, CPEng*

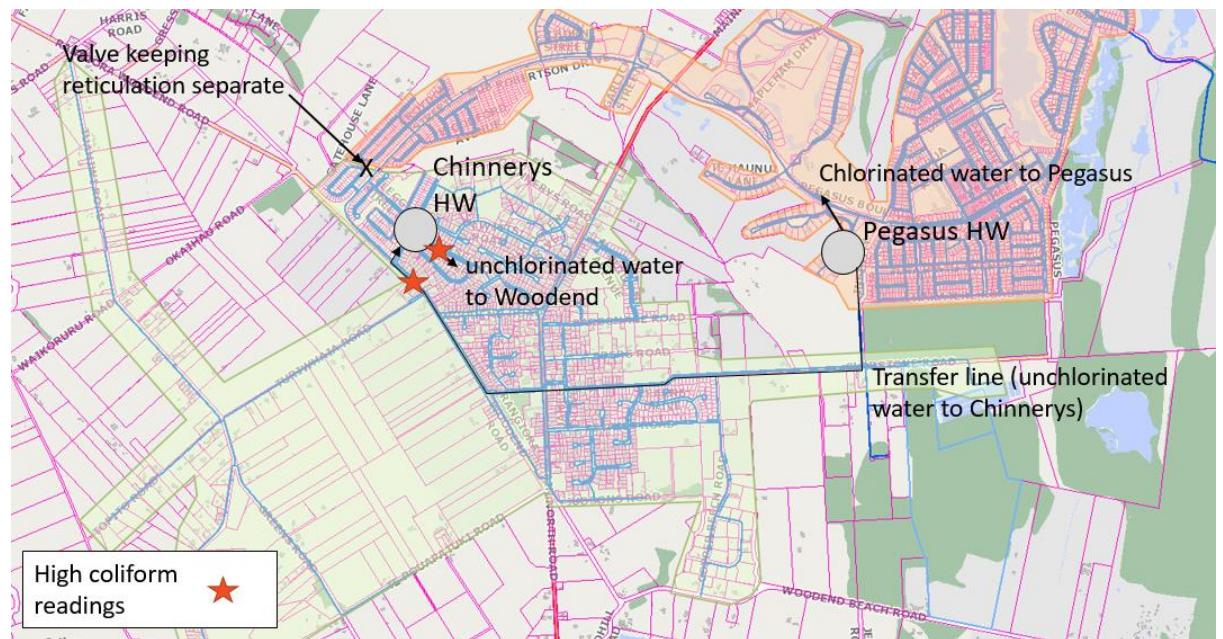
Figure 1: Woodend-Pegasus Water Supply Overview

This next stage of testing identified that the coliforms were coming from somewhere within the Pegasus site, either from the manganese removal filter at Pegasus or the Pegasus reservoirs. This conclusion coincided with the extension of the demonstrably safe reservoir inspection to the Pegasus site. These inspections were done again by external specialist engineers

As part of the 2022 inspections, a gap approximately 10mm in size was found at some points between the top of the walls and the reservoir roof. This was not immediately obvious from past inspections from the top of the roof, or from the ground below, due to the height of the reservoir making it difficult to distinguish this precise weak point. They would however be identified with the use of scaffolding during the detailed inspections.

The previous day's testing indicated that the coliforms originated from the Pegasus Reservoir B, and not further upstream in the system. This conclusion was based on the general thought process being the origin of the coliforms is the most upstream point in the system where they are detected. Following this, the reservoir in question was fully drained and inspected internally. No further defects were found during the internal inspection however.

At this stage possible causes were discussed. The most probable cause was that as part of the repair process in which sealant was installed around the reservoir perimeter some organic material must have been dislodged which had dropped into the reservoir, leading to it being detected downstream. Conversations were held with the repair contractor, and while they did not believe they had done anything to cause this, it was understood that they would not necessarily have known had they inadvertently done this.

Following the above assessment, the repairs were completed with the reservoir in service. These were successful in that the immediate risk was resolved, and the weakness in the reservoir addressed with full sealing around the perimeter. Following the completion of the repairs, further sampling was undertaken downstream of the reservoir in the transfer line between Pegasus and Woodend, and within the reticulation in the Woodend system. This sampling led to coliform counts in the order of 40 per 100mL sample, far higher than past detections in the order of 1 – 2 per 100mL sample. As a result of these detections, the following steps took place:

With the cause thought to be identified, but still not 100% confirmed, the part of the system that had been taken out of commission was carefully re-commissioned, in a staged way. This included super chlorination of the system from Pegasus Reservoir B through the transfer pipe, and into the Chinnerys Road reservoirs. This chlorine was then neutralized, the system, drained, then re-filled, and testing for coliforms undertaken again prior to recommissioning.

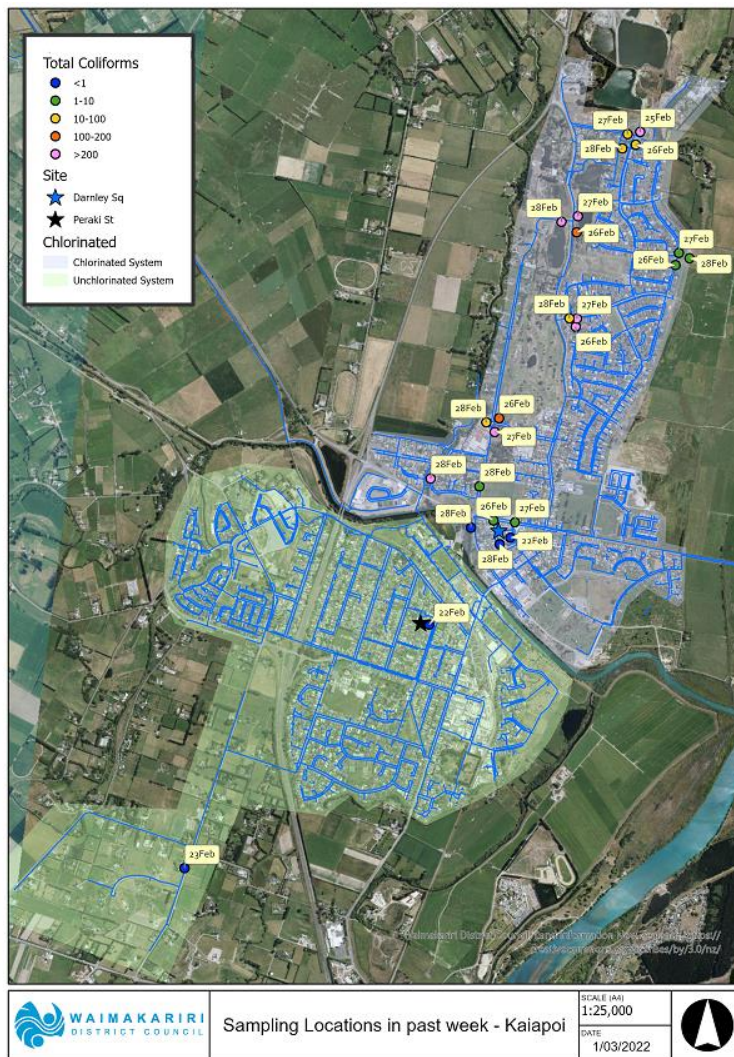
Figure 2: Overview of Kaiapoi Scheme and Initial Sampling Results

The results of the intensive sampling were however inconclusive, in that coliform detections were found right throughout the northern Kaiapoi reticulation system, but still not from the source or headworks. The first batch of results are summarised below:

These results were more difficult to explain as they did not suggest a point source breach of the system (which would have had more limited spread throughout the wider system), but rather a simultaneous occurrence within the section of the reticulation network more generally. This type of event had not been experienced before.
