***E. COLI* CONTAMINATION IN “SECURE” GROUNDWATER SOURCED DRINKING WATER SUPPLIES**

*PF Callander¹, C Steffens¹, N Thomas¹, S Donaldson², M England³
Pattle Delamore Partners Ltd¹, Marlborough District Council², Selwyn District Council³*

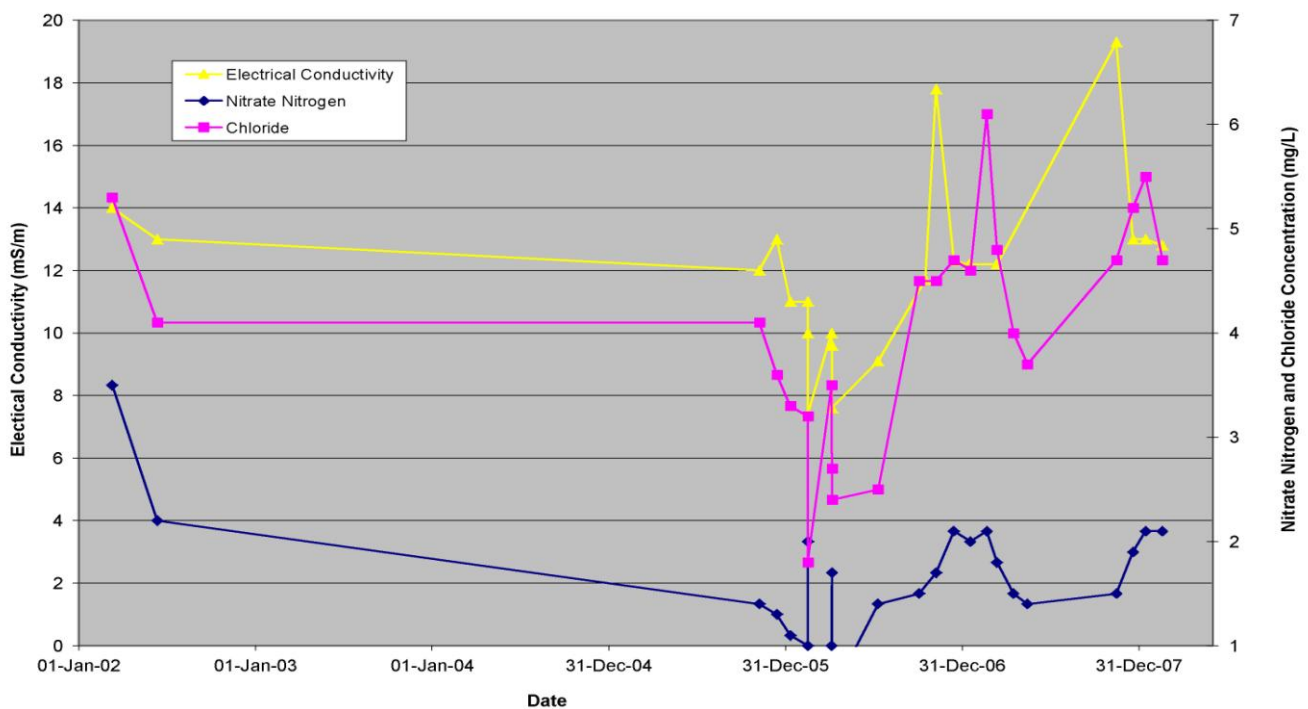
Figure 4: General Chemical Indicators (PDP, 2008)

Occasional measurements of electrical conductivity, chloride and nitrate-nitrogen have historically been made in the MRR bores and show some variability, as presented in Figure 4. The recorded values are all relatively low (nitrate-nitrogen < 4 mg/L, chloride < 7 mg/L and conductivity <20 mS/m), indicating good quality groundwater. However, the variation of measurements over time also provides a clear indication of shallower near surface groundwater having a greater influence on the MRR bores at certain times of the year.

The last two samples plotted in Figure 4 were collected on 14th January and 10 February 2008. The results show this was the time of year when land surface activities were having their greatest influence on the quality of the MRR bores, but the concentrations of nitrate-nitrogen and chloride were not unusually high compared to previous years. Similarly, the abstraction rate from the bores at the time of the *E. coli* detections was not unusually high.

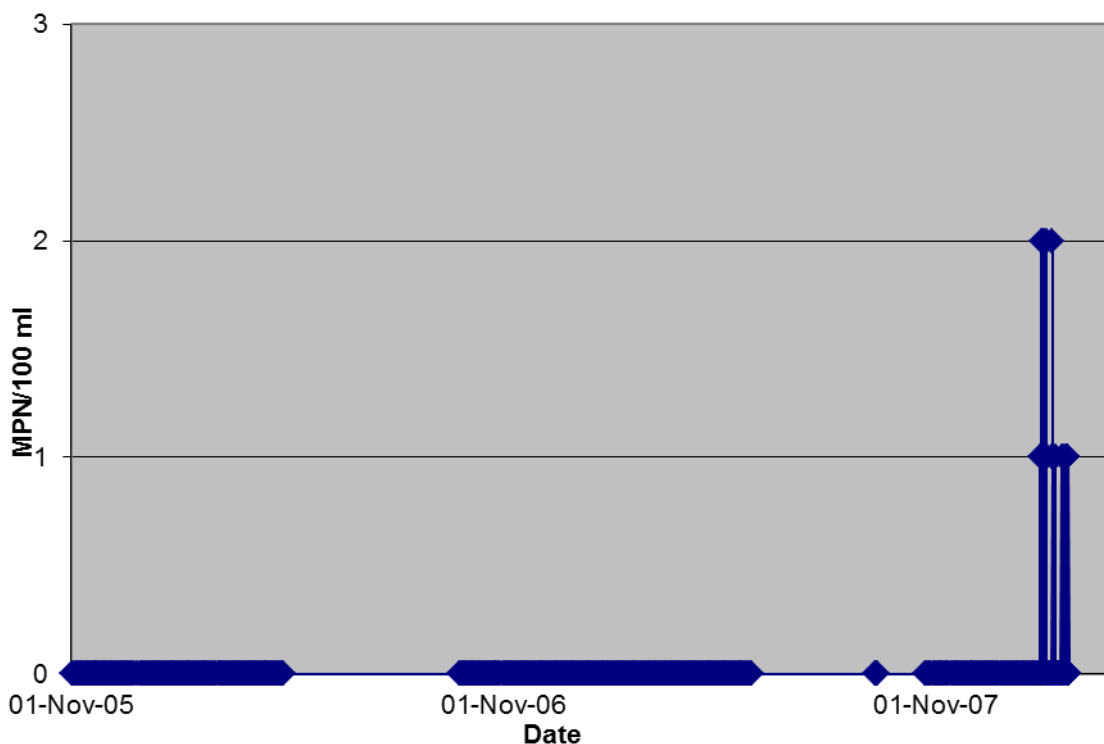
Figure 5: Historical Monitoring for *E. coli* Detections (PDP, 2008)

In recent years, daily sampling of the water from the MRR bore field for faecal coliforms and *E. coli* has been carried out by Marlborough District Council (MDC) during those times when it is in use. On 29 January 2008, the microbiological contaminant indicator *E. coli* was detected in groundwater from the bore field, resulting in a boil water notice being issued for all Blenheim water users. *E. coli* continued to be detected on the following days and the bores were taken out of service.

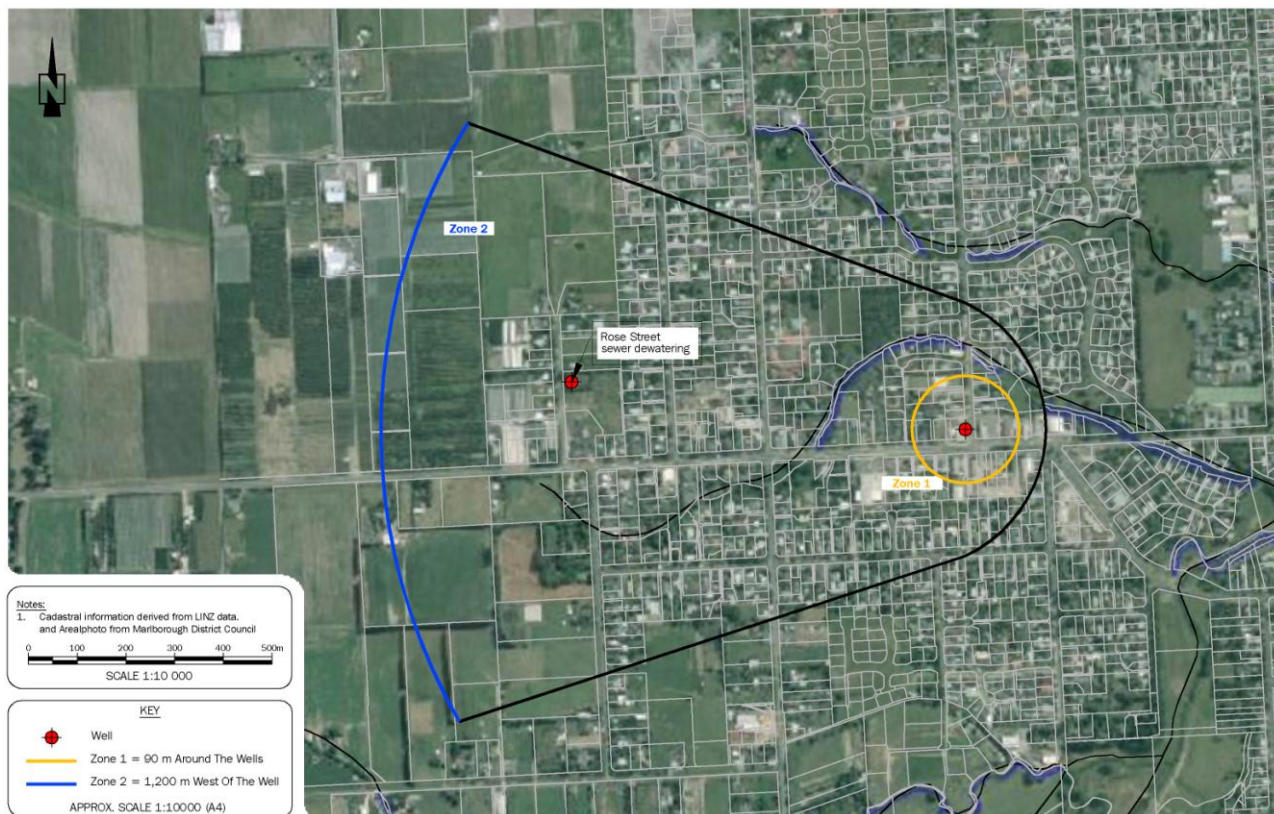
Figure 6 : Estimated Capture Zone For MRR Wellfield

On that basis, Figure 6 shows two zones around the bore:

- ▣ a highest risk zone at a distance of 90 m from the edge of the bore field;
- ▣ a lower risk zone extending out to 1,200 m in the upgradient direction from the bore.

Sources of contamination within this capture zone include leaky sewer pipes, septic tanks in the vicinity of Rose Street as well as some excavation works along Rose Street and their associated de-watering discharge that were taking place around the time that the contamination was detected. The Rose Street area is located around 800 m to the west (upgradient) of the MRR bore field and the de-watering discharge entered Murphy’s Creek via an open drain at a location around 400 m in a general westerly direction from the MRR bores.

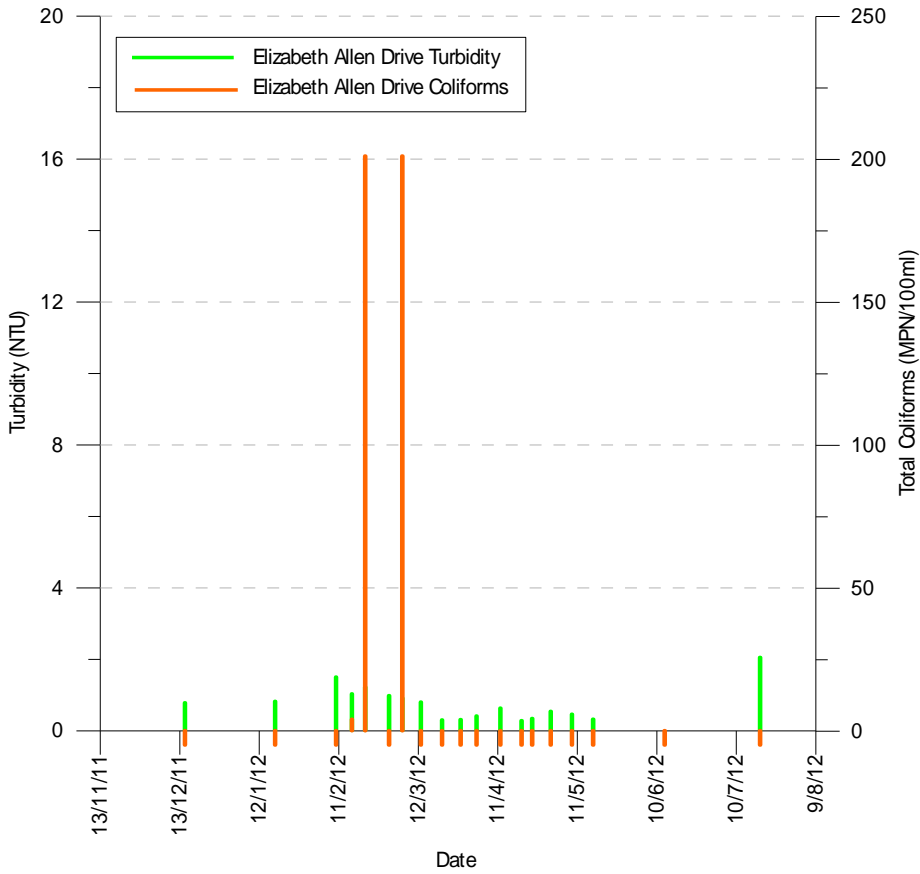
Figure 8: Elizabeth Allen Drive – Turbidity and Total Coliforms (PDP 2012)

The bores commenced regular use for water supply purposes in September 2011. Sampling over this period has indicated variable instances of turbid water and total coliforms, as shown in Figure 8. The occurrence of elevated turbidity in these bores is typically associated with pump start-up or high rainfall events.

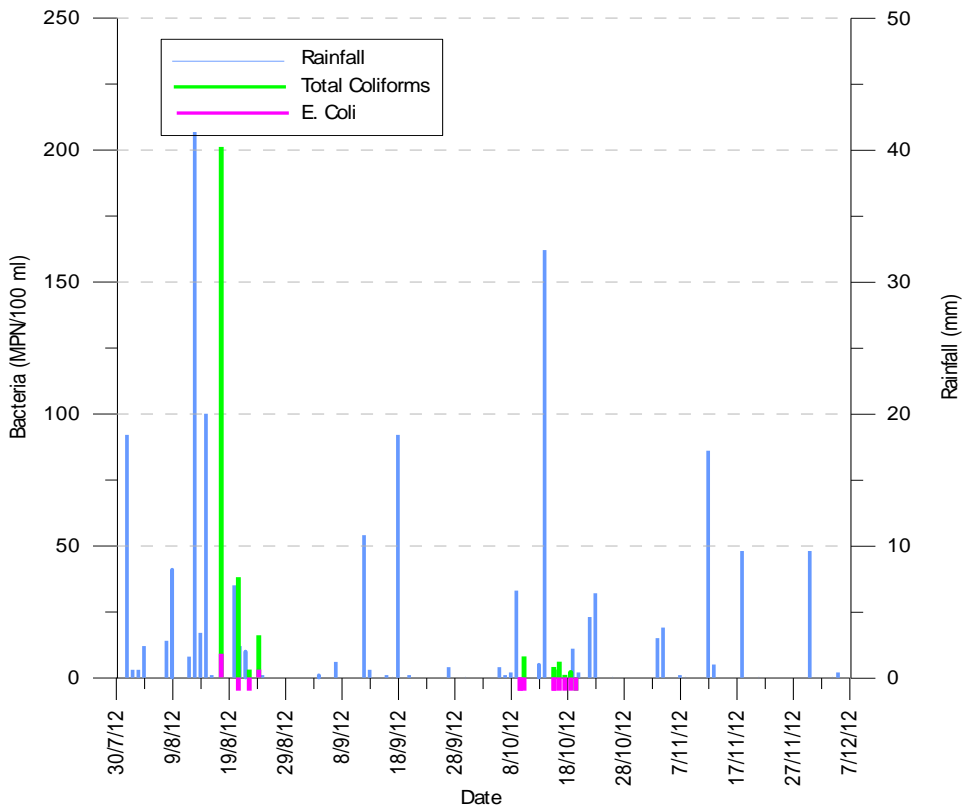
Figure 9: Bacteria counts and Rainfall for samples collected from Elizabeth Allen Drive well since first observations of poor water quality (PDP 2012)

No detections of *E. coli* occurred until a sampling round in August 2012 following turbid water being observed in the reticulation. The results are plotted in Figure 9 and as a result the bores were taken out of service.
