WASTEWATER PUMP STATION 15 – A CASE STUDY IN ASSET REUSE AND RESILIENT DESIGN

*W Jacobson, Designer at Stronger Christchurch Infrastructure Rebuilt Team (SCIRT),
Water and Waste Engineer, MWH, GIPENZ*

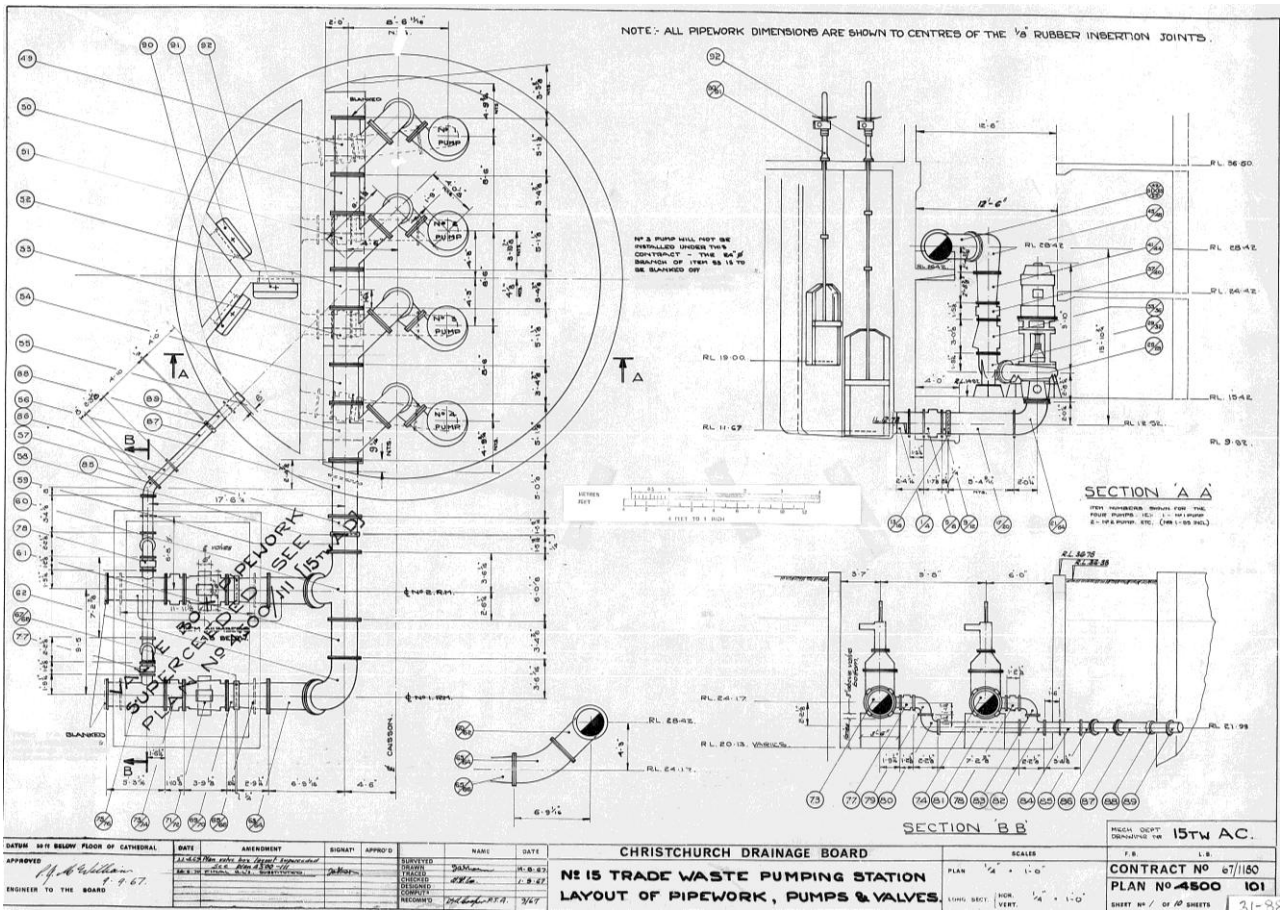
Figure 3: Pump Station 15 1967 For Construction Mechanical General Arrangement

weather capacity. It is also beneficial to allow for further settlement of the trunk main network in future earthquakes. The height of the existing bifurcation chamber between the wet wells currently allows for a free discharge to each wet well (refer Figure 3). A free discharge is not necessary for an even flow split to the wet wells and so there is some level available to relay new gravity main inlets. In this case the flow split could be provided separate to the station in a bifurcation chamber in the street with new gravity mains laid to new inlet chambers attached to caisson. Isolation penstocks in each of the inlet chambers allows for isolation of the wet wells. Discussions with the SCIRT Construction Delivery Team highlighted the benefits of locating the bifurcation chamber further from the existing terminal manhole. This will reduce the risk of damage to the existing inlet pipe during the repairs and allow for adequate space for over-pumping arrangements.

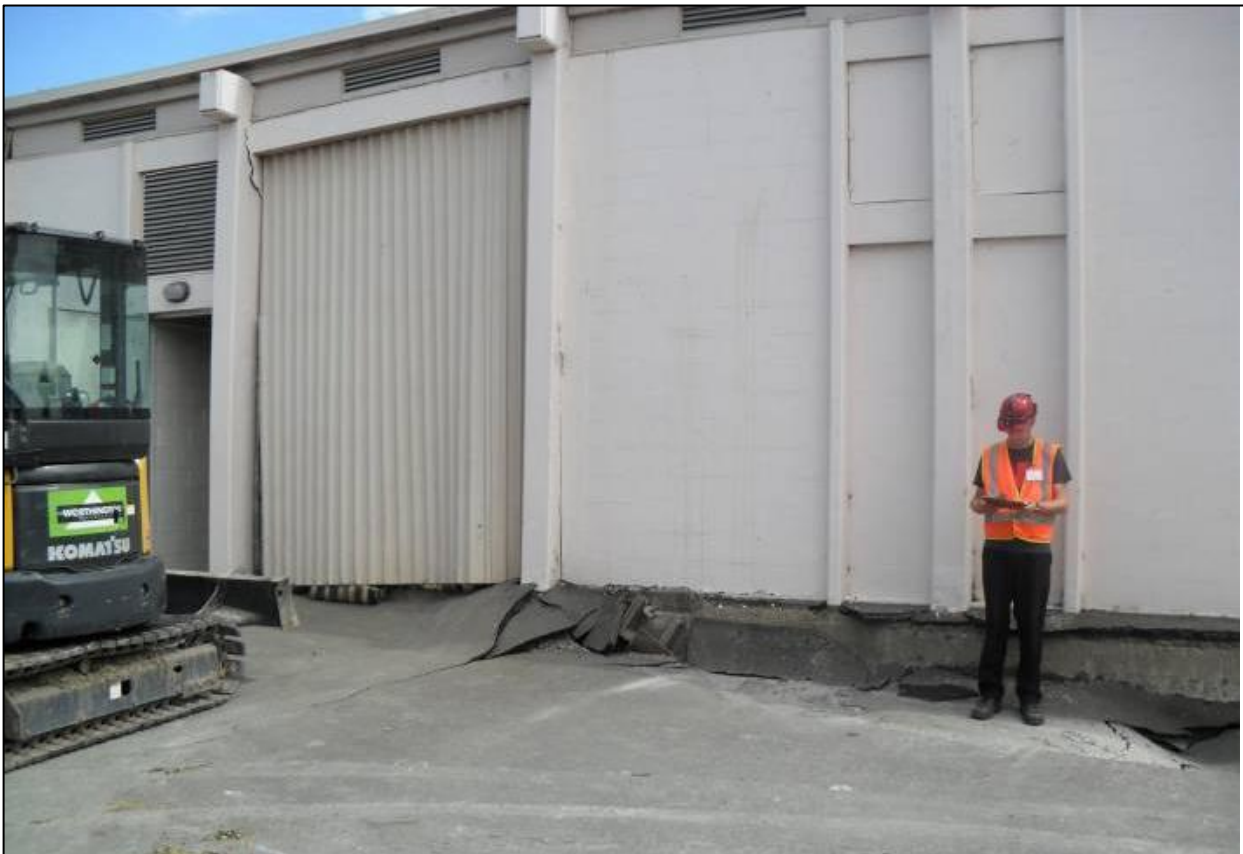
Level survey of the pump station structure and the local gravity trunk mains indicate the substructure and superstructure lifted by approximately 620 mm. Some of the uplift is regional, but 300 to 400 mm of differential movement (flotation of the structure and/or settlement of the adjacent land) occurred between the pump station and the incoming gravity reticulation. This can be seen from the site photographs taken after the earthquake (refer Photograph 1). Damage to PS15 primarily resulted from the effects of this differential settlement and was observed in damage to the superstructure, including the adjoining generator service/area, and the pipework connections to the caisson and valve chamber.

Photograph 1: Relative displacement of Caisson to ground level.

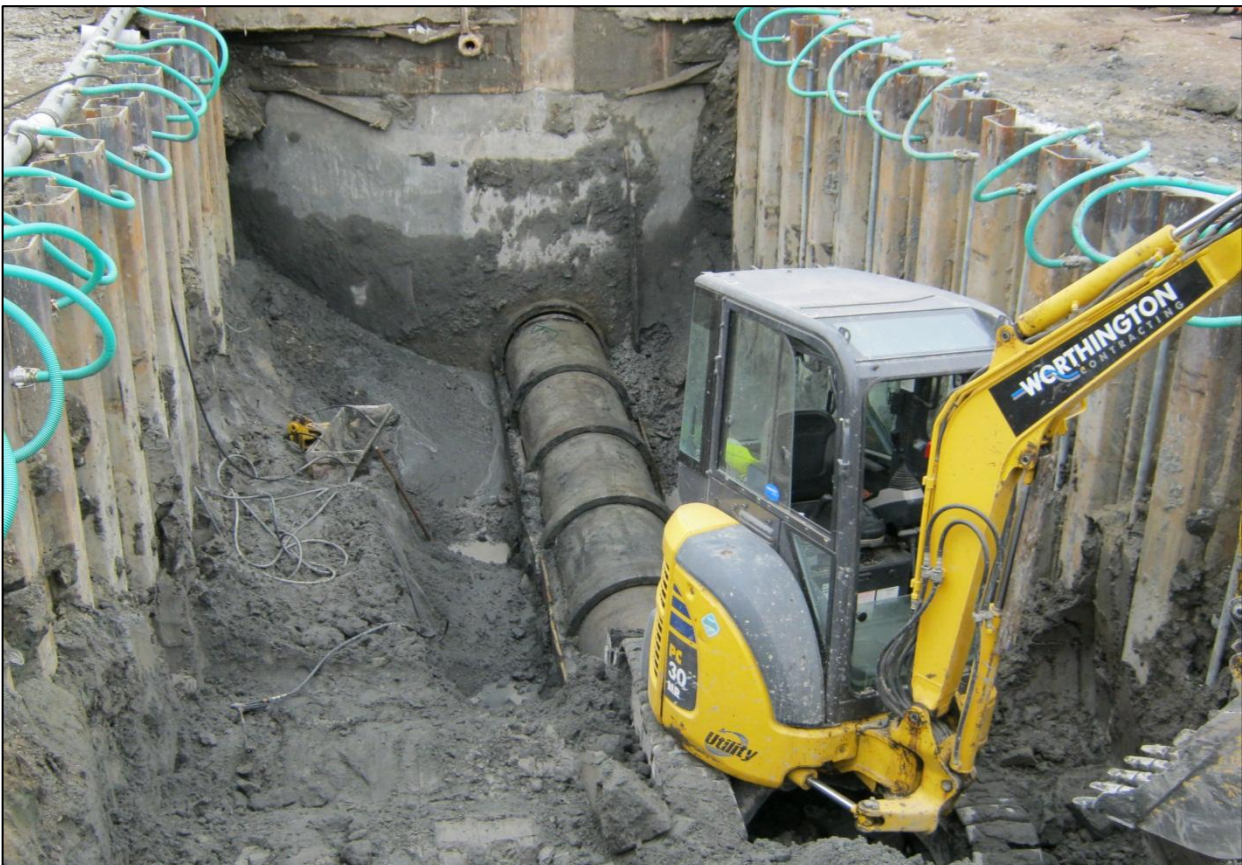
The differential settlement caused the inlet gravity pipe to be reverse graded and resulted in the pipe caisson connection pulling out by approximately 50 mm (refer Photograph 3). Repair works after the February event included casting a concrete corbel at this location to prevent groundwater infiltration drawing soil fines into pipe and the wet wells.

Photograph 3: Damage to caisson gravity pipe inlet (900 mm) showing pull out at connection to structure.

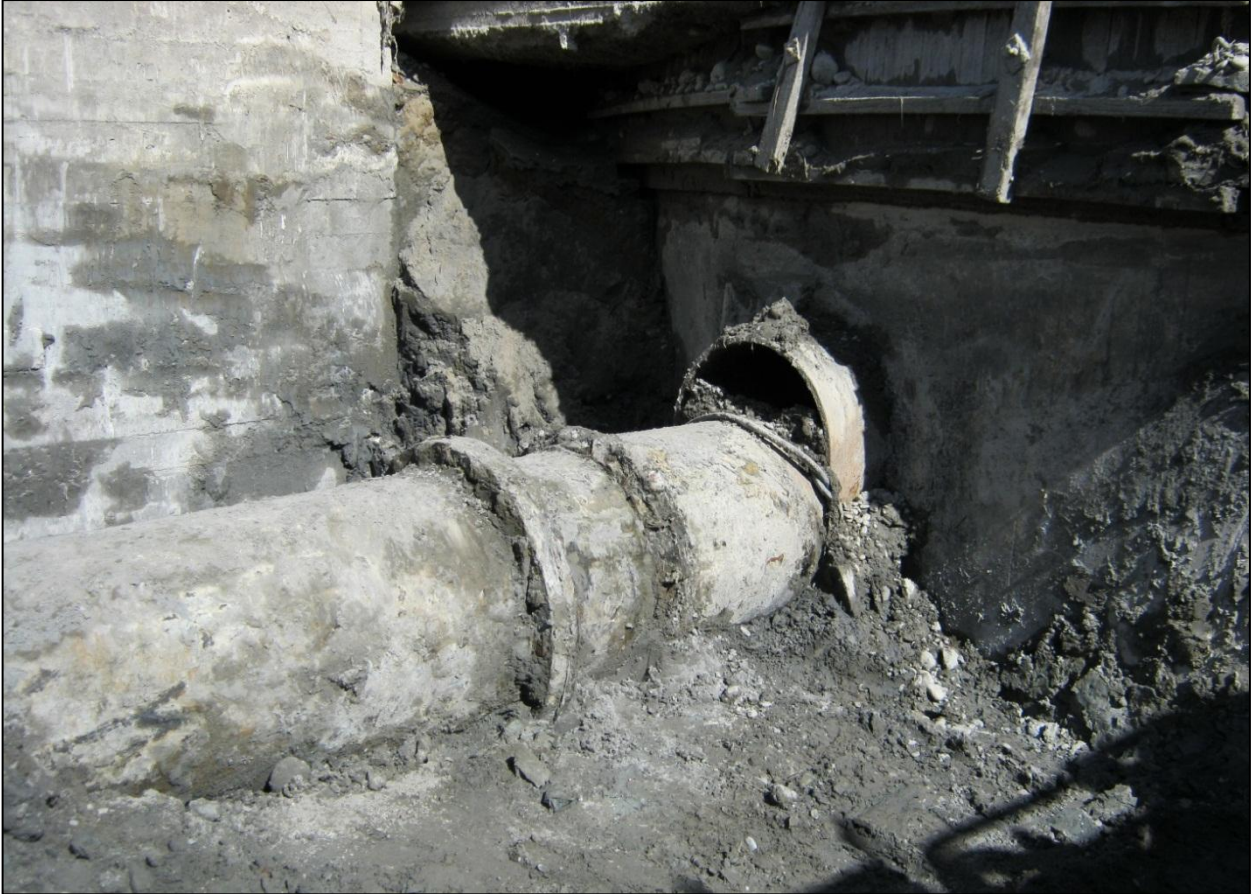
The pressure pipe connection from the caisson consisted of a short spigot of cast iron and an unrestrained mechanical coupler. Mechanical couplers (or spigot socket joints) are often used in pairs to form a rocker pipe connection for pipe to structure connections. This can allow for some differential settlement in the short term due to construction loads or in the long term slow settlement of unconsolidated soils. In this case, the scale of the differential settlement (250-300 mm) as seen in Photograph 4 easily exceeded the allowable deflection of the coupler and the joint sheared clean through.

Photograph 4: Damage to caisson pressure pipe outlet (DN 27" or 685 mm) showing failure of first rocker joint.

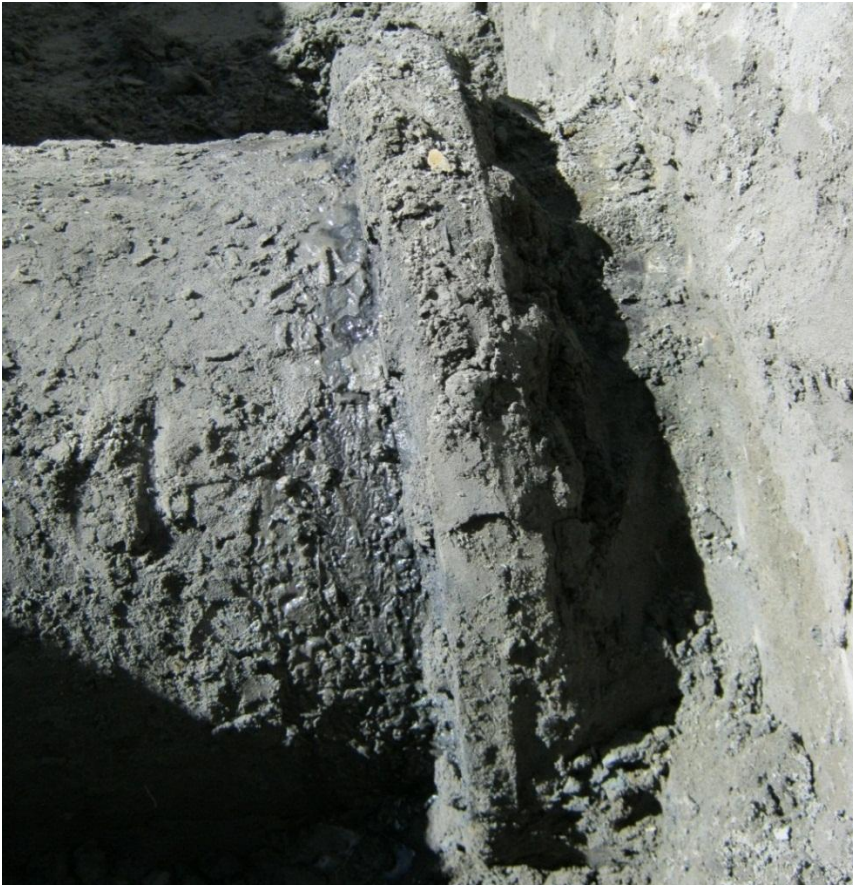
The brittleness of cast iron pipe and the large movements of the valve chamber structure during the earthquakes caused fracturing of the cast iron flanges outside of the valve chamber and to the puddle flanges cast in the valve chamber walls (Refer Photograph 5). Further damage was evident in the pressure mains discharging from the valve chamber which consisted of an adapted coupler between cast iron and asbestos cement pipes as seen in Photograph 6. This was repaired by recasting concrete corbels at this location. The uplift of the valve chamber caused the Supertite asbestos cement joints collars nearest to the structure to fail by over extension as shown in Photograph 7.

Photograph 5: Shear failure of buried cast iron pressure pipe mains at connection to valve chamber. Circumferential crack to cast iron with seeping

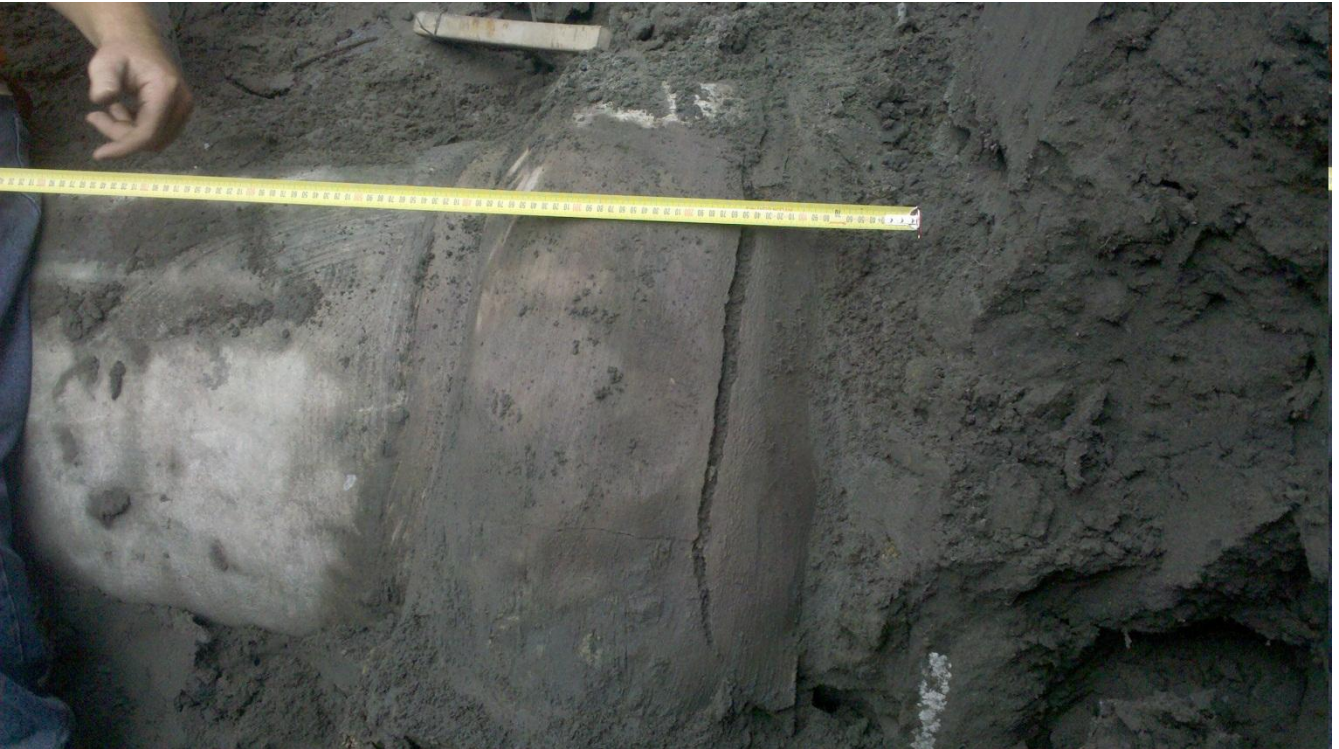
Photograph 6: Damage to asbestos cement pressure main at connection to cast iron exit from valve chamber.

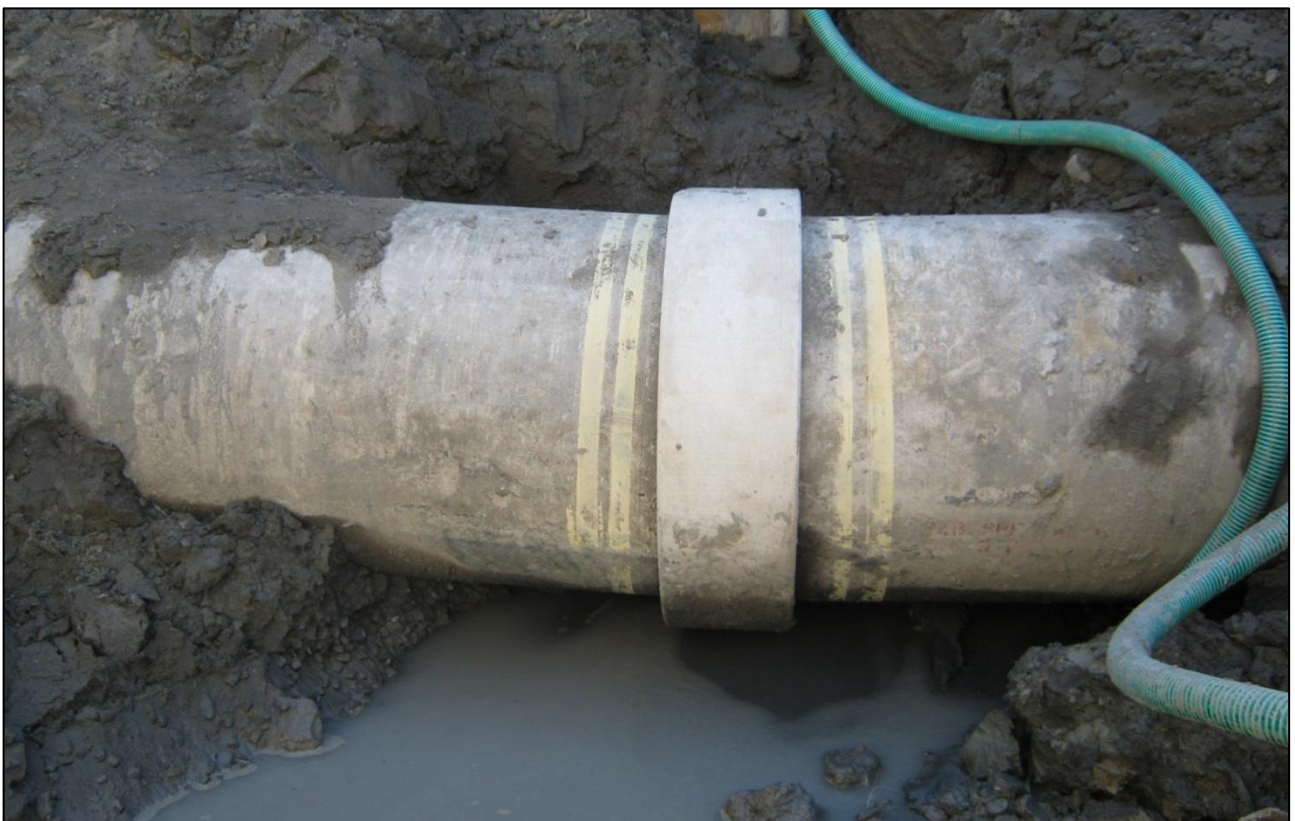
Photograph 7: Damage to asbestos cement pressure main Supertite Joint.

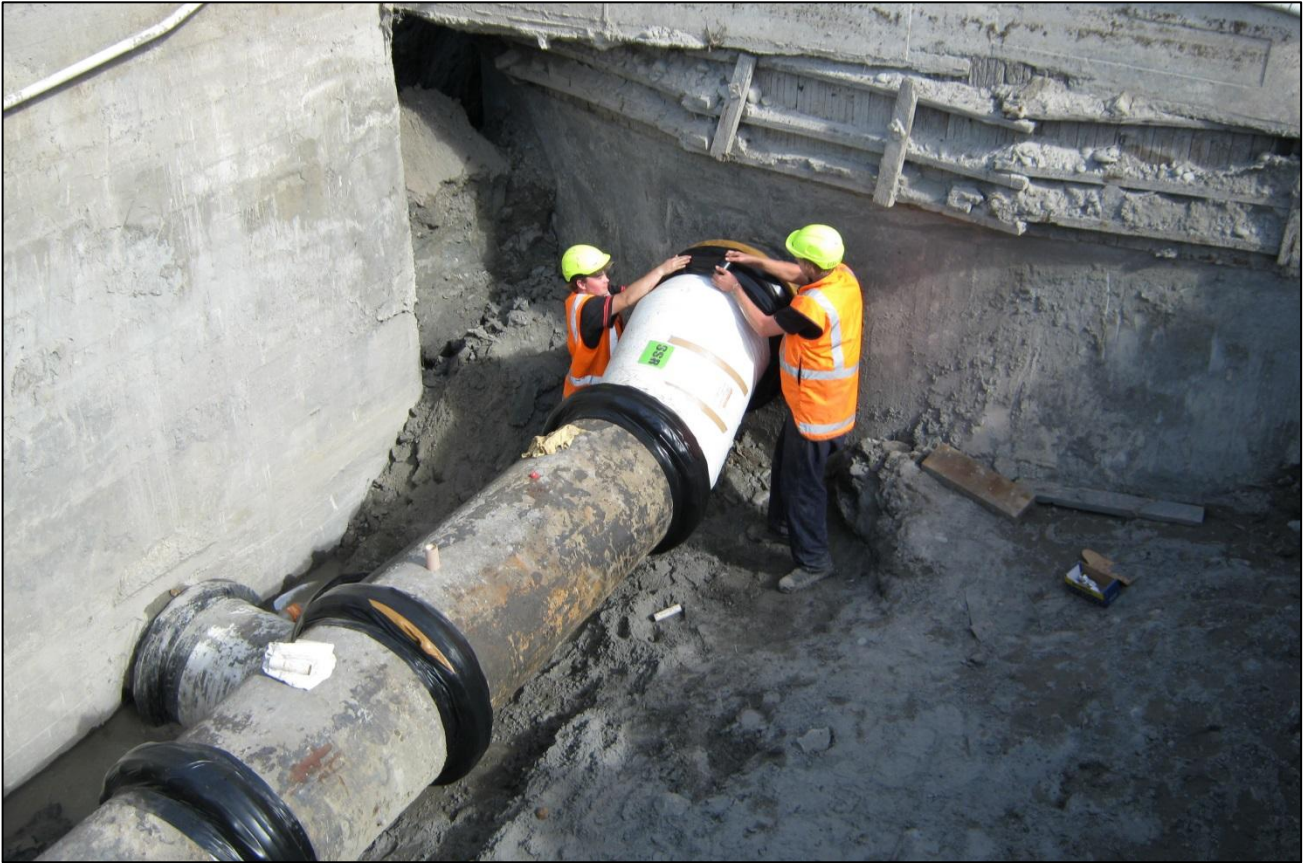
Photograph 8: Post-February 2011 Repairs to Pressure pipe Outlet.

Pressure pipe repair works following the February event consisted of replacing failed cast iron pipe sections with galvanised mild steel pipe fittings as depicted in Photograph 8. Although these restored service to the station, they were not able to withstand the ongoing sequence of aftershocks. It is evident from the damage in the June event that the use of these fittings combined with the unsupported pressure main upstream of the valve chamber caused the sections of cast iron cast into the valve chamber to fail. The bends were then reinstated with welded polyethylene (PE) mitre bends fabricated from large diameter water pipe as shown in Photograph 9.

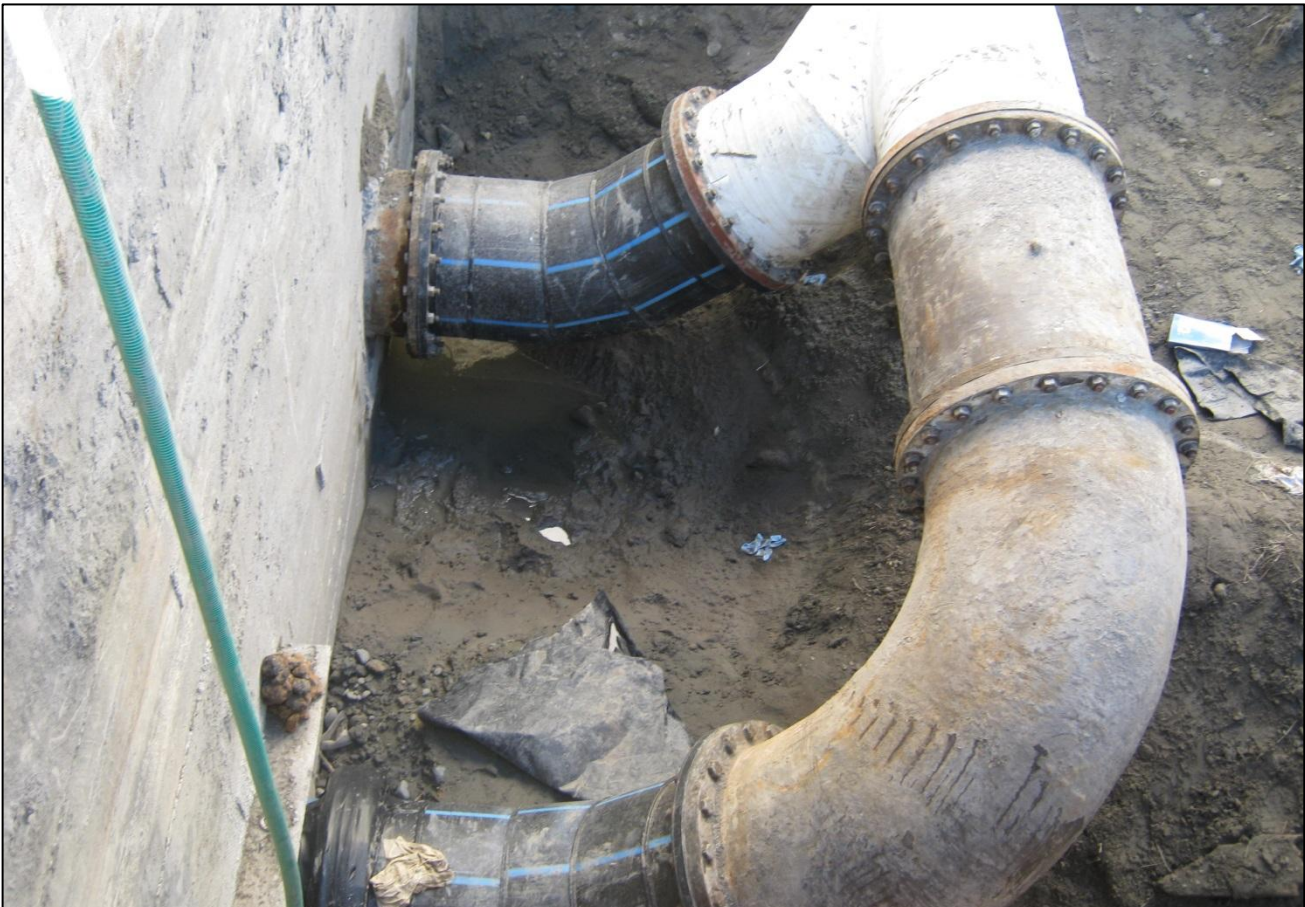
Photograph 9: Post-June 2011 Repairs to Pressure pipe outlet.

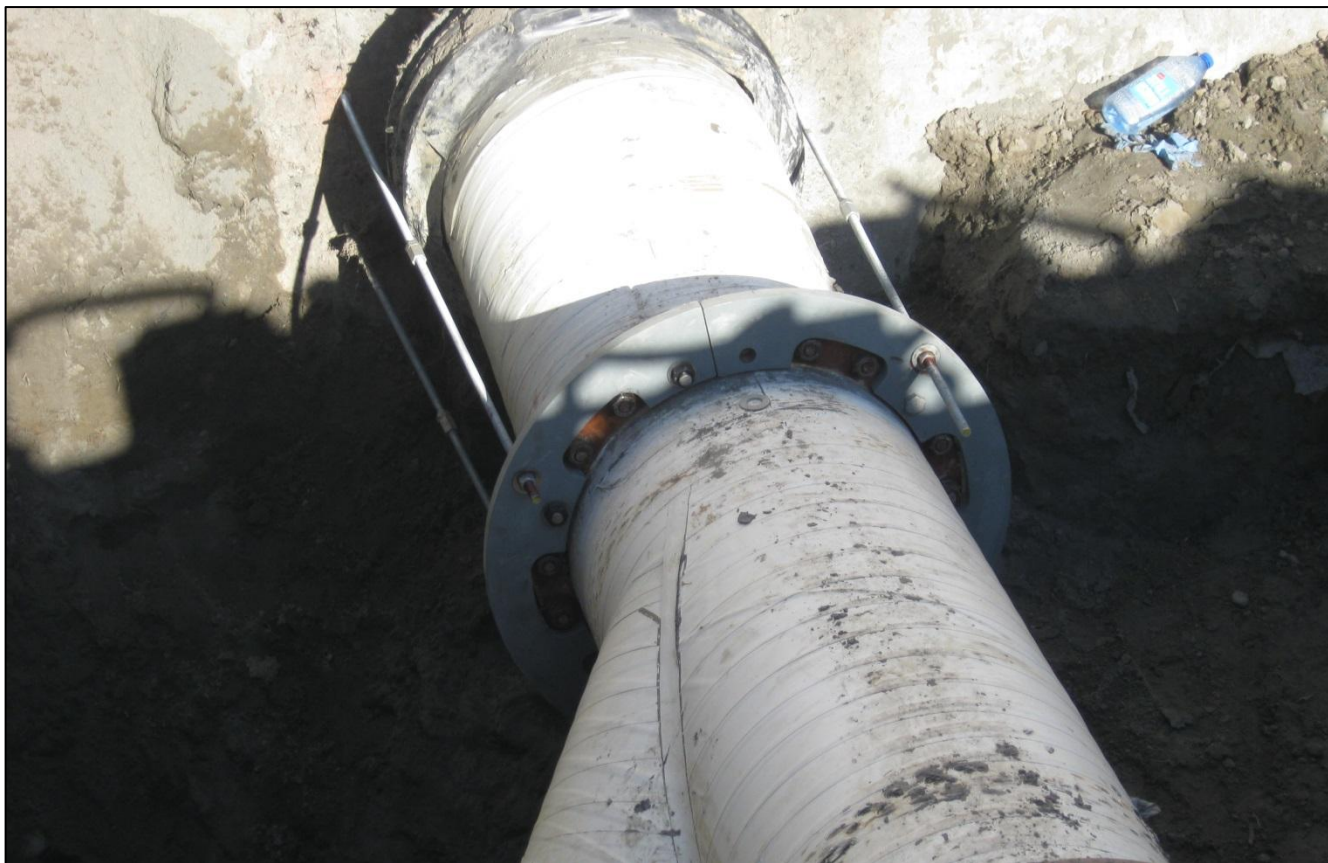
Photograph 10: Post-June 2011 Repairs to Pressure pipe Outlet depicting use of flange modification and steel tie back rods..

The difference in level of the pressure mains at the caisson connection was temporarily resolved by using a fabricated steel flat-down-flat 3 piece mitre adjustment fitting with a mechanical coupler to the existing cast iron stub. Again this coupler looked to have failed in the June event due the freedom of movement of the pressure pipe exceeding the allowance of the mechanical coupler. Repairs to this section following the June event again used galvanised mild steel pipe but this time steel tie rods and an additional flange bolting ring allowed some axial restraint back into the caisson. Although the added strength of this modification was not likely quantified, and would likely fail in another significant earthquake, the addition would have provided some restraint in a moderate earthquake and reduces the risk at a relatively low cost. Refer Photograph 10.
