CHRISTCHURCH COLLAPSED BRICK BARREL STORMWATER REPAIR

Preston, Tim

The Antigua Burke Stormwater rebuild project, undertaken by Stronger Christchurch Infrastructure Rebuild Team (SCIRT) as part of EQ repair for Christchurch City Council, included a section of brick barrel pipe with several unusual features. These provided significant challenges for asset investigation and design, prompting a variety of uncommon techniques for investigation, repair and rebuild, and several changes of direction as the investigation and design proceeded.

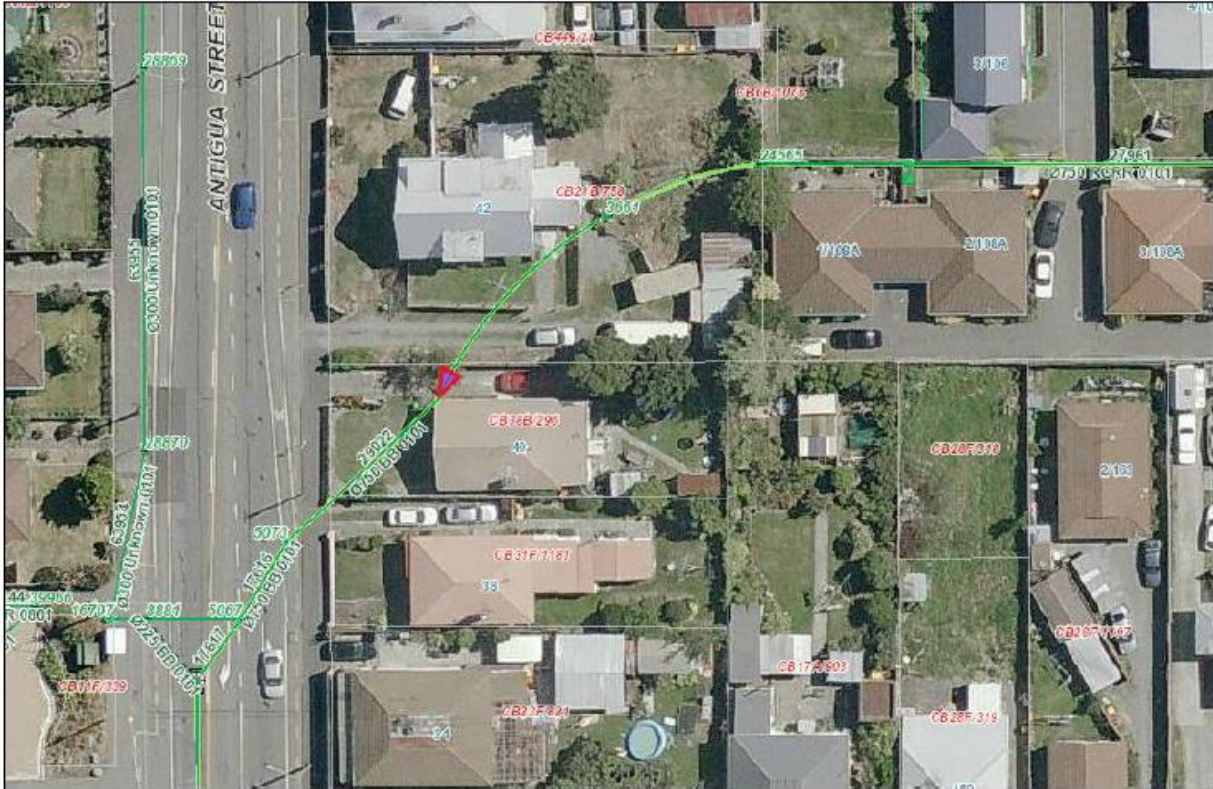
Figure 1, Aerial view showing location of the worst collapse (red triangle) and proximity of pipe to dwellings at 40 and 42 Antigua St. (note other damage is toward Antigua St to manhole 5073).

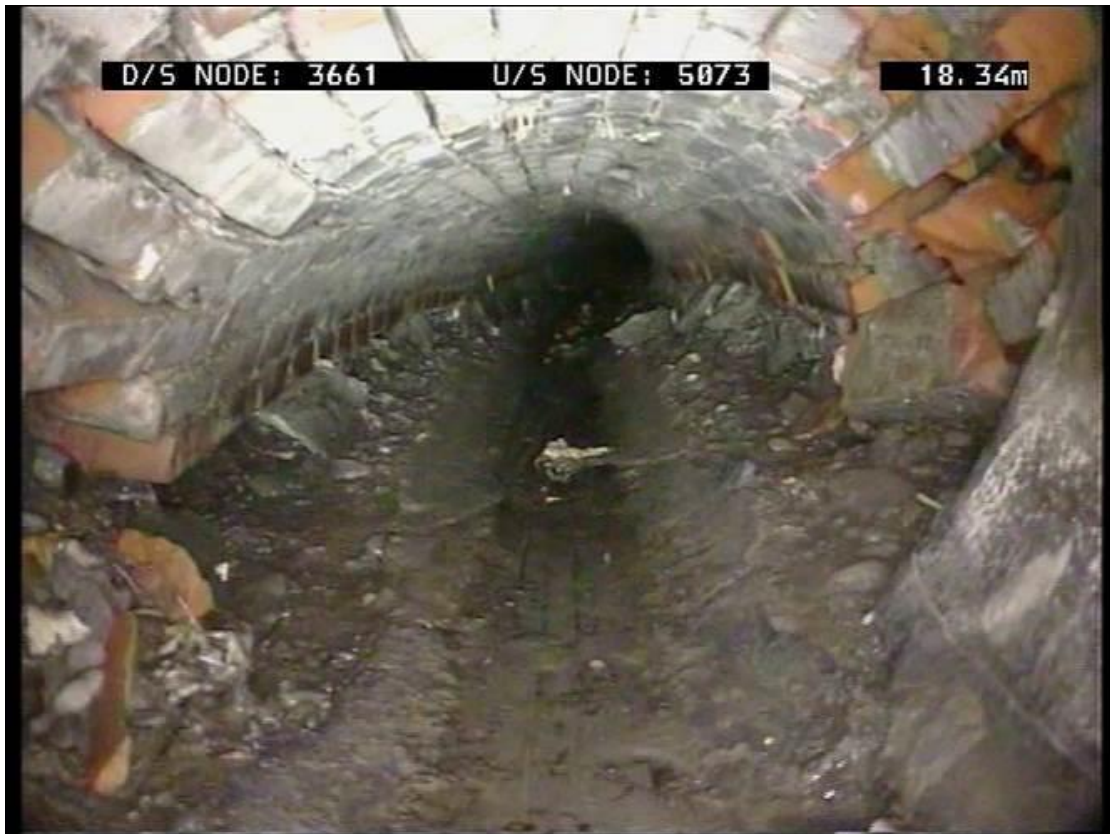
Photograph 1, Close-up CCTV image of 50% collapsed pipe, March 2012

This initial view of the 50% collapsed pipe prompted significant and urgent concern, with what appeared to be an imminent risk of full collapse. Based on the GIS mapped horizontal alignment, it appeared that the collapse was 3-5m distance from the nearest house, but this alignment was unverified and appeared likely to be incorrect.

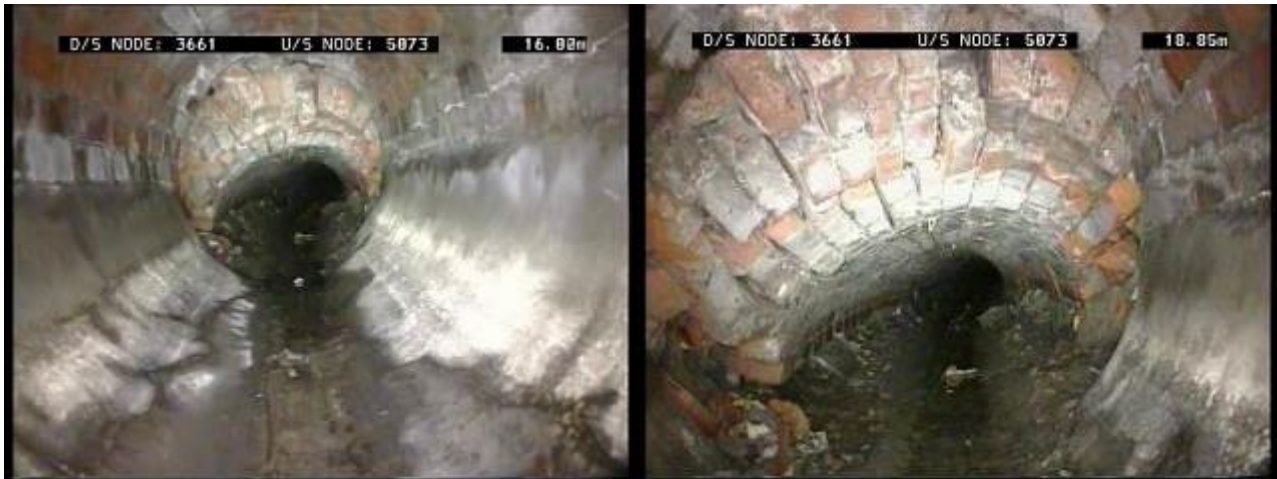
Photograph 2 and 3, Current CCTV images of the collapsed pipe in March 2012

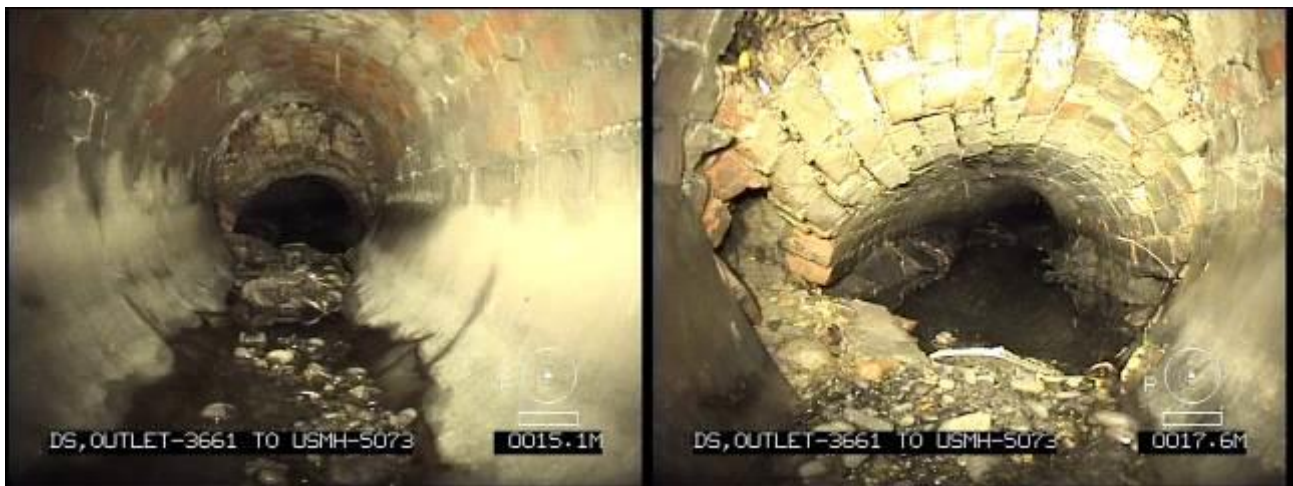
Photograph 4 and 5, Historic CCTV images of the collapsed pipe in January 2009 showed little difference

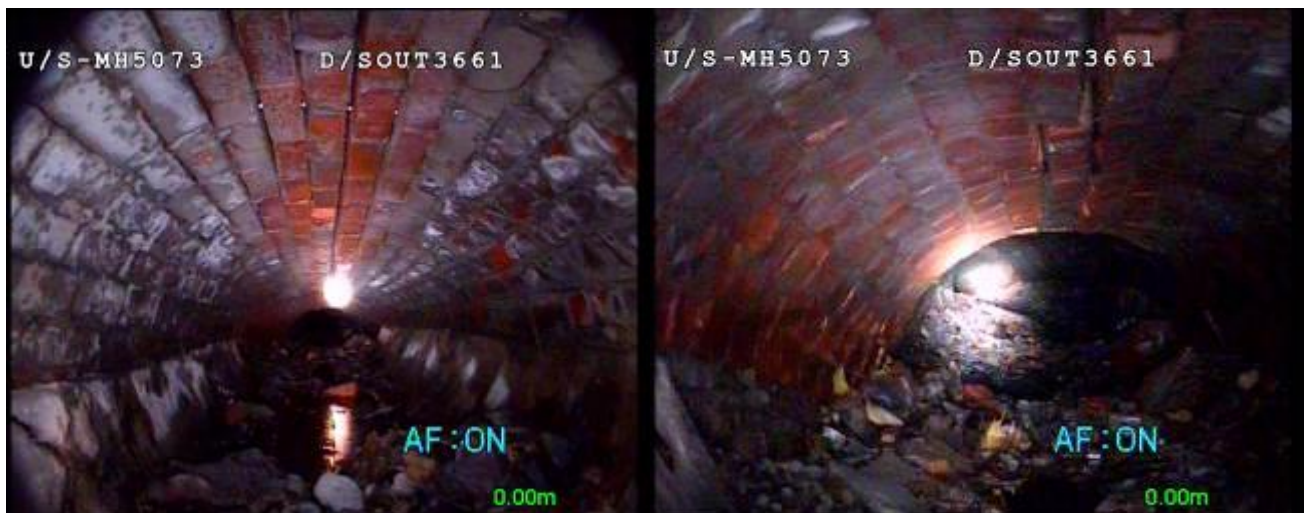
Photograph 6 and 7, Where CCTV was risky Polecam was used to enhance the process

Polecam footage showed clear distress in the soffit of the upstream end of the brick barrel, with ovality appearing to various degrees along the length and some brick movement evident. In the absence of pre quake CCTV footage of this section, this damage was cautiously attributed to earthquake damage.

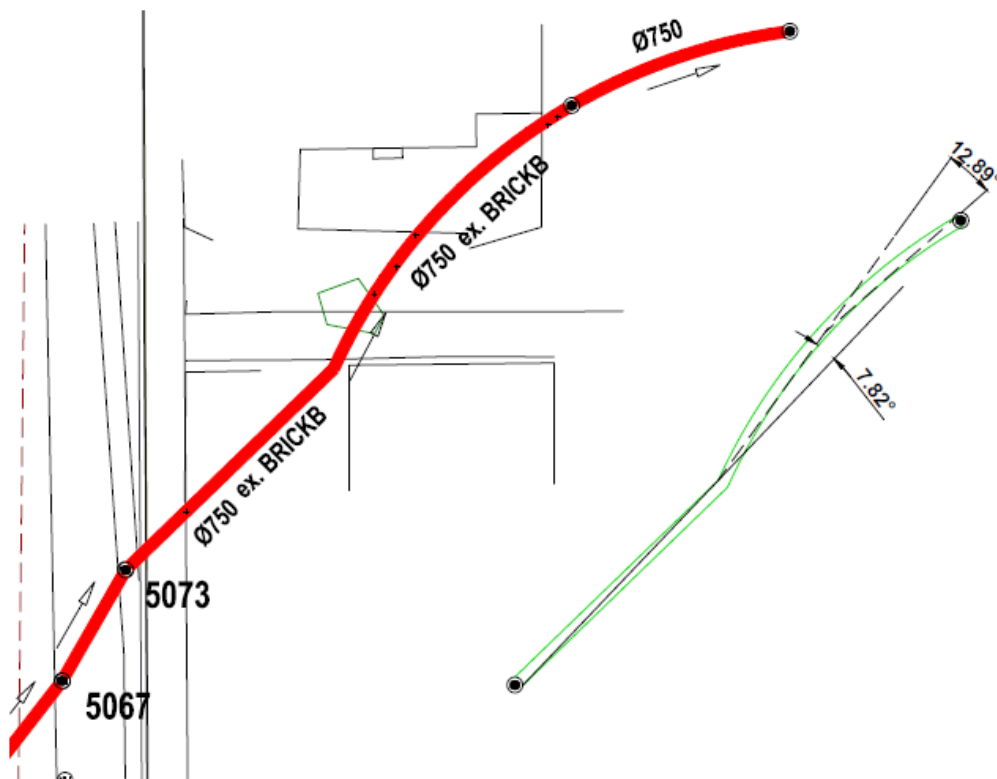
Figure 2, Alignment geometry resulting from survey work

This new alignment was submitted to the CCC GIS team and the core GIS data was updated to suit. The new alignment was quite different to the previous GIS alignment and confirmed that the pipe was much closer to both houses than previously indicated.

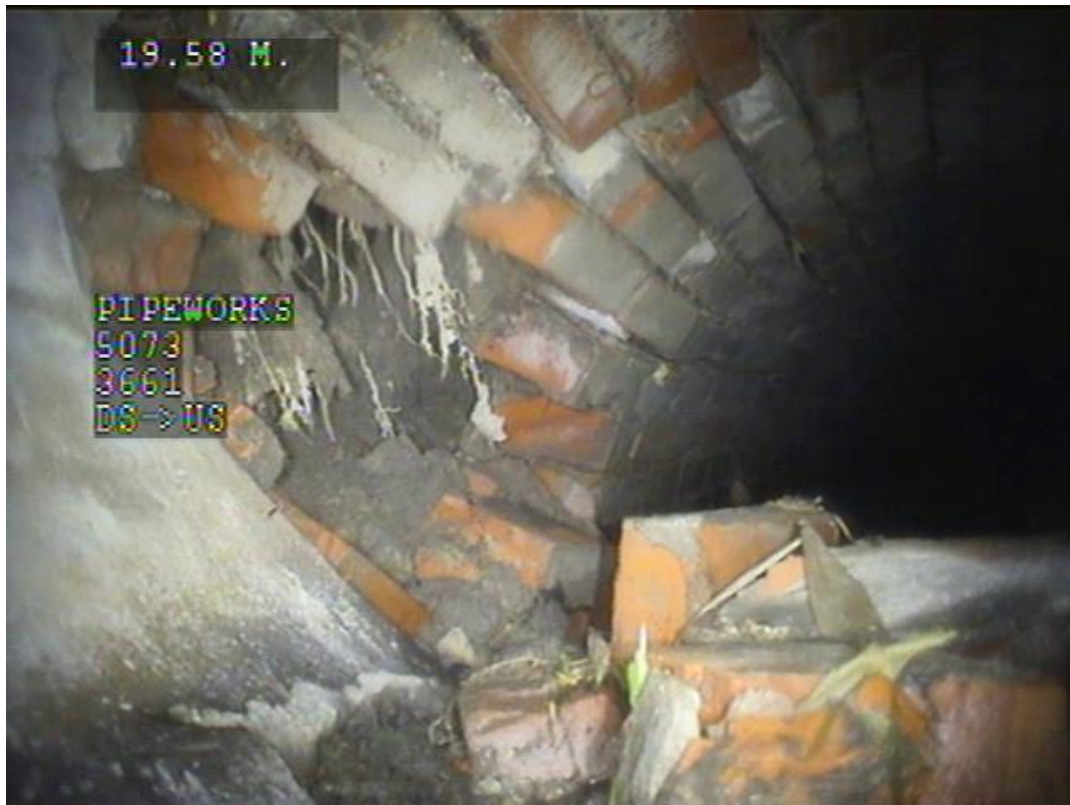
Unfortunately, the jet cleaning resulted in further damage to the pipe, in the immediate area of the worst of the collapse. Based on post cleaning CCTV it appears that the jet head penetrated the wall of the pipe and opened an underground cavity outside the pipe wall. We knew from the alignment that this cavity was within 1-3m of the corner of the residential house. To make matters more interesting, this occurred a few of weeks before Christmas 2012.

Photograph 10, View of pipe showing hole in wall caused by jet cleaning

This incident effectively changed the course of the project. With no apparent way to fill the tomo without either undermining the house or spilling grout into the pipe, it was decided that there was now no likely practicable method for cleaning debris from the pipe and therefore the CIP liner option was no longer practicable.

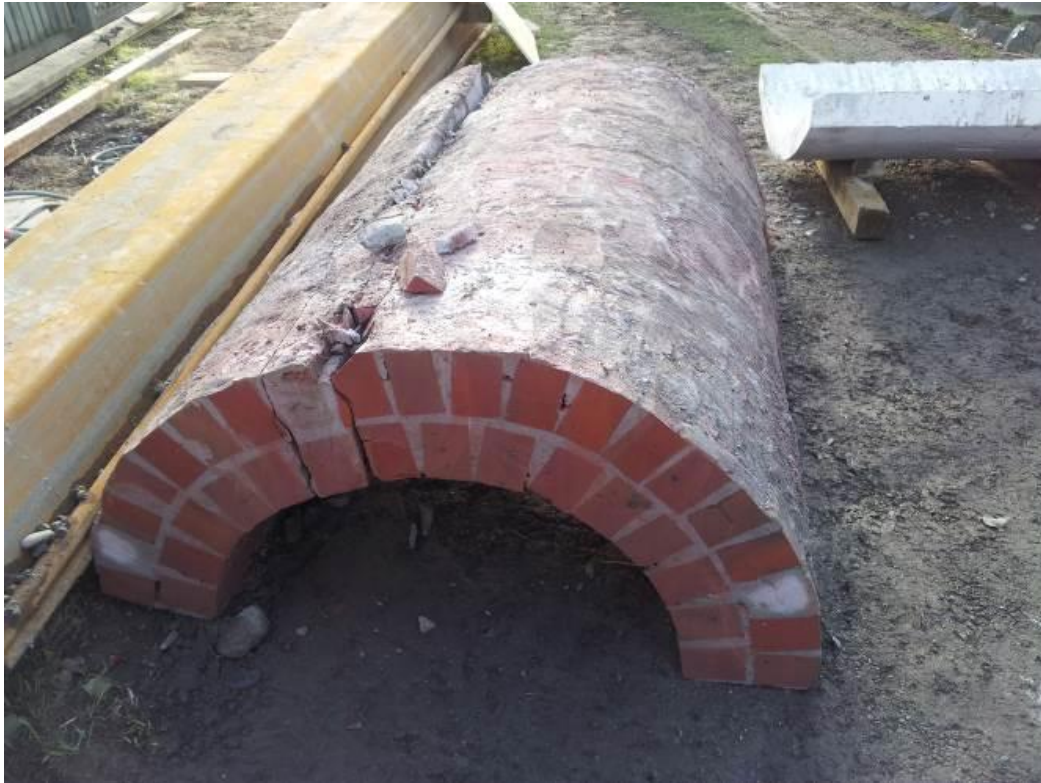
The latest plot twist was when the Citycare construction crew exposed the brick barrel pipe. They determined that it was a double skin brick barrel and at the point of connection it was in very sound condition. While the design precaution of the cement mortar bandage was applied, they found it was not needed and were able to successfully sawcut into and remove the top portion of the pipe intact in the same way as would be normal for a concrete pipe material (refer photo 9).

Photograph 11, Section of brick barrel saw cut out and removed intact.

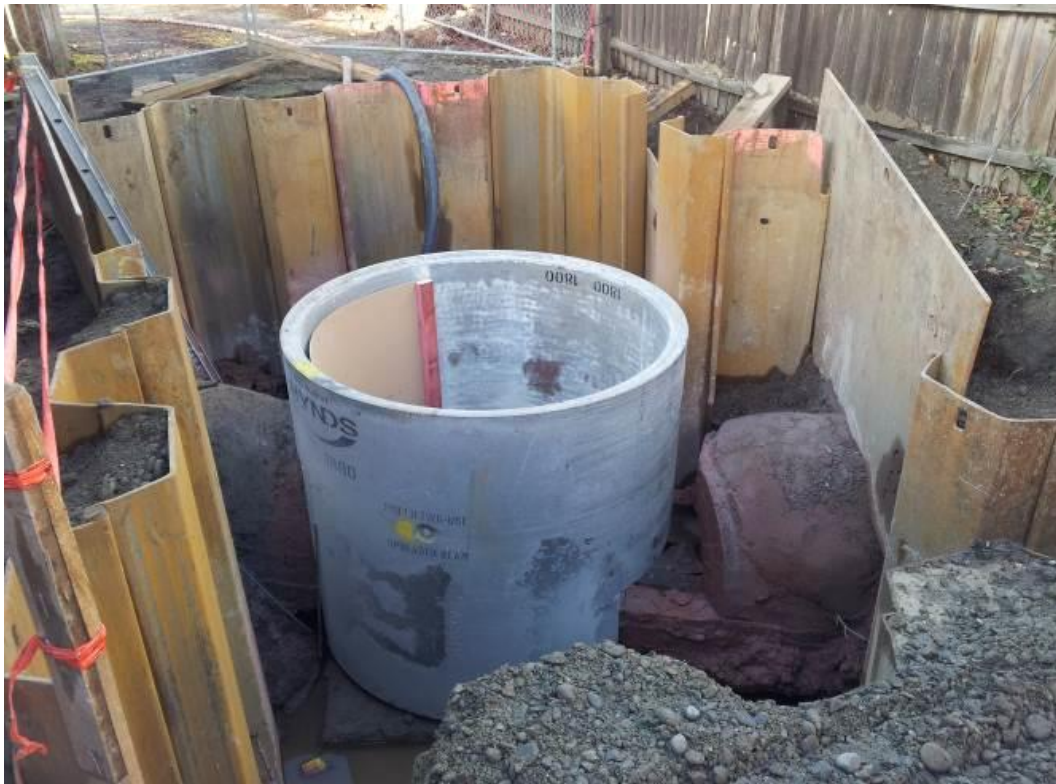
Photograph 12, New manhole construction with remaining brick barrel pipe exiting downstream

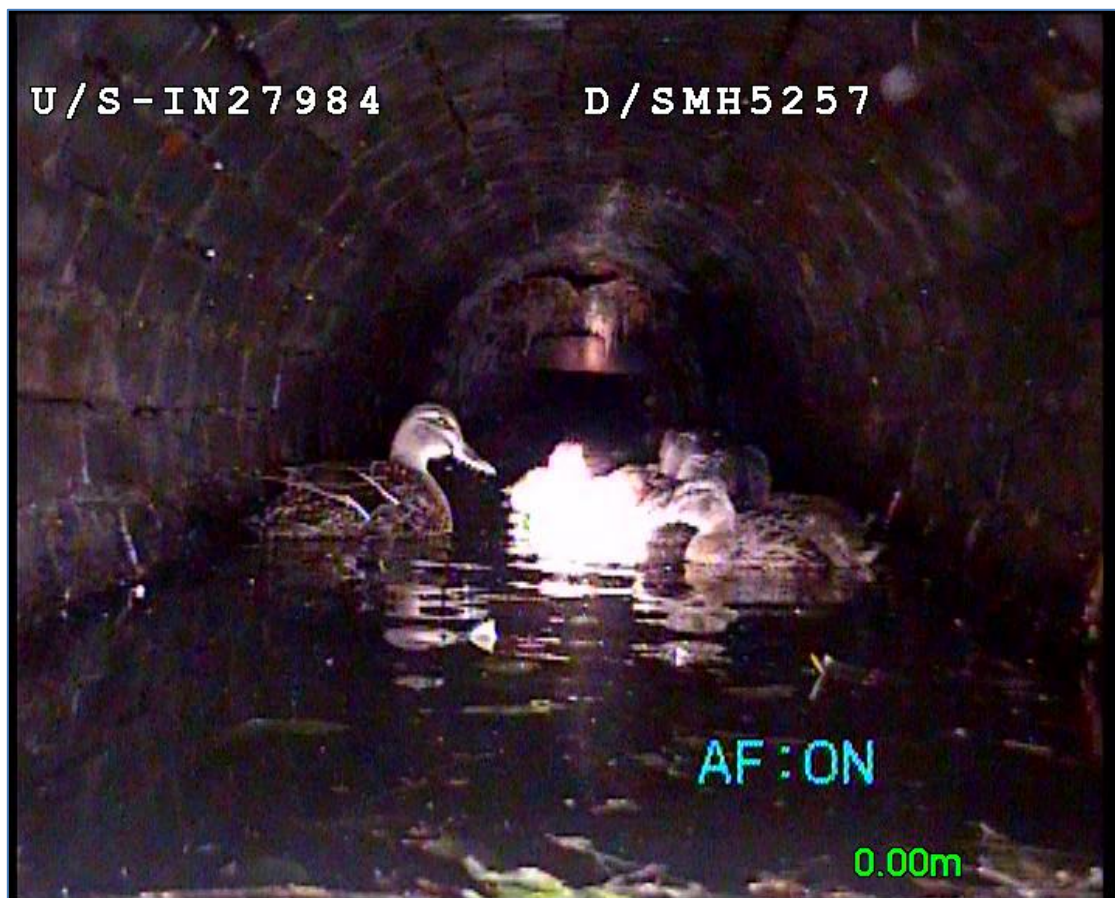
The following image is from another section of 750 diameter brick barrel, about 200m further downstream, as it crosses Montreal St. Just goes to prove that there is no knowing what you might find until you start looking.

Photograph 10, Surprise!
