HASTINGS BRICK ARCH SEWER REHABILITATION

*A Patterson-Horner
MWH Ltd, Hastings, New Zealand*

ABSTRACT

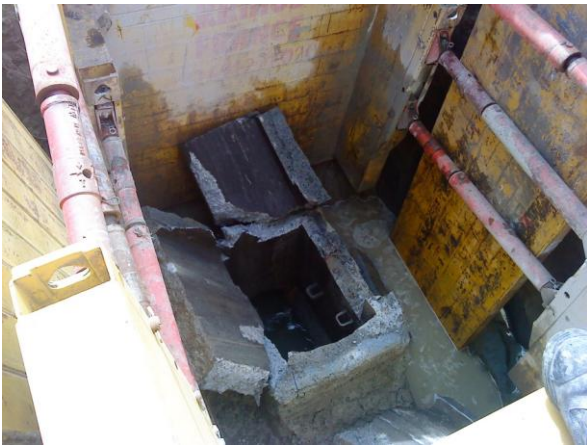
Photograph 1: Deconstruction of original brick arch manholes

Prior to the contract commencing a manhole was deconstructed as a trial. The trial was to ensure the manholes could be safely and practically removed. The trial was successful and the contract proceeding with the inclusion of all 22 manholes for removal.

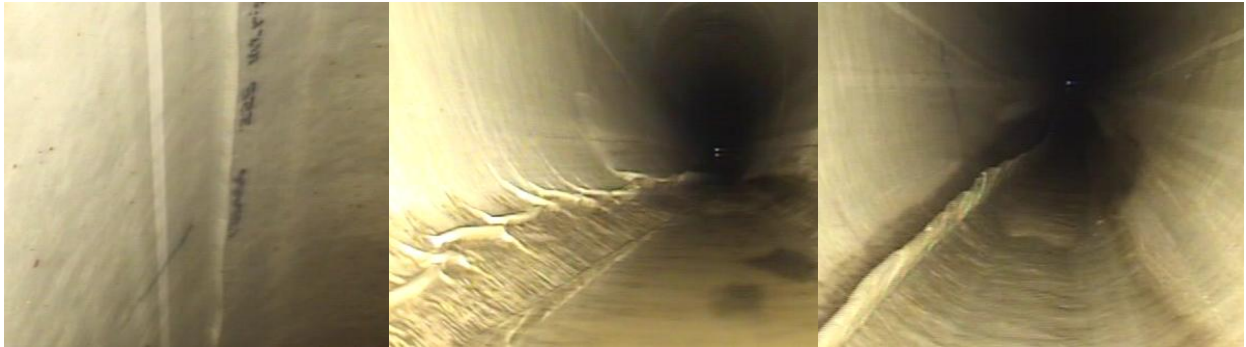
Photograph 2: Example of a minor wrinkle, major wrinkle and a major fin from other CIPP projects
