Stephen Molineux & Timbi Poon

Asset Management of Brownfield Reservoirs – Opportunities/lessons from a comprehensive condition assessment and remediation programme

WSP & Beca-HunterH20

water
NEW ZEALAND
CONFERENCE & EXPO
17-19 OCTOBER 2023
Tākina, Te Whanganui-a-Tara Wellington

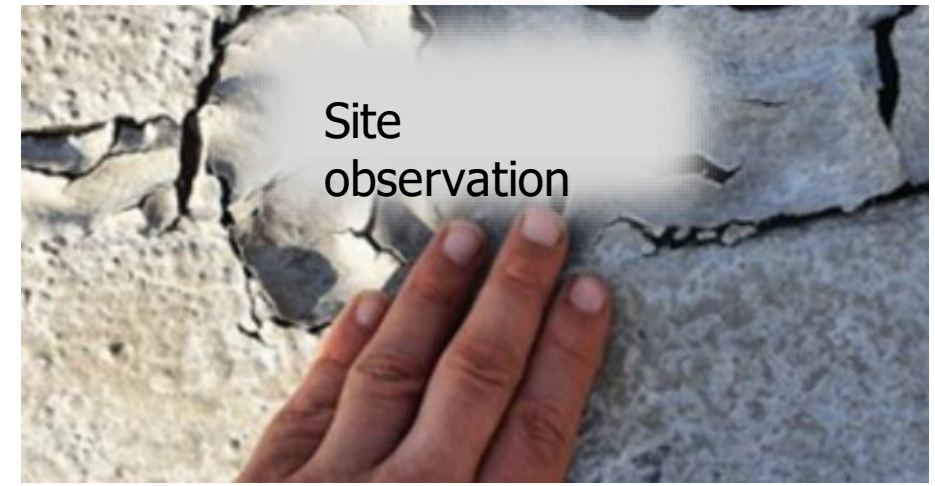
Assessment scoring

FAILURE MODE ASSESSMENT - FM #4 - Contamination - through all roof surfaces, including, defective membranes, cracks and joints

Failure Mode Assessment - Failure Mechanism #4
4 - Poor

Explanation of Failure Mode Assessment - Failure Mechanism #4
Sealant between roof joints is pulling away/ missing in places. Painted membrane flaking over roof sealant. Some ponding near hatch, though that ponded area near hatch has a more robust membrane in place and appears to be watertight. (unconfirmed)

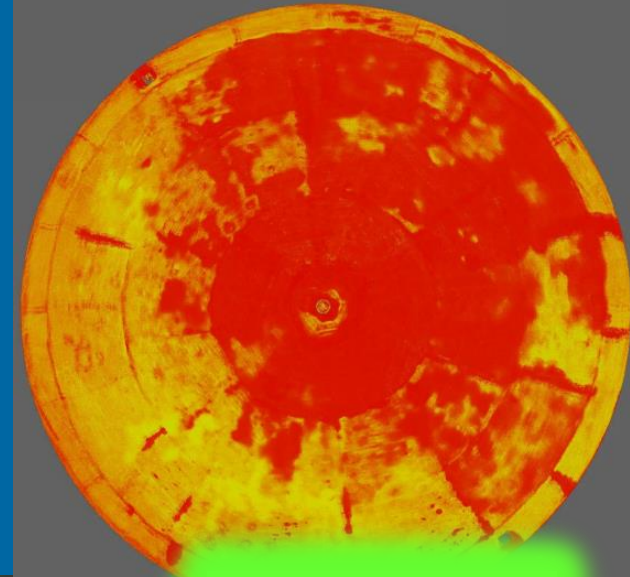
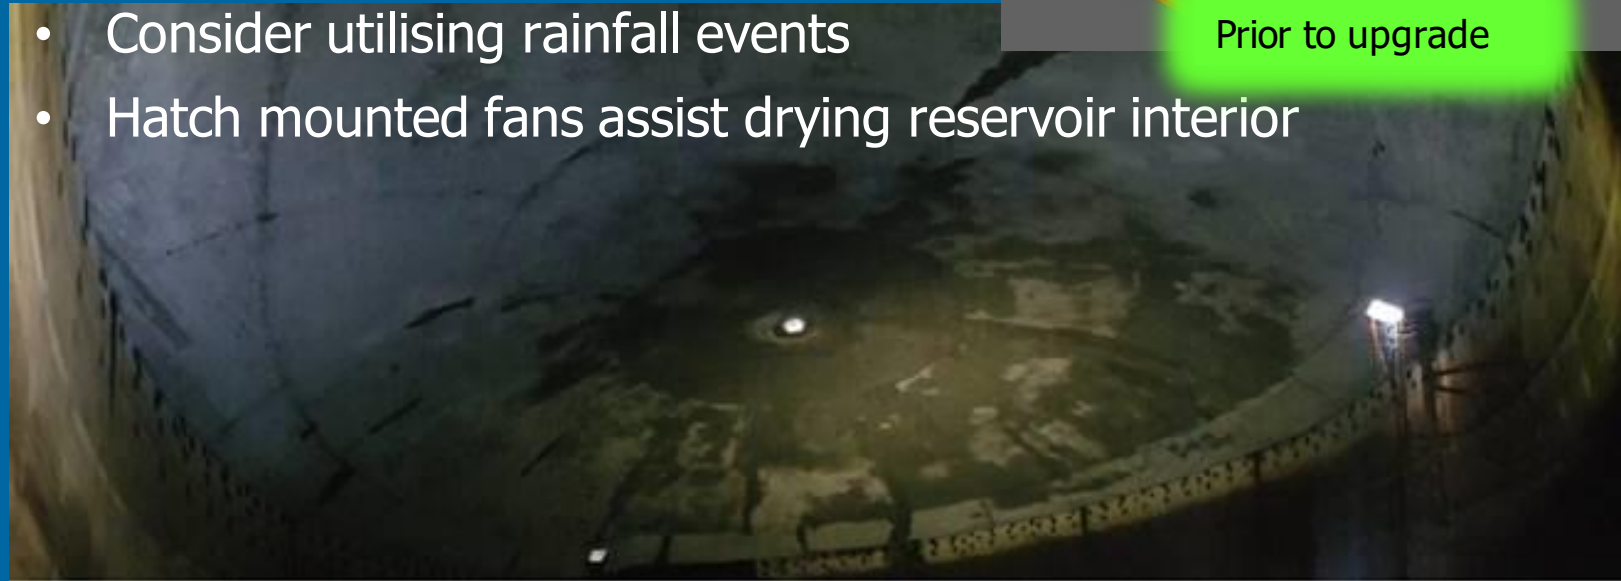
Prior to upgrade

- Industry best practice to demonstrate water tightness
- Can be difficult and expensive to take reservoirs offline

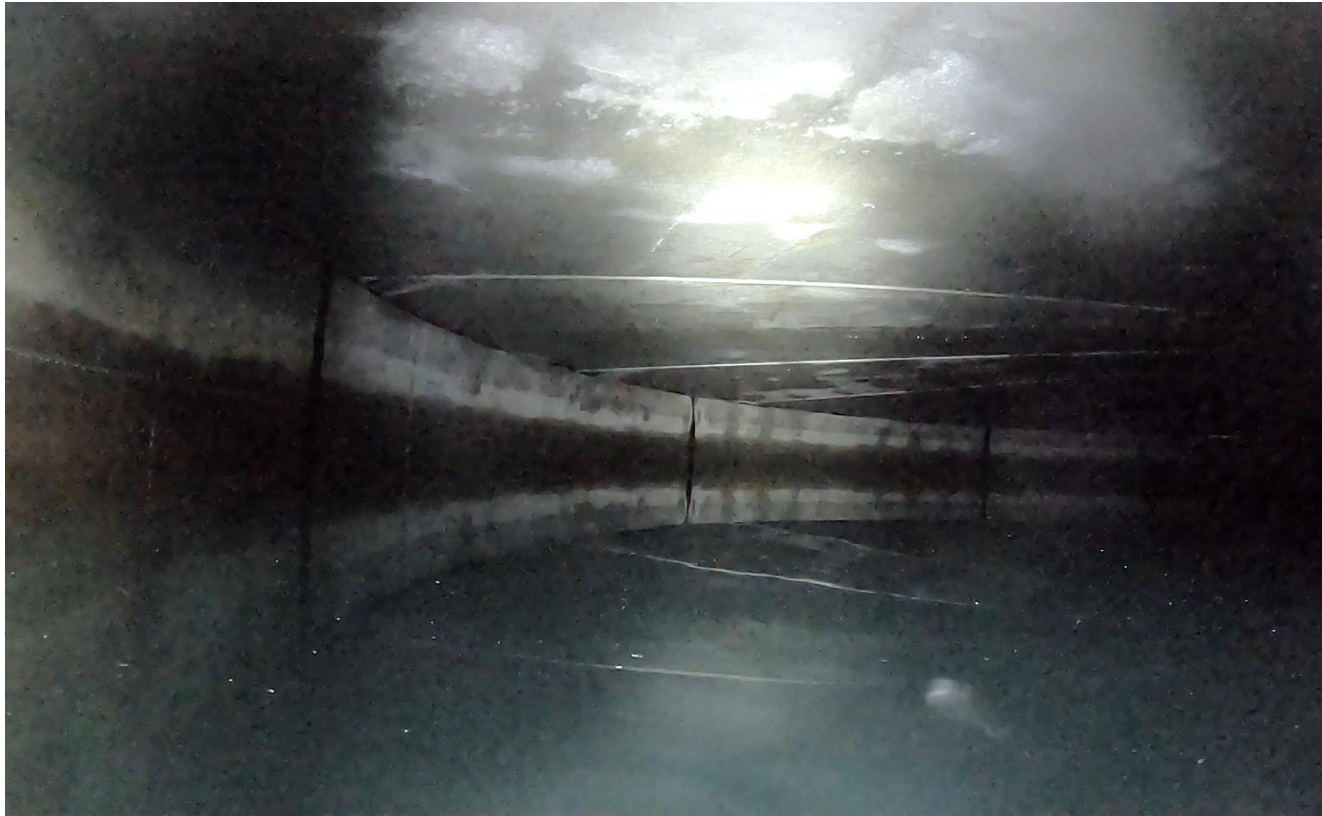
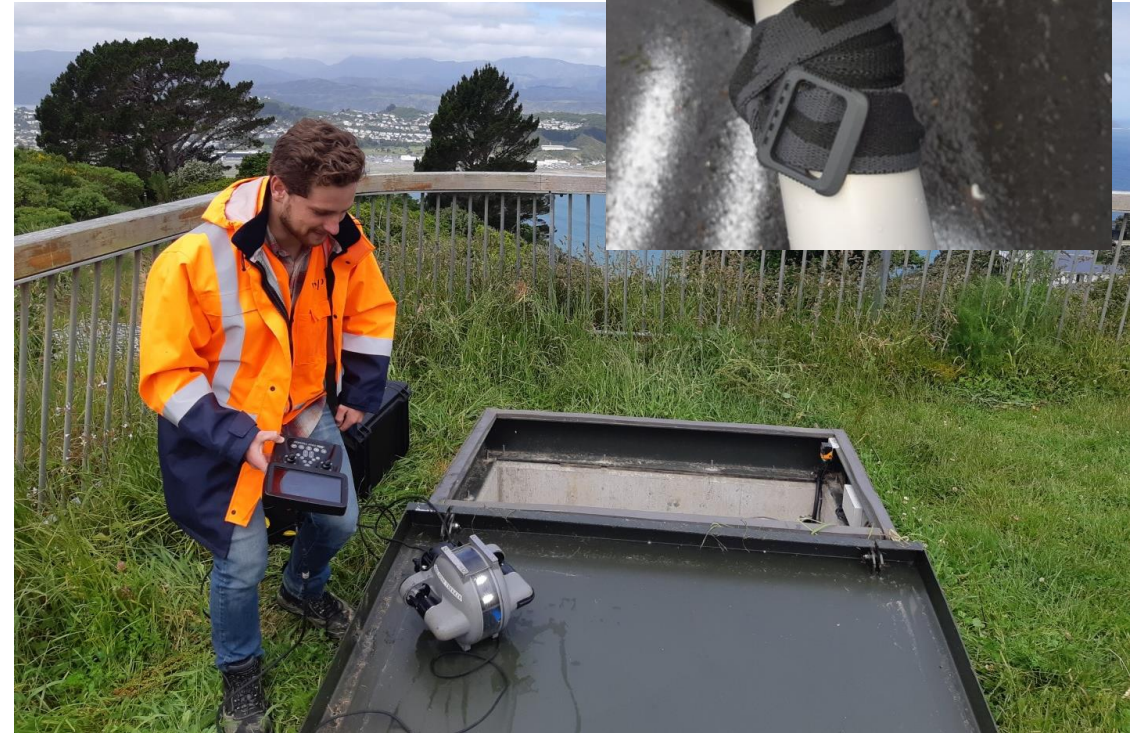
Online Leakage Testing

- Use of drones, boats & selfie sticks
- Experience required to differentiation between condensation and leakage
- Observations inform the 'Visual Assessment Guidelines'

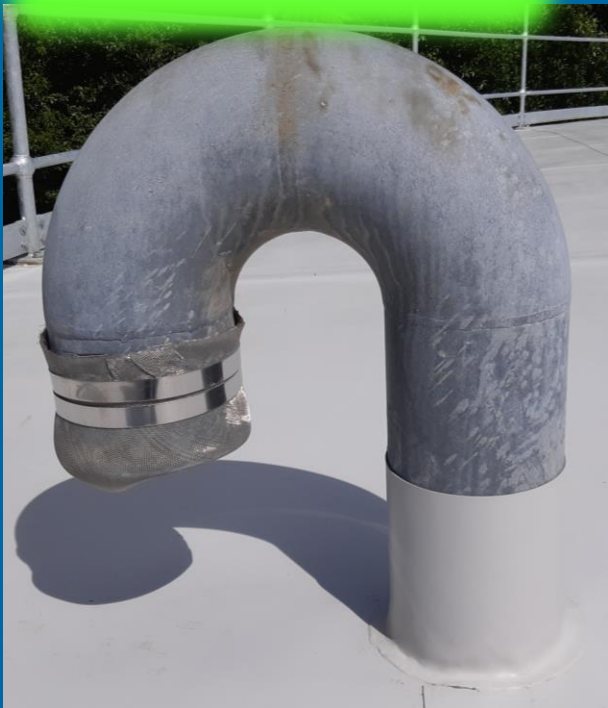
Air Vent Mesh installation

- Warm blooded animals – Very High risk
- Insects – lower risk
- Venting capacity requirements need to be considered when using flap gate valves on overflow pipes

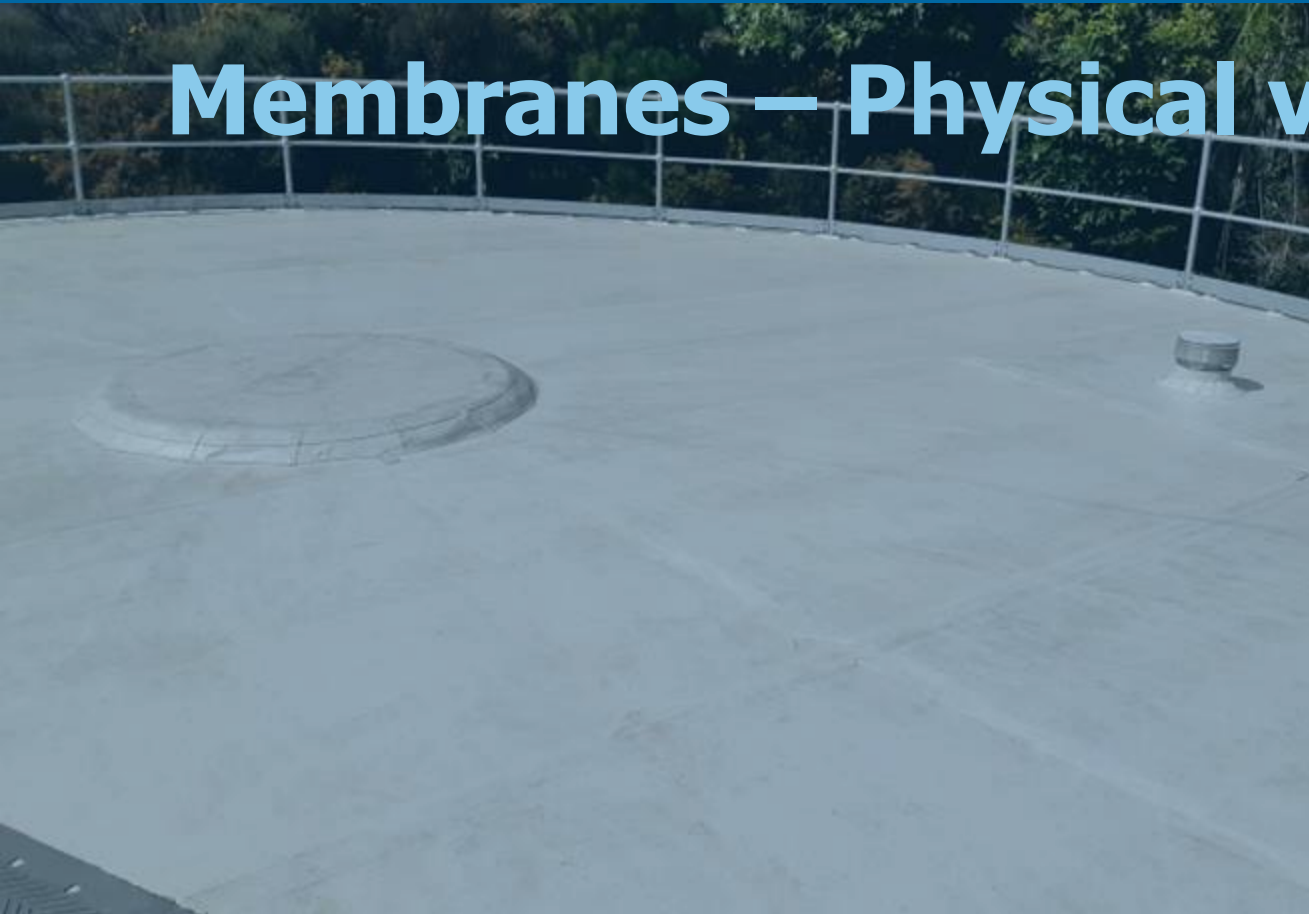
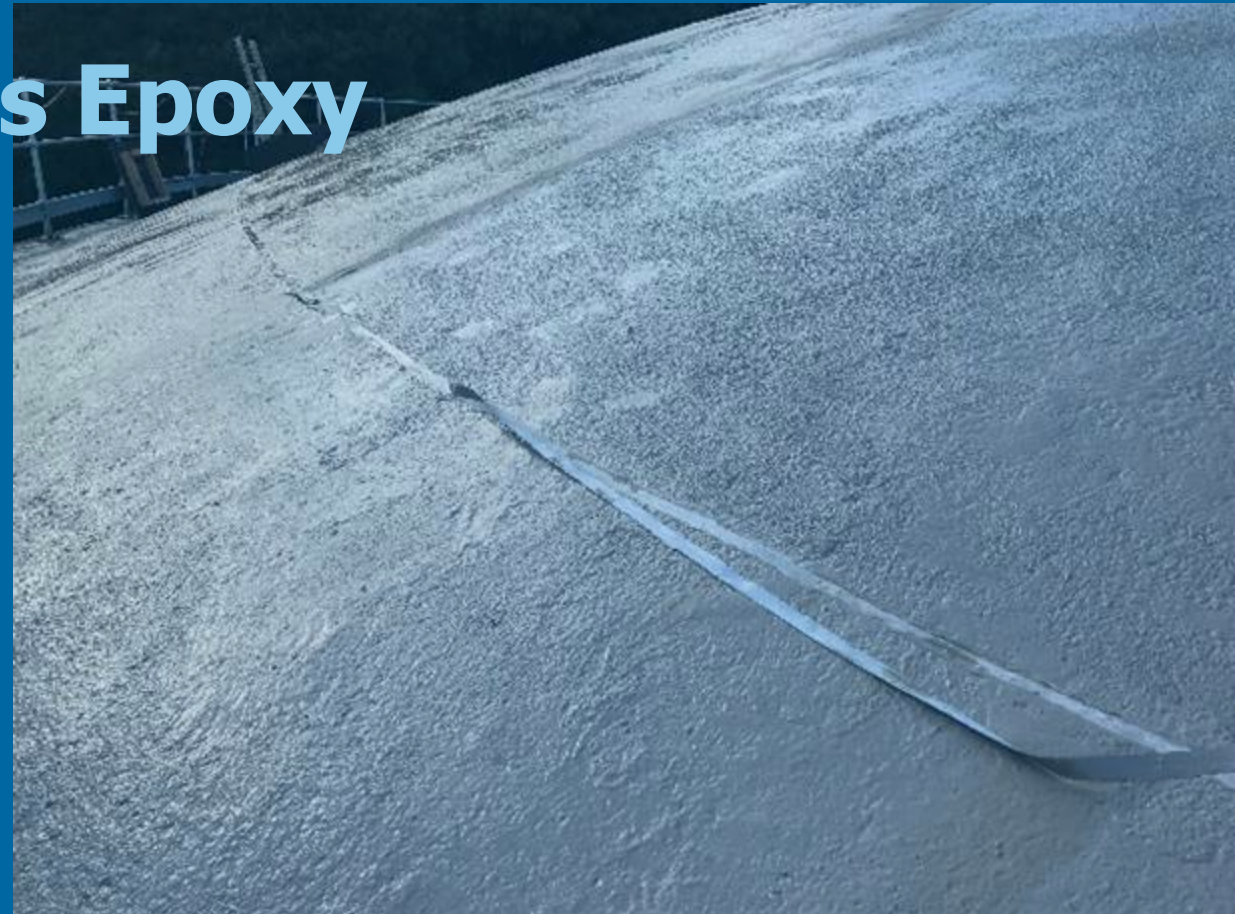
Membranes – Physical vs Epoxy

More expensive.

Longer design life, more durable with less maintenance

Effective solution for roof surfaces with minimal thermal movement and few construction joints.

Decay quickly with roof ponding
