A FLOOD TWO MONTHS IN – A WAIĀRI RESILIENCE STORY

Rodney Clark (Tauranga City Council), C Olivier (Beca)

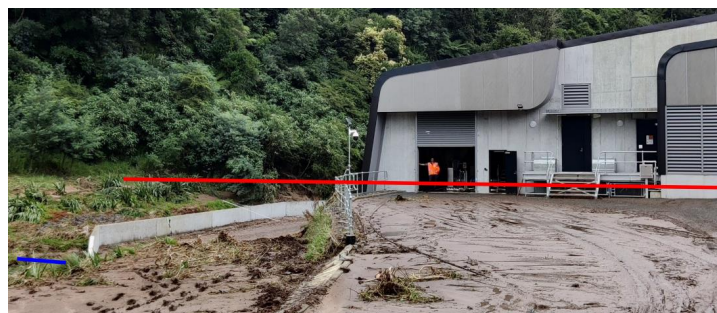
Within the first two months of operation, a significant rainfall event occurred within the catchment, causing the stream flows to peak at approximately 250 m³/s and flood levels to rise 5m above normal stream level. The flood also carried significant amounts of silt and debris and changed the stream bed significantly around the intake site. The event occurred between midnight and 1am. Although the plant was offline at the time, the proof of performance of the intake lies in how well it survived the impact of the event and its ability to be brought back online.

Photograph 1: post-flood photo showing indicative typical stream level (blue) and flood level (red)

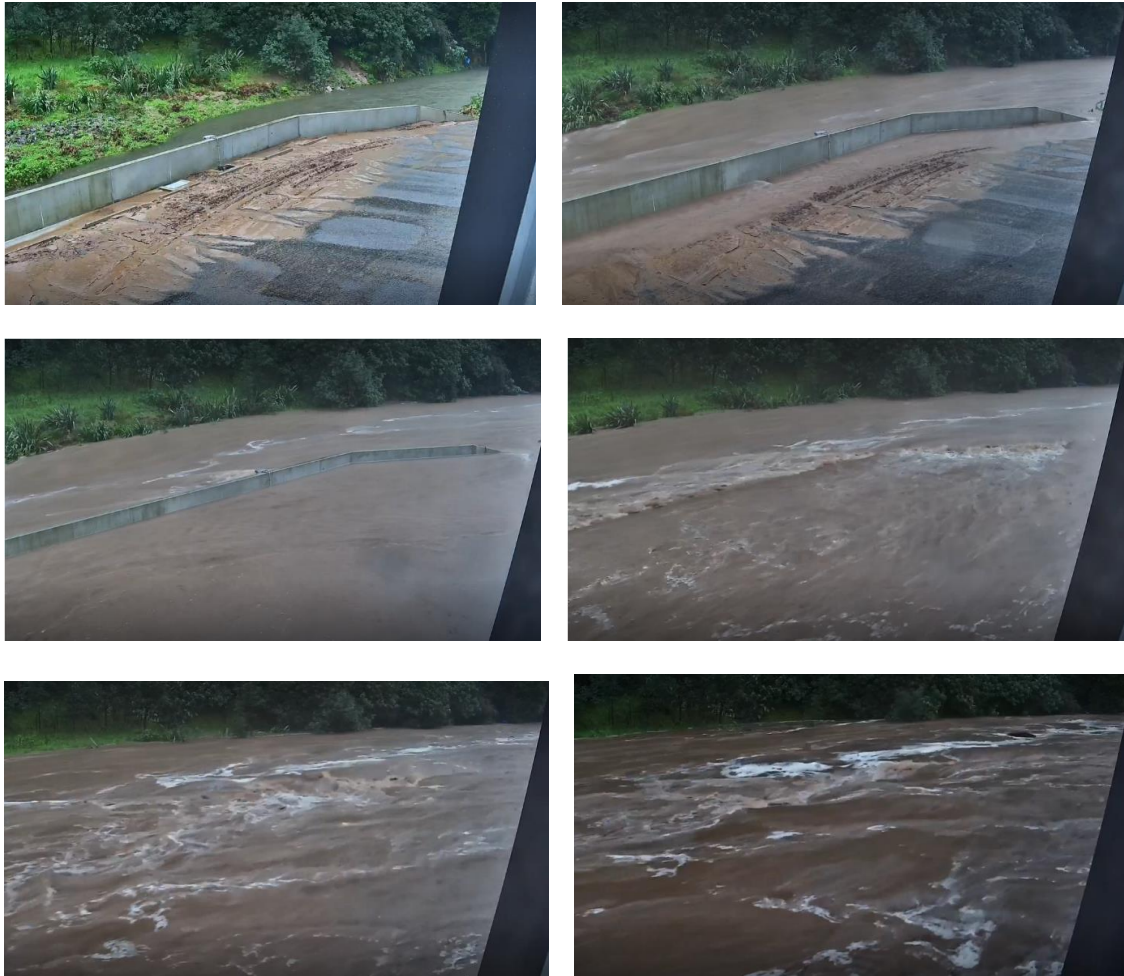
A second flood event occurred between the hours of 5pm and 7pm on the evening of 23 May 2023. Peak flood levels reached 12.8mRL, again being deep enough to enter the pump room with a floor level of 12.7mRL.

Photograph 6: Time lapse photographs of flood event of May 2023.

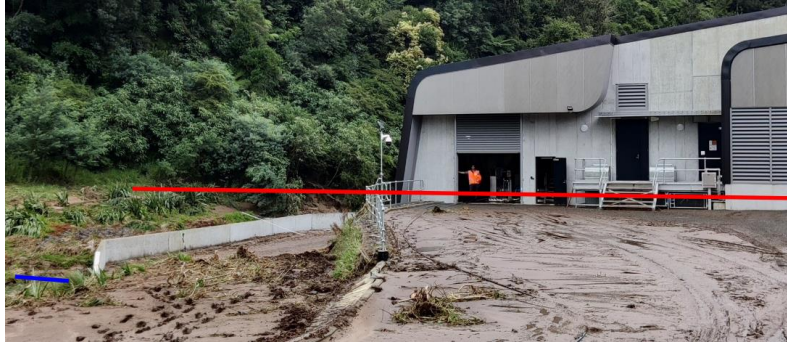
Dry weather flows in the stream adjacent the intake works would normally be in the order of approximately 8.5mRL. At the peak of the flood river levels were recorded as 13.17mRL, estimated to be equivalent to a 1:250 flood event and sufficient to flood the pump room.

These events were far greater than that predicted 1:50 year event, and the impacts took more than the one-day recovery period to overcome. However, the core structures and design intent withstood flood effects well and the experience and learnings picked up from those events will enable improvements to be made that will assist with more rapid recovery in the future.

Photograph 7: Jan 2023 flood level.

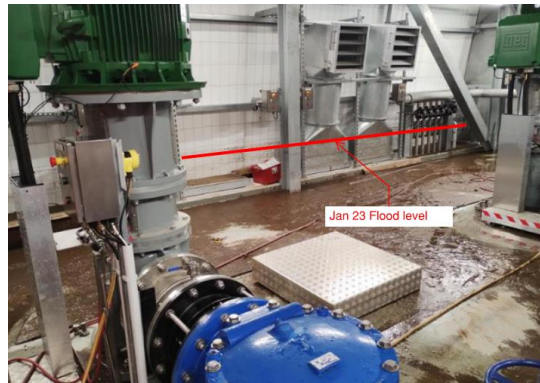
Clean up was required after both events, but all electrical switch gear, motors etc. were positioned above the 1:2,500 flood level and suffered no damage. The effect of flood waters themselves did not cause any lasting or permanent damage preventing the operation of the intake.

Photograph 8: Height of flood within the pump room.

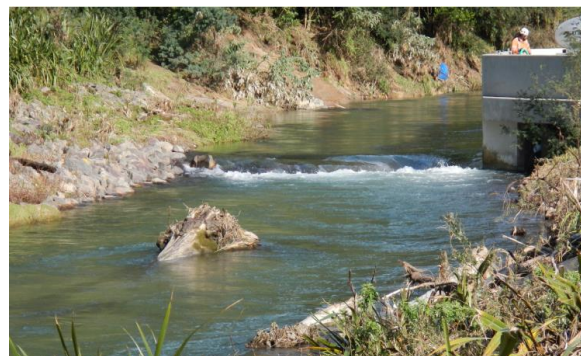
The intake structure, building and platform forms worked well in not providing protrusions that would cause the hang-up and accumulation of debris. There were some large logs that were deposited in the stream bed and beneath the screens, but these were limited, did not prevent the operation of the intake and were easily removed in the days subsequent to the flood event.

Photograph 9: Typical debris residue following the flood events.

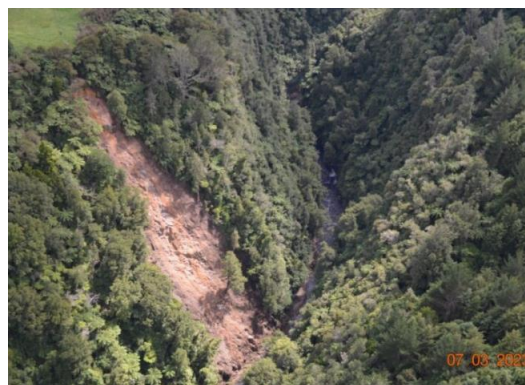
Since the two flood events a significantly increased silt load and movement has been experienced in the stream. A flight over the catchment after the January flood identified 13 major slips had occurred during the rainfall event. These slips will take time to recover and stabilize so an increased silt load in the stream can be expected for some time to come.

Photograph 10: Typical slip in the upstream catchments.

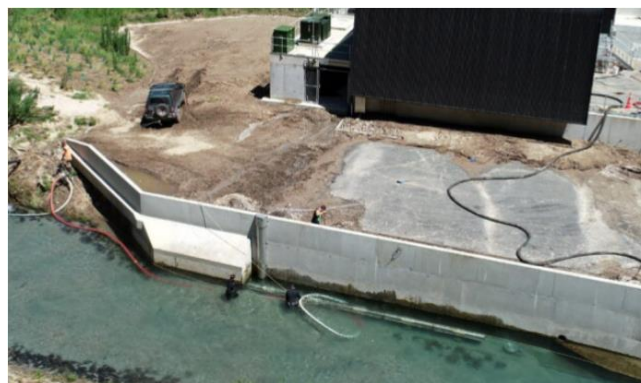
Although the intake structure was designed with a downstream control weir and notch to control silt levels, the sheer quantity of silt was such that the passive intake Tee screens were becoming submerged in silt. The risk of silt build-up had been identified during the design and spool pieces had been ordered with the screens when they had been purchased. These 300mm spool pieces have been installed and have enabled the intake to operate effectively since the January event.

Photograph 11: Divers installing spool pieces to the TCC screens.

This is not expected to be a permanent solution. At some stage the stream flows will reduce back to their pre 22/23 levels and at that time it will be necessary for the screens to be returned to their design level.

In-stream sediment levels are being monitored and plans have been developed for the installation of further flow training weirs, with the intent to increase scour velocities immediately adjacent the screens. By July 2023 silt levels measured along the line of the intake screens had started to return to pre flood levels. An implementation decision will be made on this subject to the ongoing sediment monitoring and stream flows.

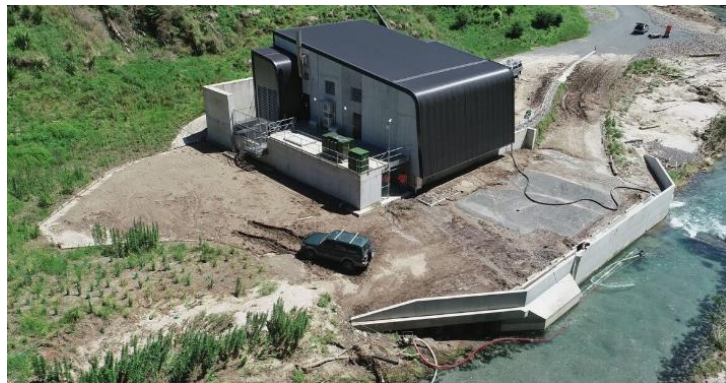
The quantity of silt deposition remaining on the access platforms as the flood has receded has been greater than anticipated. There have been areas where this is greater than 300mm thick.

Photograph 12: Partly cleared silt from lower platform.

Actions for the Waiāri Intake are to implement minor modifications and to document clean-up procedures that will make the clean-up operation more streamlined and efficient. It is also intended to upgrade the platform from a chip seal finish to asphalt to make clean-up easier.

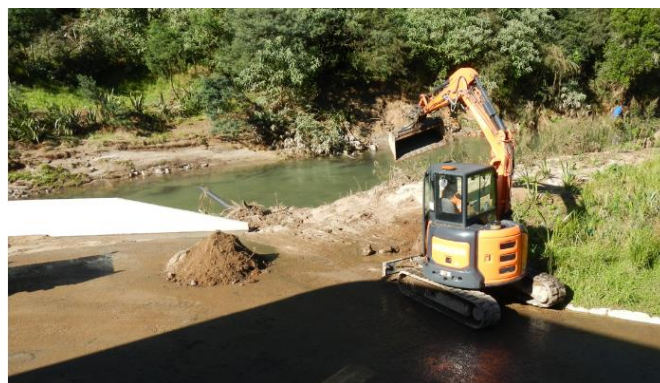
Although the silt deposits to the working platforms do not in themselves prevent the operation of the intake facilities, they hinder the ability to be able to move around the site to be able to complete tasks that are operationally critical. To that extent therefore this was a risk that was not fully appreciated. Clean-ups have proved to be relatively expensive and disruptive, taking well over a day to complete.

Photograph 13: Clean-up operation in progress.

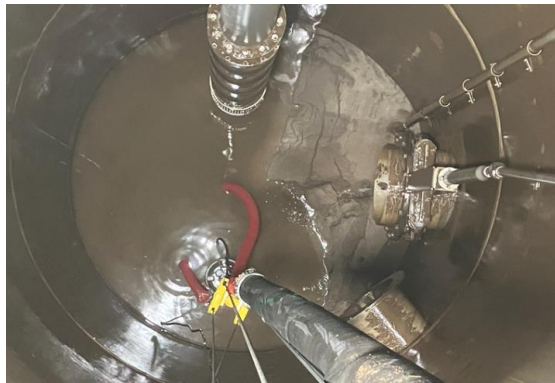
Notwithstanding that the pumps were not in operation during the flood of January 23 a considerable amount of silt entered the wet wells and settled there. This was to an extent where the inlet and bowl of the pumps were submerged in silt.

Photograph 14: Silt build-up in wet well.

Although the design philosophy for the intake and treatment train is for silt passing through the 3mm screens to be conveyed together with the pumped flow to the treatment plant for removal, the pumps were never designed or specified for this sort of submerged start up.

This resulted in the blocking of gland water discharge ports, seal failure, wear rings worn, and column shaft bearings being worn. Although the pumps have been able to be nursed through a period to continue to deliver flow to the treatment plant all three pumps have had to be refurbished.

Instruments are now being installed that will prevent pump start up if the silt levels get to close to the pump bowl entry.

Operational procedures to be followed after a flood event are being documented. These will include a two stage pump initiations procedure post such an event but will also include for the manual pumping out of silt from the wells in the event that the new instrumentation has locked the pumps out from starting.

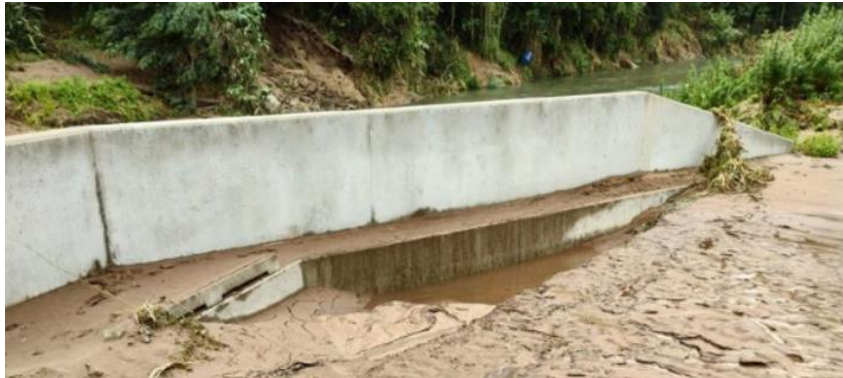
The river training works withstood the flood effects well. The only sign of scour damage was to the screen servicing platform behind the parapet wall and that had no effect on the intake and pump station operation.

Photograph 15: Scour damage on downstream face of parapet wall.
