# USING MODERN TECHNOLOGY TO SOLVE PROBLEMS TAURANGA'S WASTEWATER OCEAN OUTFALL

*M. Mooney (Bay Dynamics NZ), C. Thomas (Tauranga City Council)*

This paper will provide insight into some of the problems facing TCC with its existing Ocean outfall asset and some of the mitigations currently underway to investigate these.

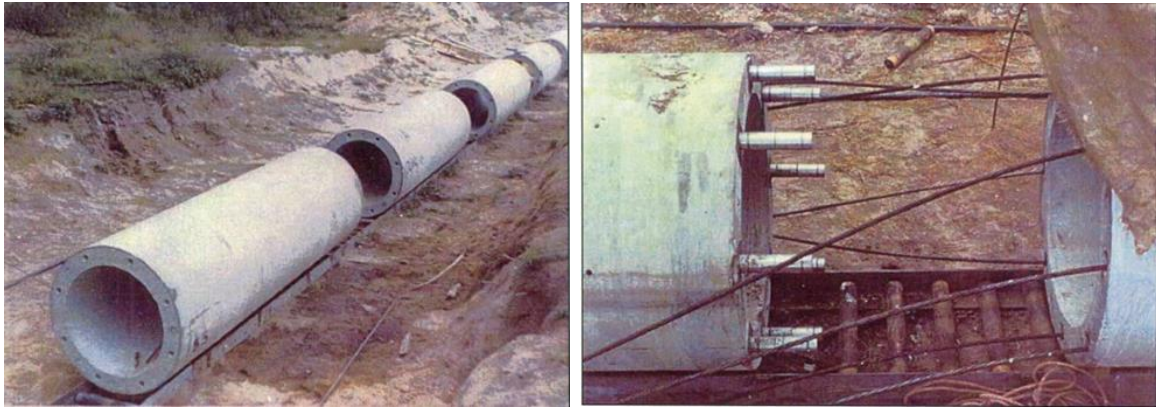
*Photo 2 : Ocean Outfall Pipes*

The ocean section of the pipeline was badly damaged during construction, when it was being floated into position. Repair work carried out at the time included banding significant cracks, as well as grouting of cracks and defective joints.

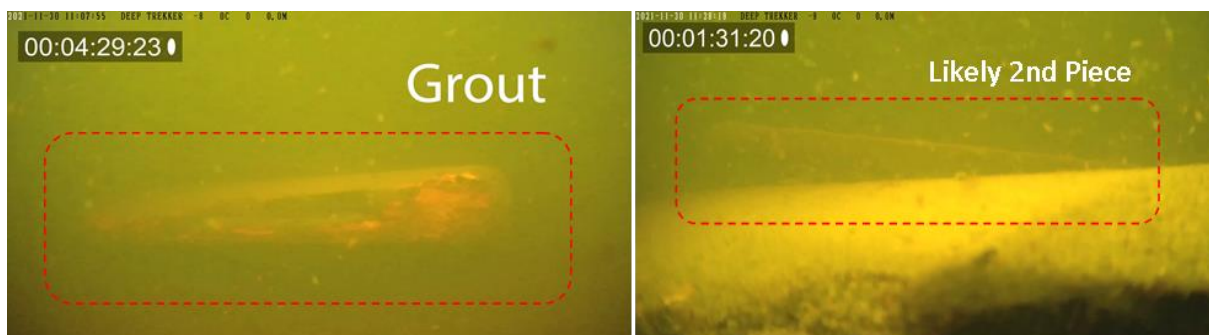
Bay Dynamic's conducted an initial assessment based on previous data and footage obtained from historical inspections of the outfall pipe. Footage typically showed poor visibility and it was difficult to obtain usable data from it. It did however show what appeared to be a piece of grout blocking the pipe approximately 100m inside the pipe. With no scale of visual reference being readily available, this grout was estimated to be around 400mm in width and 60-80mm thick. Its length could not be accurately established but the footage also indicated a second piece was likely lodged directly behind the first. No further footage beyond the initial blockage was obtained or available for assessment.

*Photo 3: Historical Inspection Photos showing debris*

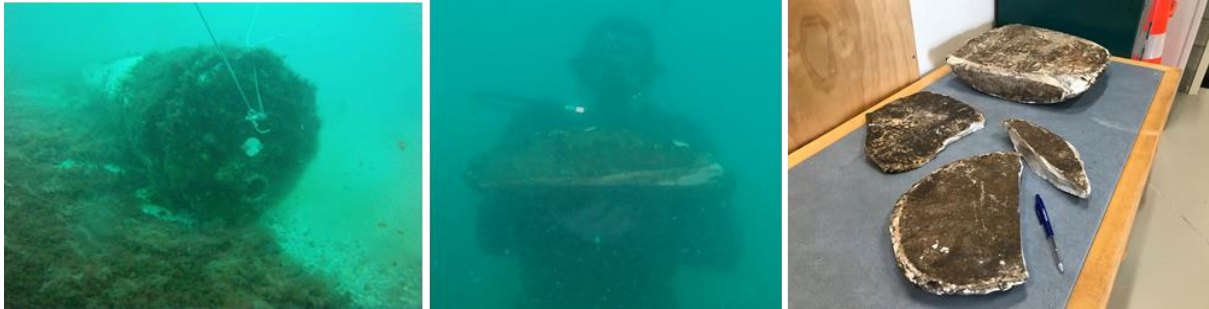
Several external/ internal inspections and maintenance tasks had been conducted over the years which recovered several pieces of grout. It was thought that these grout pieces were created by oversupply of grout during historical grouting repairs

and became dislodged over time or by previous attempts (chain dragging) to clear the ocean outfall section.

*Photo 3: Debris Collected from Ocean Outfall*

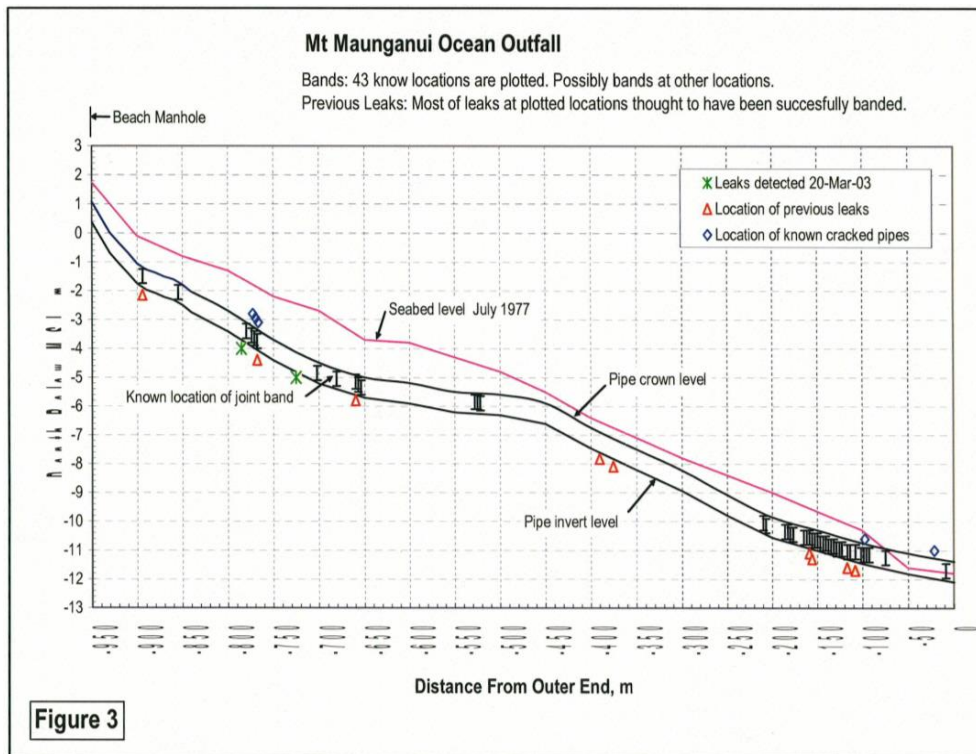
At its discharge end the ocean outfall is 12.7m underwater. Previous pipe plots had indicated the pipe may not be entirely straight or at a consistent incline the entire way, as shown in the Figure 2 below.

Figure 2: Historical Defects - Ocean Outfall

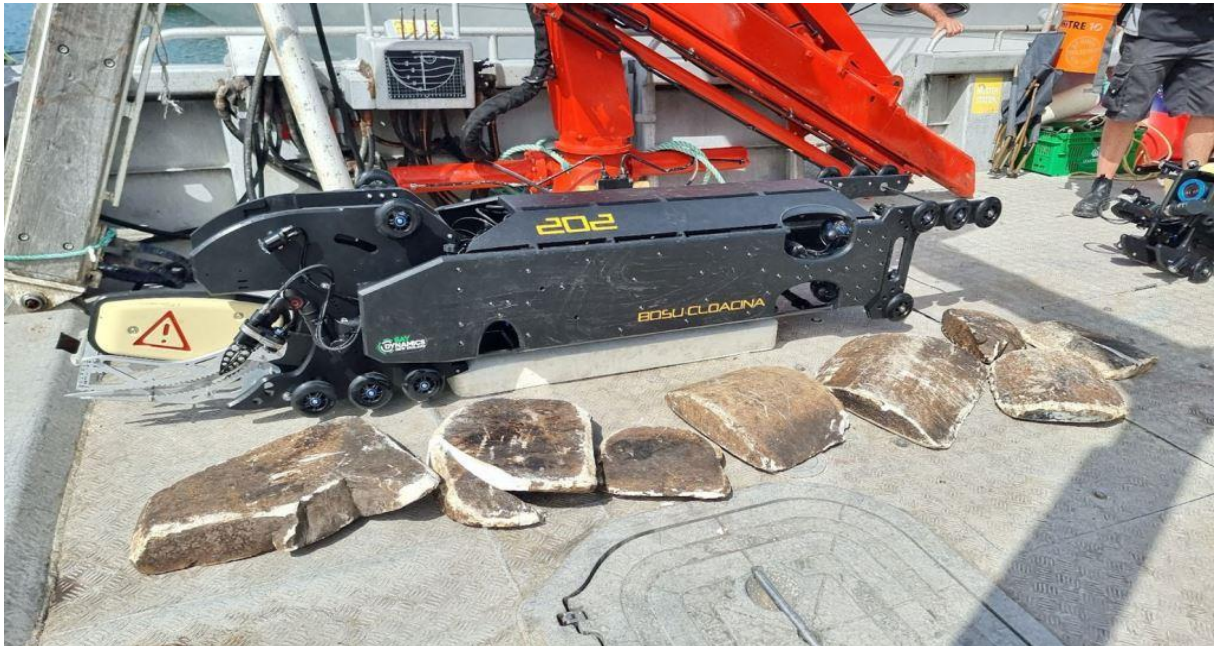
The first operation phase was debris removal which took three days to 'dismantle' the blockages and clear the pipe of debris. Approximately 120kg of grout debris was removed, the largest being 20kg in weight and measuring approximately 500mm in length. Three blockages were located removed. At the locations of these blockages, it was evident that over-grouting had created ridges on the pipe floor trapping large grout pieces and causing additional grout pieces to pile up and

become wedged. The blockages formed significant cross-sectional restrictions to water flow.

*Photo 9: Grout Debris Removed on Day 2*

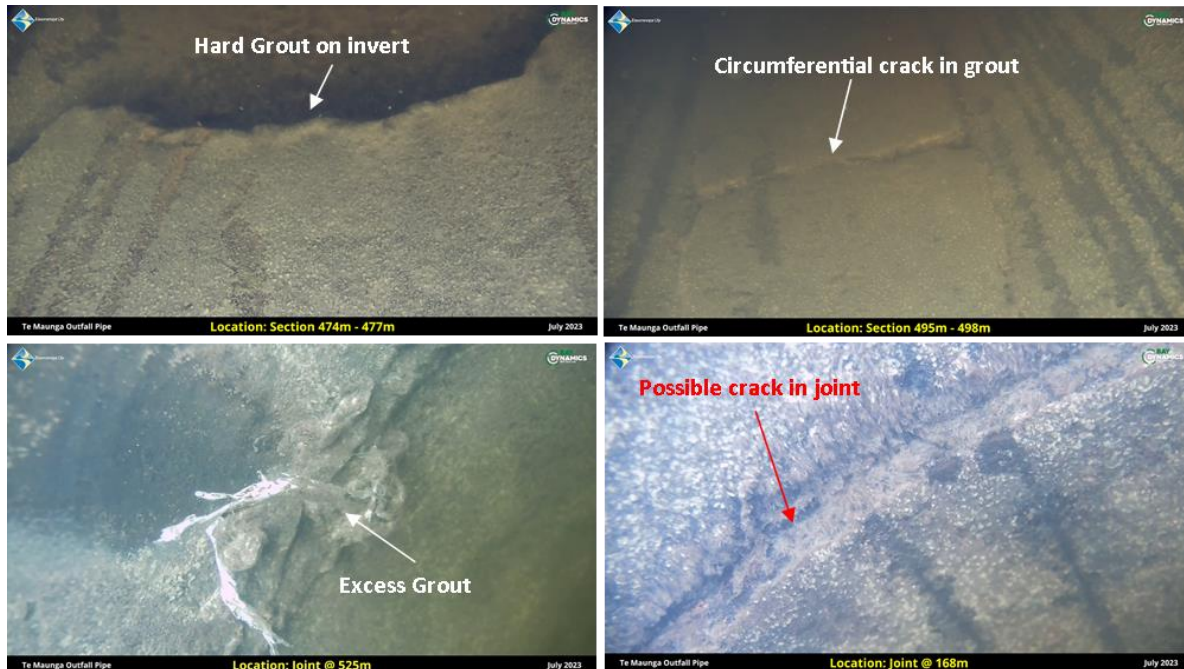
The second operational phase involved using the high resolution camera to inspect the internal pipe wall and joints. This inspection established that a significant number of joints had excessive grout protrusions into the pipe.

The inspection yielded very good images and detected some type of anomaly on almost every one of the 316 joints. The most common anomaly was the excessive grout protruding into the pipe.

*Photo 11: Screenshots from Inspection*
