THE CHALLENGES OF RELINING A BRICK CULVERT IN AN URBAN ENVIRONMENT

Branko Veljanovski, Principal Design Specialist, Auckland Council

Sarah Sinclair, Chief Engineer, Auckland Council

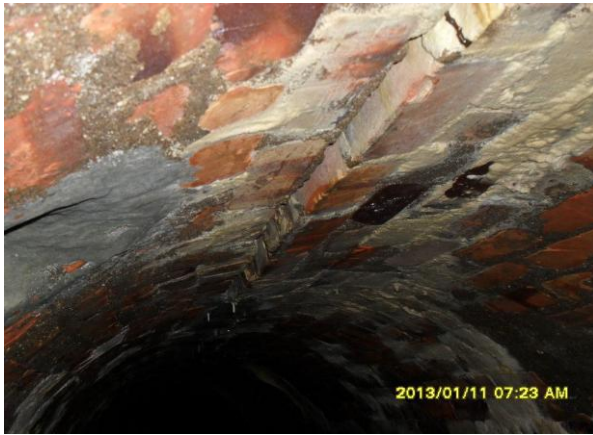
Fig. 6 Displaced brick, longitudinal crack at crown

Some of the actual photographs (Figures 6-9) are indicative of a brick culvert in Internal Condition Grade 4 (see Table 1), which is deemed likely to collapse in the foreseeable future according to the WRC Sewer Rehabilitation Manual 4th edition.

The photographs show degraded mortar and mortar loss at least to a depth of one brick and there are signs of fracture and longitudinal cracks in the crown, and displaced and sheared brickwork at the crown. Some loose and missing bricks were evident, indicating continuing deterioration. Also, bricks missing from the inner ring demonstrate that the brickwork is no longer in compression and is potentially unstable. Changes from circular to oval shape and extensive lime deposits were also observed, particularly in section L. Lime deposits and encrustation are usually taken to be evidence of running infiltration through the damaged brickwork. Table 2 shows the walk through inspection data.

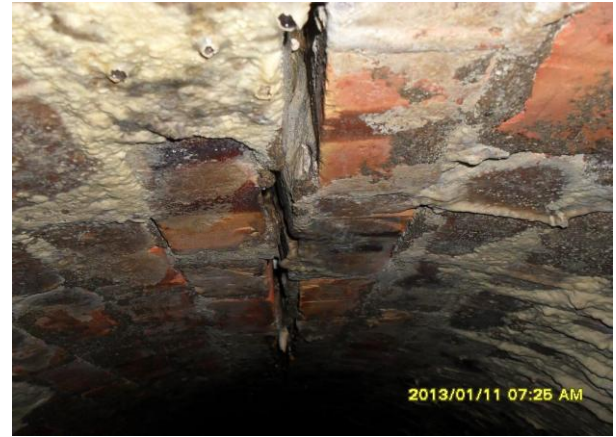
Fig. 7 Extended longitudinal crack, lime deposits

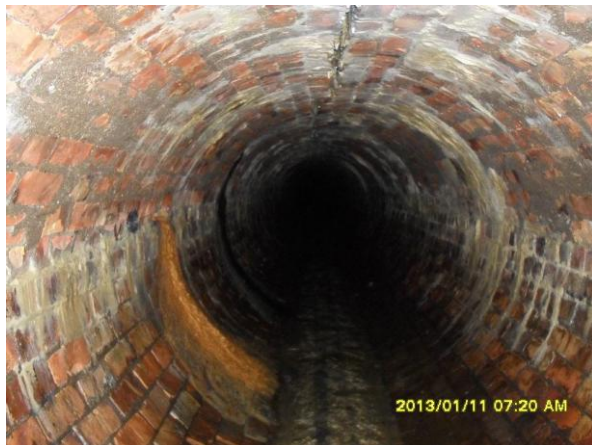
Fig. 8 Extended longitudinal crack, deformation

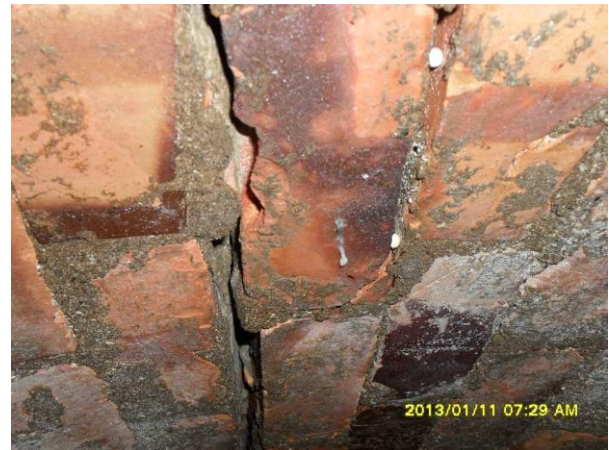
Fig. 9 Multiple cracking, old repointing

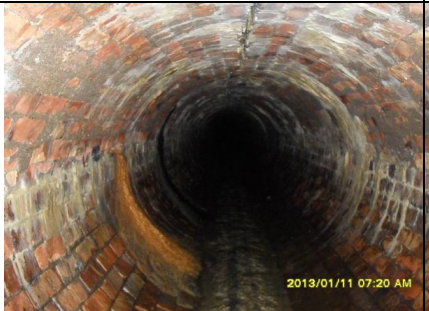
Crack in Crown, profile deformation
18		U	ED	D			See above	Lime deposits
20		U	LO		9	9		150 dia EW
28		U	LO		10	10		150 dia EW
42		U	CC	M				
43		U	PB	S	6	6		Missing brick
45	F2, S3	U	DF	M	12	12

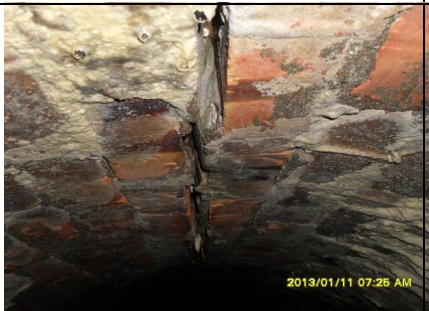
Multiple Cracks in crown , profile deformation

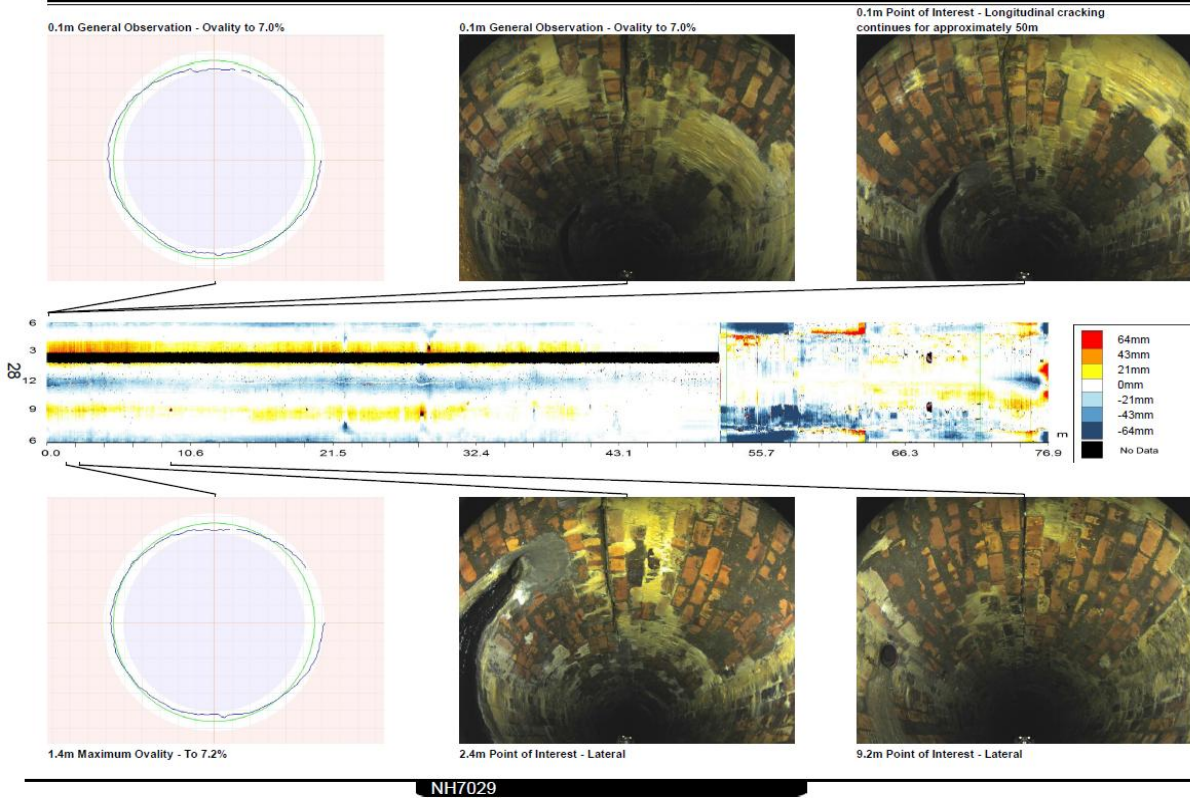
Fig. 11 Laser Profiling and Ovality Graph

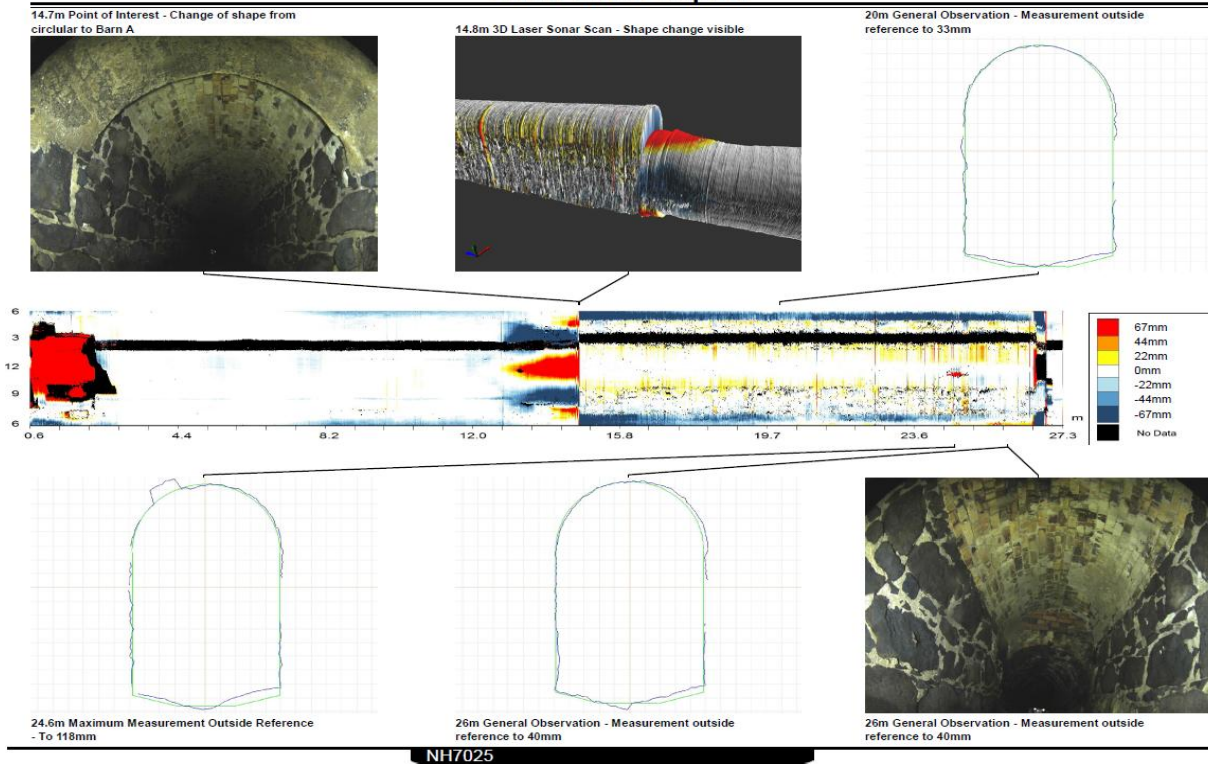
Fig. 12 Laser Profiling, Change of Culvert's Geometry
