URBAN STREAM RESTORATION - EROSION CONTROL AND FISH HABITAT ENGINEERING

B. Quilter, Civil & Environmental Engineer, Tonkin & Taylor Ltd, Hamilton
D. Miller, Freshwater Ecologist, Tonkin & Taylor Ltd, Hamilton

ABSTRACT

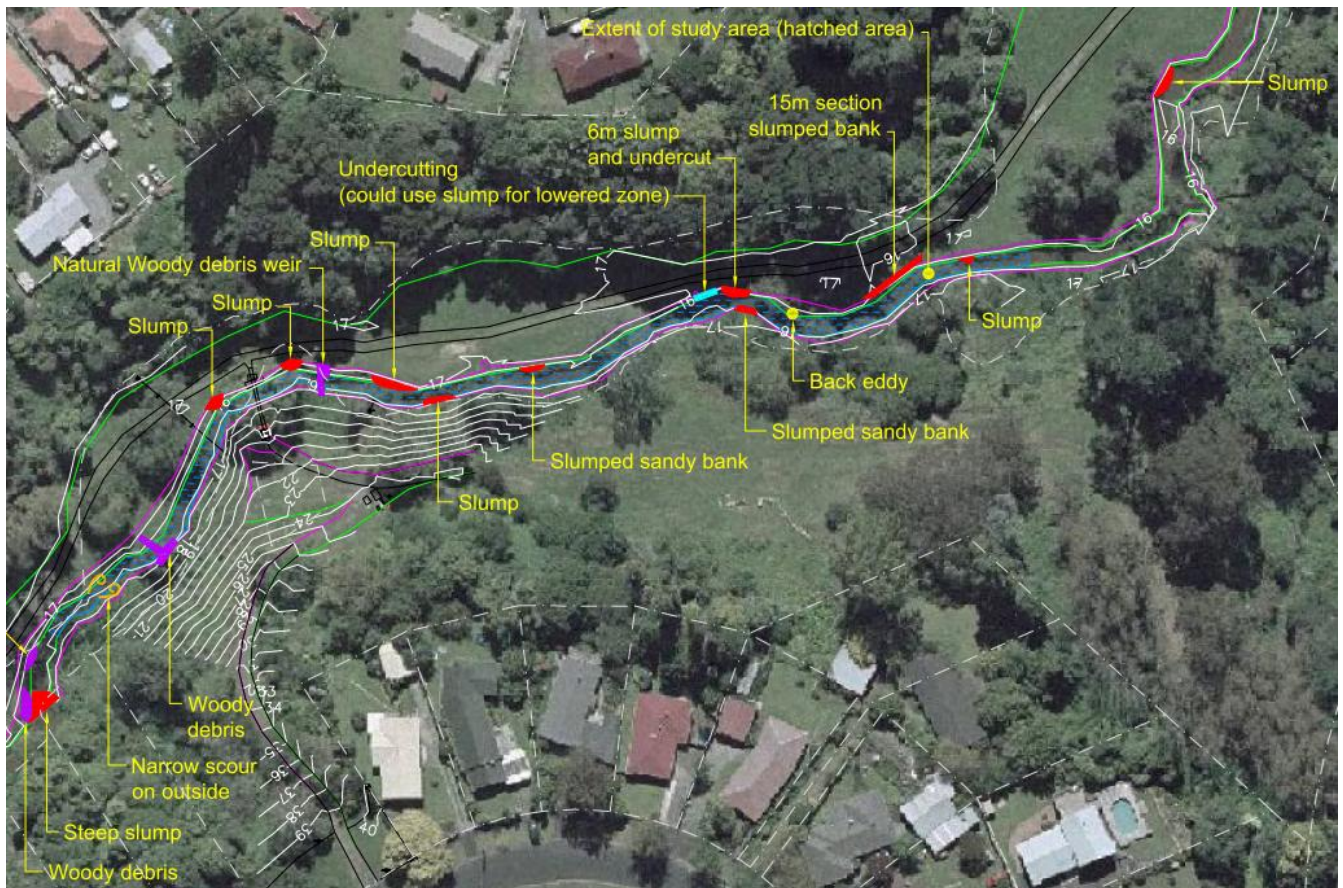
Site inspections have been conducted by T&T staff on a number of occasions since March 2008. The main channel of the Mangakotukutuku Stream running through Sandford Park is typically characterized by near vertical, vertical or over vertical banks with regular bank failures. In general, the stream channel has severe bank erosion and fine sediment build-up on the streambed. A number of bank erosion features were noted within the site and typically included slumping and bank undercutting. Slumping has occurred in various locations over the trial reach and is most likely caused by stream flows undermining the toe of the bank and/or stream bank undercutting. Stream bank undercutting was observed at the outside of a number of bends over the site reach and is most likely caused by increased velocities and turbulence that naturally occurs at the outside of bends.

Figure 5 shows an overview of the observed erosion and stream features within the site reach. No new erosion sites were noted between the first site inspection in March 2008 and October 2008. Subsequent clusters of inspections in late 2011 and late 2012 identified some new sites and noted significant worsening of other sites.

Bank undercutting at one site (BRO4) was originally identified as critical due to its proximity to an existing walking/maintenance track and between 2008 and 2013 had migrated some 3-5m closer to the track. Another site (BRO3) was also very close to the track but degradation of the bank appeared to be much slower.

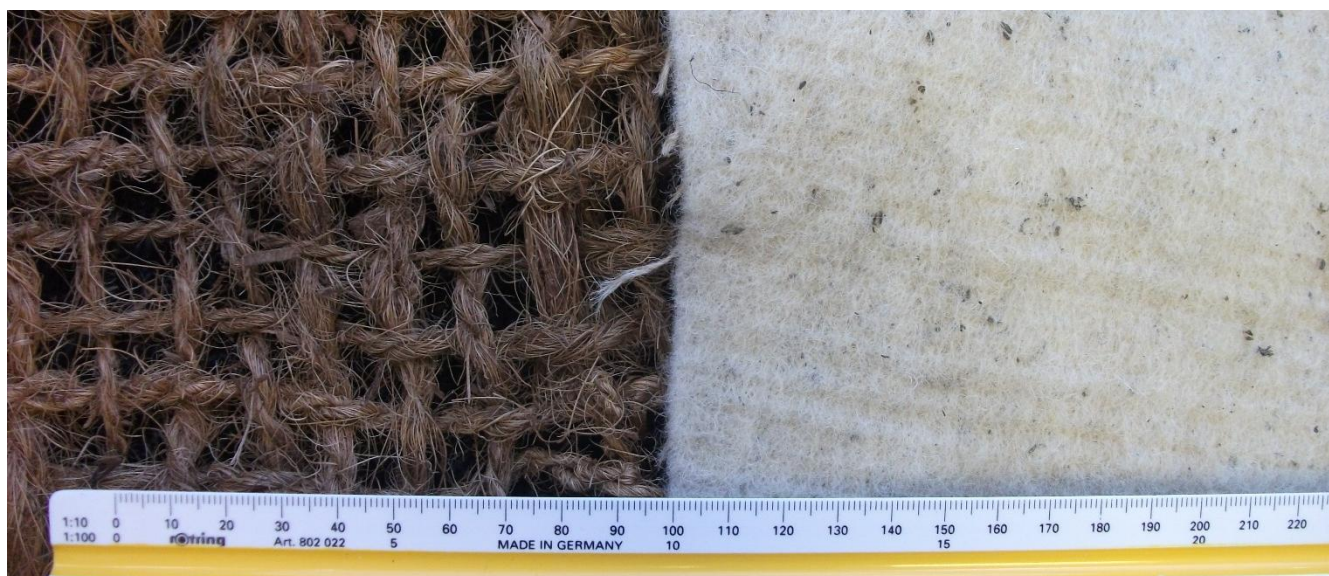
The product selected was a 900g/m^2 coir fibre coarse core (rope like), open weave (net like) product. However, immediately upon award of tender it became apparent that this type of product was not available in stock and, to avoid construction delays, a 450g/m^2 mixed coir fibre/wool fine core, closed weave product was substituted. Photograph 1 below shows samples of the selected and substituted products.

Photograph 1: 900g/m^2 coir fibre selected product (left) and the 450g/m^2 mixed coir fibre/wool substituted product (right).
