RESPONDING TO A 100 YEAR STORM – AN ACTUAL EXAMPLE IN AUCKLAND

Frank Tian, Barry Carter, Nick Brown, Dukessa Blackburn-Huettner and Mark Thomson – Auckland Council, New Zealand

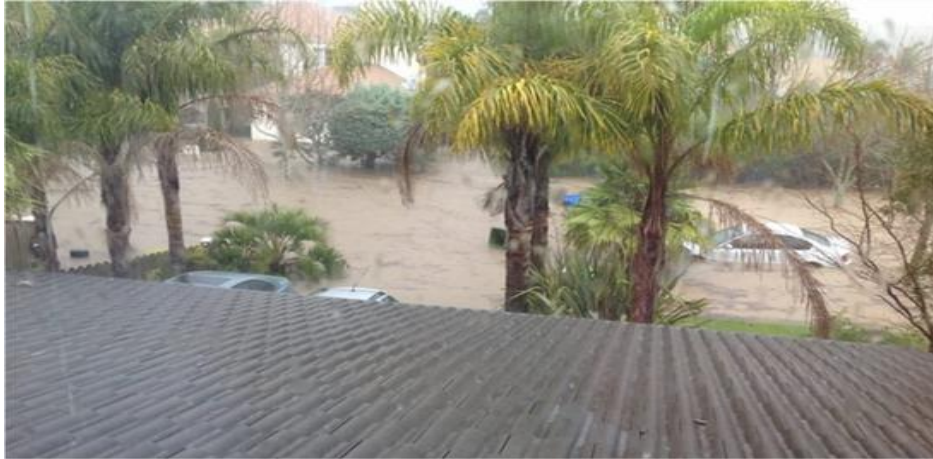
As this storm was a high-intensity, short-duration event, most flooded buildings and land areas were located in the upstream or middle area of the affected catchments. Building flooding and water ponding in streets was mainly due to blocked catchpits or inlet structures, exceedence of pipe capacity (this is an overdesign event) and building in an overland flow path, rather than increased water levels in streams. Figure 2 shows a flooded street in the Albany area.

Figure 2 A flooded street in the Albany area

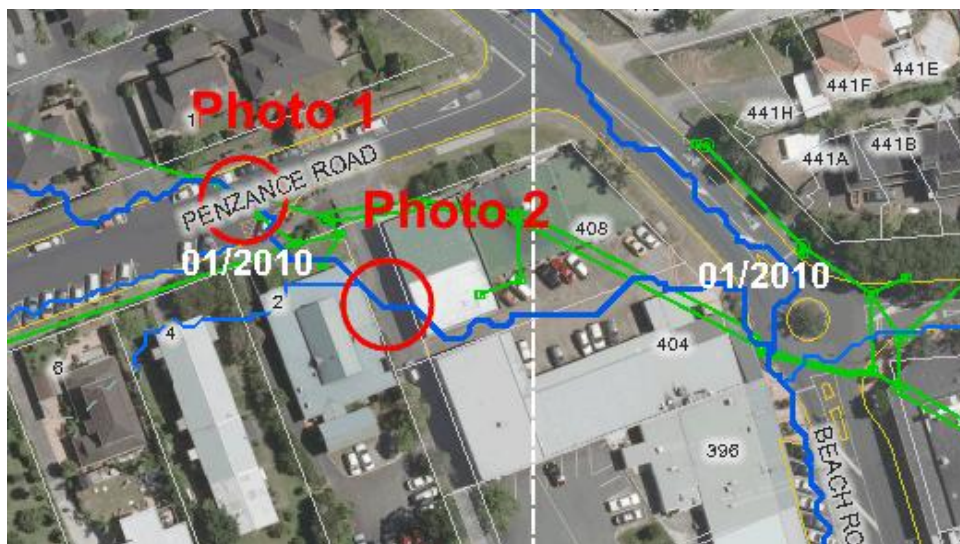
Modelling results indicate there is a significant overland flow path running through the Mairangi Bay town centre and a number of commercial buildings are very close to the modelled overland flow path. Photos taken during the heavy storm around this area verified the modelling results. Figure 3 shows the modelled overland flow path. The photos taken during the storm (see Figure 4) show the significant overland flow, which flooded three nearby commercial buildings and damaged a car, at two locations in the modelled overland flow path.

Figure 3 The modelled overland flow path around the Mairangi Bay town centre.

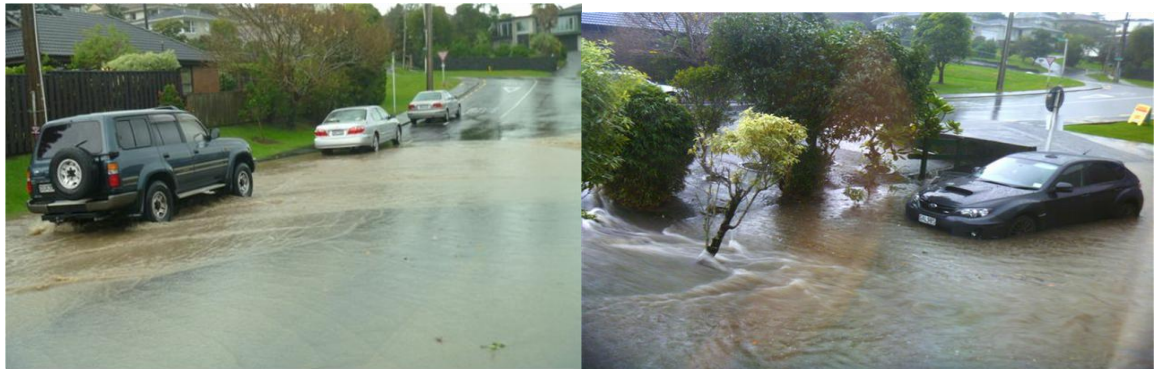
Further detailed investigation indicated that such a large volume of overland flow was formed due to:

- A. The short duration rainfall intensity in this area exceeding the design capacity of the twin downstream culverts (1500 mm and 1200 mm in diameter); and

- B. Two large water supply pipes (100 mm and 375 mm respectively), which ran through the big twin culverts (refer to Figure 5) and intercepted a large piece of timber, resulting in a significant proportion of the culverts being impeded.

Figure 4 Significant overland flows along the modelled overland flow path which flooded three nearby commercial buildings

Watercare has relocated the 100 mm pipe and is in the process of relocating the larger (375 mm) water supply pipe.

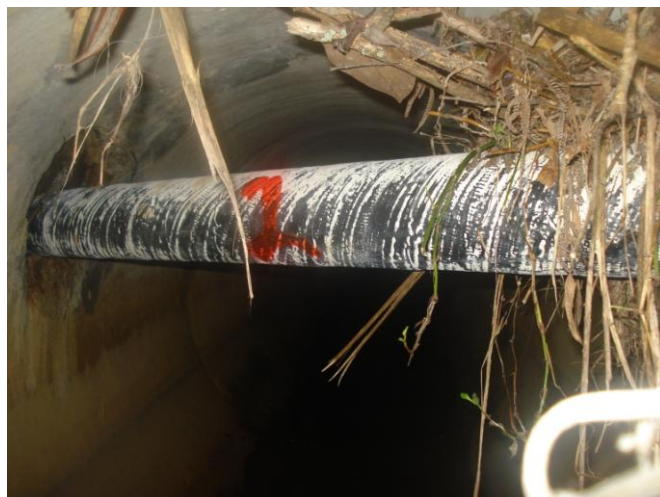
Figure 5 A large water supply pipe running through the big twin culverts

As discussed in Section 4.2, the two large water supply pipes running through the large, twin downstream culverts at Mairangi Bay, contributed to the significant overland flow which flooded three nearby commercial buildings and damaged a car. If the problem was identified and resolved proactively at an early stage, the overland flow might cause less damage. The Stormwater Operations Group is currently implementing an identification and inspection programme so that the critical assets, such as these twin culverts, can be identified, inspected and proactively maintained.

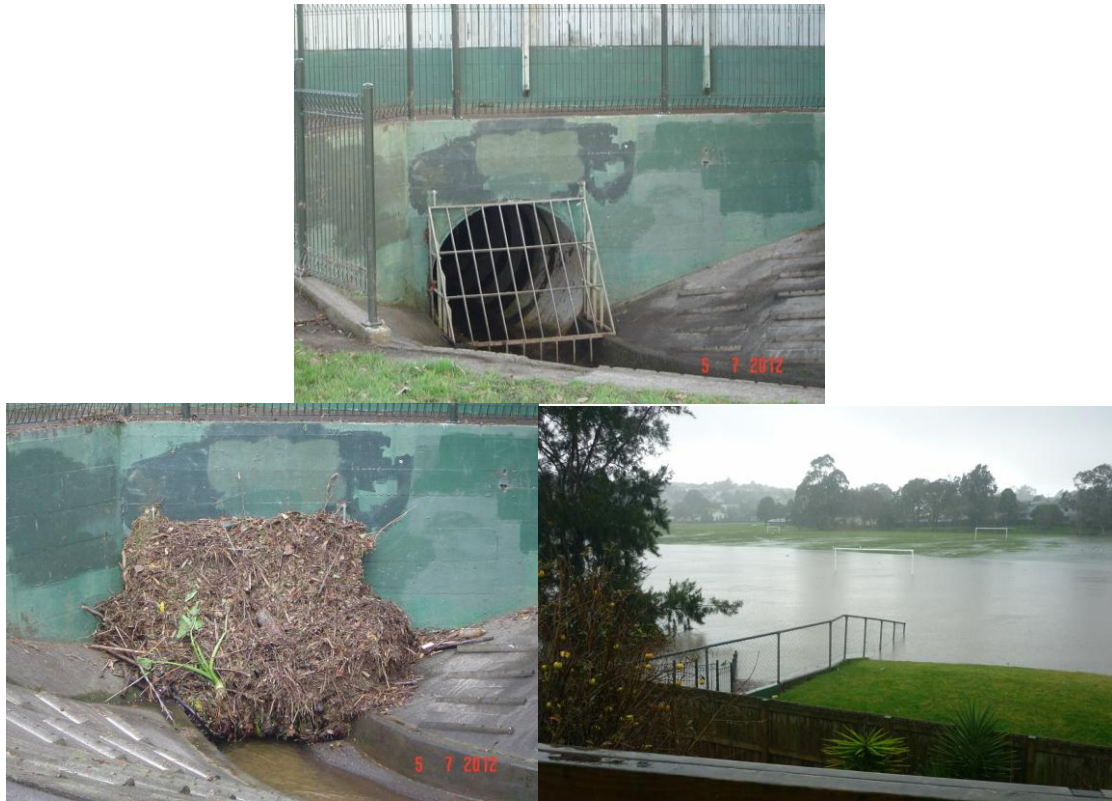
Due to historical reasons, many of Auckland's watercourses (natural streams or man-made channels) have been partially piped, resulting in many watercourses being of an open-piped-open-piped nature. Due to safety concerns, some inlets must be fitted with safety grilles to prevent children entering the downstream pipes. Blockage of some inlets, particularly those with safety grilles, is another major reason for flooding. Our field observations confirmed that not only are smaller inlets easily blocked, but that even larger inlets can be completely blocked. Figure 6 shows a blocked 1.8 m diameter inlet. Due to the blockage of this inlet the majority of a large recreational reserve was inundated.

Note that this inlet was fitted with a safety grille to prevent children entering the downstream pipes. The gap between each steel bar is approximately 180mm. Requests from local residents for Council to reduce the gap between steel bars have been received in the past. The safety issue for children, in relation to stormwater inlets is of serious concern to the Council. Unfortunately, it is not a simple issue and a balanced approach to resolving this problem is required. If the gap between steel bars is significantly reduced, the grille can be more easily blocked by debris. A blocked inlet may result in property flooding and popped manhole lids within the catchment which may expose the public to further hazards. Furthermore, a child falling into an open watercourse may be trapped in front of the grille by the force of water, even if the grille is not blocked. Considering these factors, we did not reduce the gap between the steel bars. Figure 6 shows that even with a wider gap a large inlet could still be entirely blocked, causing extensive upstream flooding.

Figure 6 A totally blocked 1.8 m diameter inlet and the flooded, large recreational reserve resulting from that blockage

- B. A balanced approach must be given to safety concerns raised by the public in relation to inlet grilles.
- C. Identification and publication of overland flow paths has proved to be a very useful tool. The relevant Council departments should pay adequate attention to a completed development site, particularly the vehicle crossing, landscaping and legal requirements regarding ground levels surrounding a house. This should include any development in, or adjacent to, a very minor overland flow path with a contribution catchment of only several hundred square meters (based on on-site visual assessment), although a resource consent is not required for such a development under the current district plan rules.

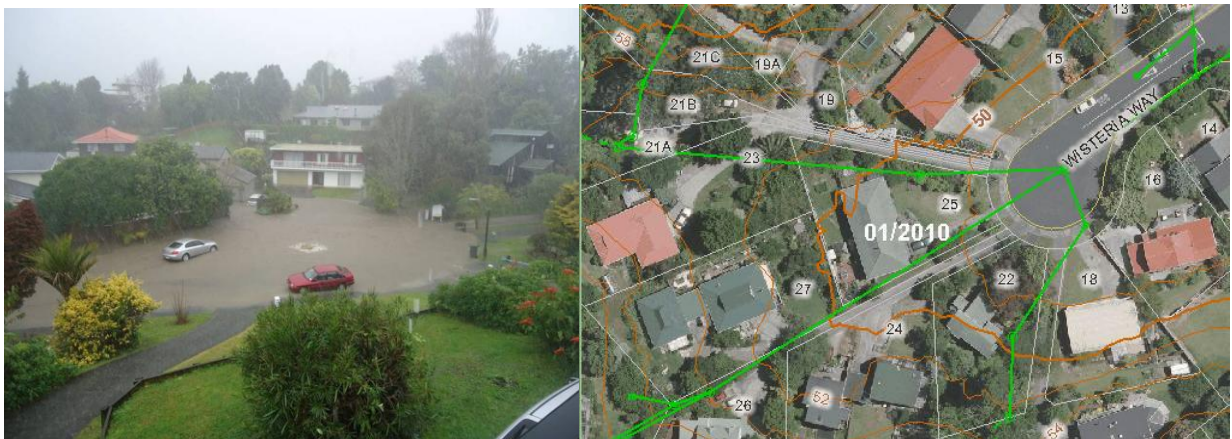
Aside from the capacity problem of the downstream pipes, we also observed the following phenomenon. Figure 7A shows a popped manhole in the middle of a flooded cul de sac. This manhole popped again on 3 September 2012 when a two year short-duration storm hit the northern Auckland region. The outgoing pipe was renewed several years ago, with the designed pipe capacity higher than 5 years. CCTV inspection also indicated that there was no blockage in the downstream pipe.

Why did this manhole pop twice? Further investigation revealed that this is a standard size manhole (1050 mm in diameter) which receives runoff from three, 300 mm diameter steeply graded pipes (Figure 7B). Fast flows from the three steep pipes result in strong turbulence in the manhole and in water levels rising in the manhole. Figure 8 shows another popped manhole which has seven incoming pipes and one outgoing pipe.

Figure 7 (A) A popped manhole in the middle of a flooded cul de sac; and (B) the incoming and outgoing pipes to and from this manhole

- A. The Infrastructure Design Manual should be modified so that we can avoid the installation of manholes with multiple steep incoming pipes. In cases where multiple inlet pipes cannot be avoided, the following factors should be carefully considered to minimise the probability of manhole lid popping: the diameter of the manhole riser, diameter and inlet form of the downstream pipe and the angles between inlet and outgoing pipes.

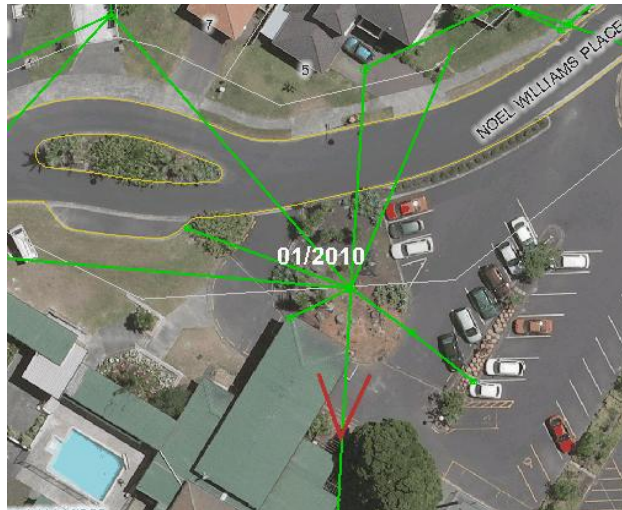
Figure 8 A popped manhole which has seven incoming pipes
