# RESTORATION OF STORMWATER INFILTRATION BASIN PERFORMANCE

*Richard Brunton and Andrew Brough (Pattle Delamore Partners Ltd)*

## ABSTRACT

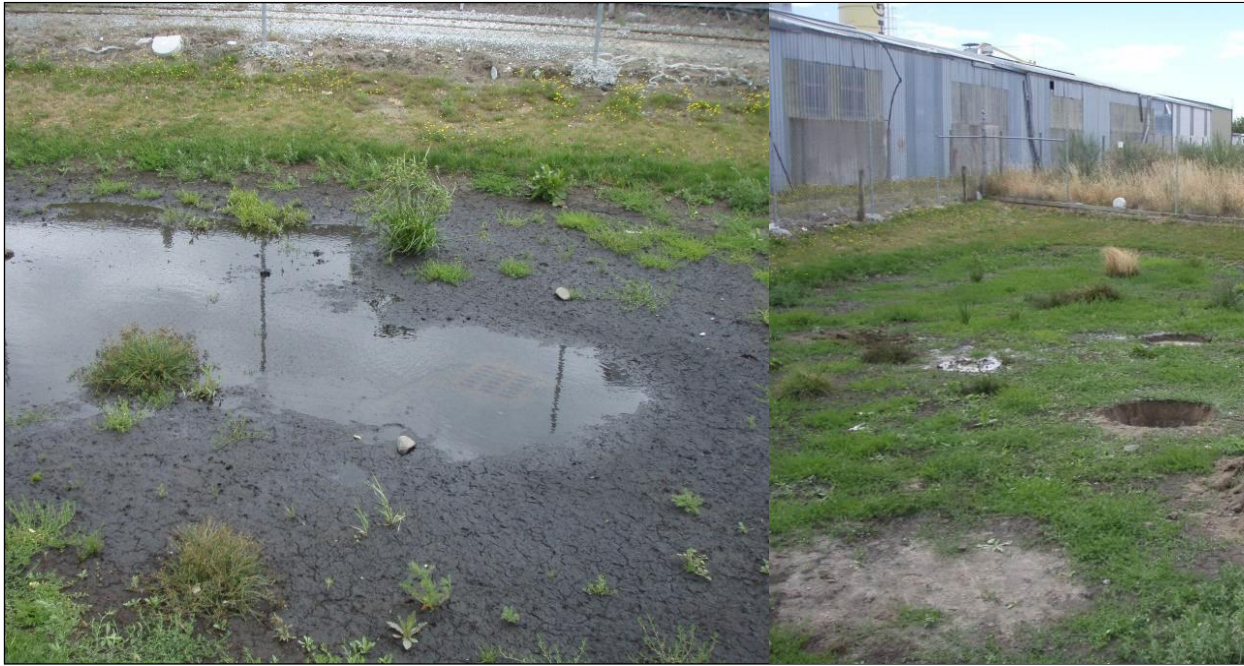
In the subsequent months following the replacement of the media reduced infiltration capacity was observed within the basin. Significant ponding for long periods of time after a storm event was observed followed by grass die off. Figure 2 shows the basin approximately 6 months after the earthquake. The reduced infiltration rates did not comply with the conditions of the stormwater discharge consent and therefore remedial action was required.

*Figure 2: Infiltration basin after topsoil replaced*

Aeration was initially carried out within the media as it was suspected that the media that was re-laid immediately after the earthquake may have been over compacted. In this case soil aeration was considered to be a significantly cheaper option than replacing the media layer. In this case a turf aerator for sports fields was considered suitable. Figure 3 shows a photograph of a similar aerator.

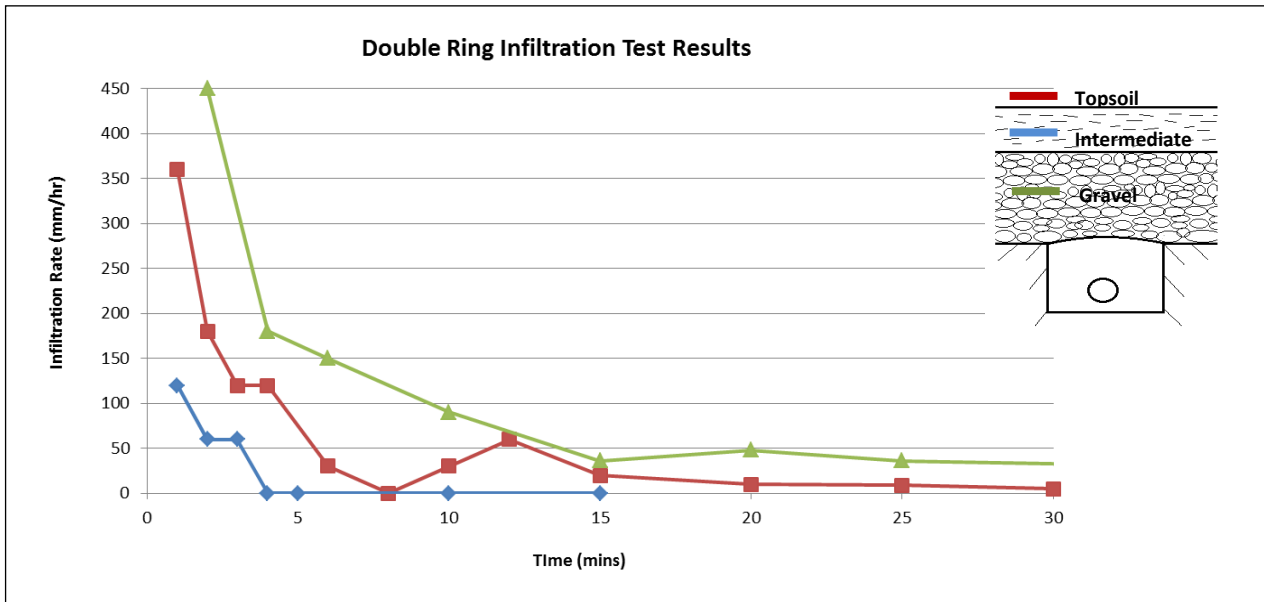
Figure 4: Double ring infiltrometer test results

Initial rates during the tests indicated that the infiltration rate was high at the topsoil layer at around 60 – 120 mm/hr. However once the ultimate infiltration rate was reached it was noted that the topsoil rate was very low (around 10 mm/hr). The intermediate test indicated similar results with initially good rates decreasing to very low rates within a short amount of time. The final test involved removing all topsoil and testing the rate of the underlying river-run gravel. The results showed that the ultimate rate of the gravel was around 30 mm/hr which is considered very low. The river-run gravel used at this site was expected to have a soakage rate of between 500 – 1000 mm/hr.

During the site investigation a test pit was also dug down to the underdrainage system. The gravel within the drainage trench and geotextile material was confirmed to be in good condition. It was noted during this test pit that there was a strong odor coming from the test pit. It was concluded that the underlying gravel layer had very low soakage capacity. Possible causes for this could include:

- Blocking of gravel pore space by spilled liquids during earthquake, (milk?)
- Compaction of gravel layer from earthquake shaking,
- Compaction of gravel during the first replacement of topsoil layer,
- Combination of all factors.

Based on the site investigation it was decided that the basin gravels would need to be replaced. The following remediation strategy was adopted:

- Excavate materials down to under drainage layer to [spoil],?
- Flush underdrainage lines to ensure that the underdrainage was not blocked,
- Relay clean river-run gravels,
- Relay infiltration media,
- Hydroseed.

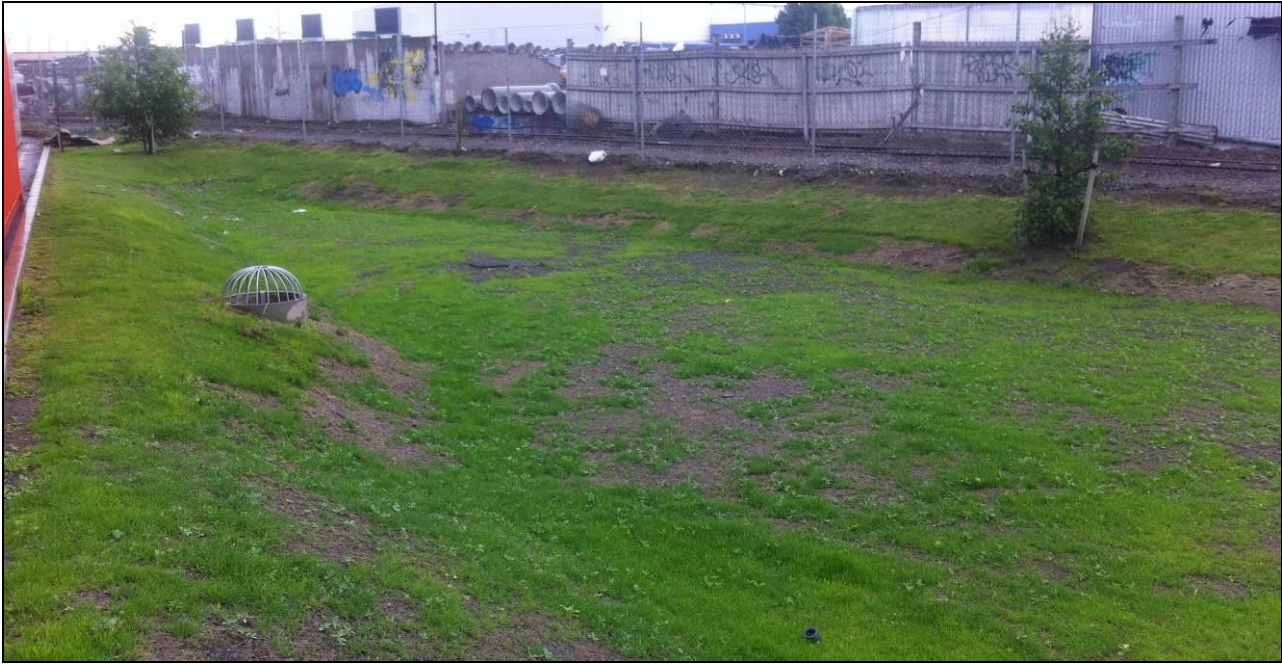
*Figure 6: Infiltration basin 1 month after remediation*

Infiltration testing using double ring infiltrometer has confirmed the basin is now operating as expected with an average infiltration rate of around 47 mm/hr. Healthy grass growth was more difficult to achieve because the basin was in active use during the hydroseeding and grass growing period. This emphasises the importance of establishing healthy grass cover before a basin is commissioned. The basin is now compliant with regional council consent conditions. Figure 6 shows the basin around one month after remediation. The photo shows non-uniform grass cover after hydroseeding as a result of discharges into the basin during the growth period. Infiltration testing was carried out a further one month after the photo was taken once further grass cover was established.

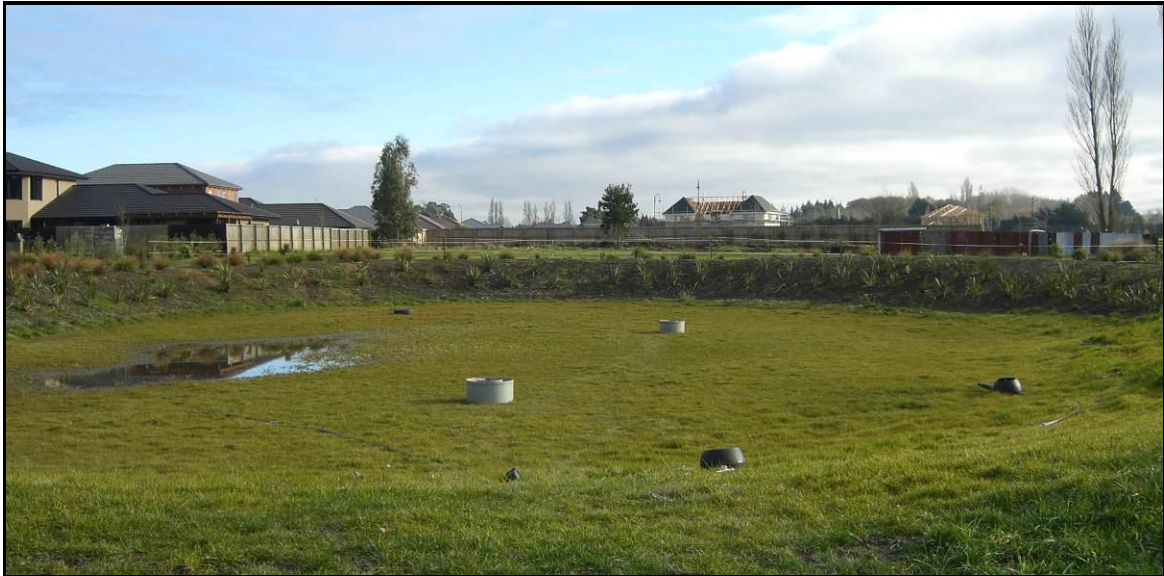
After the aeration double ring infiltrometer testing was carried out. The infiltration testing results showed that the infiltration rate was still very poor at less than 2 mm/hr. During the test it was noted that the basin had water ponded over an area of the basin, as shown in Figure 7, which indicates that there is very poor infiltration in that area.

*Figure 7: Basin after installation of trench*

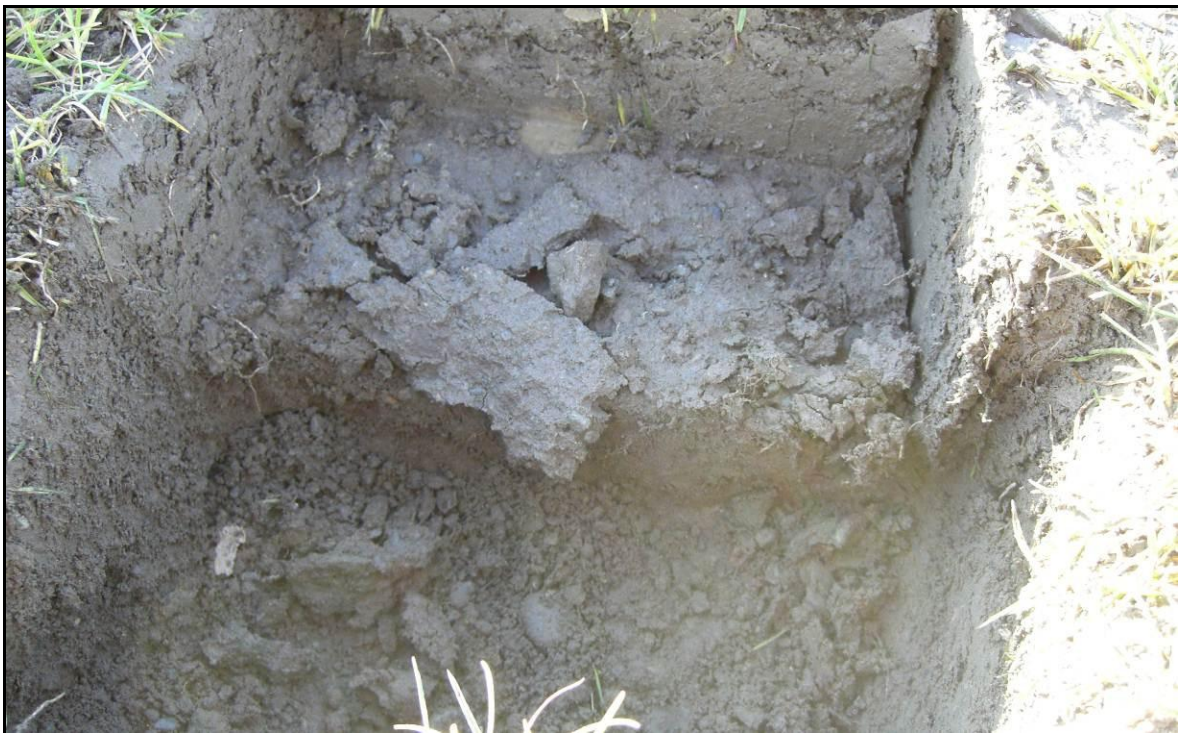
Due to the low infiltration rate further test pits were dug to see if there was any obvious reason for the poor infiltration rates. As shown in Figure 8, the test holes were characterised as having 100 mm of loose sandy loam over approximately 50 mm of tight sandy loam on loose sandy gravel. It was evident from the test holes that the tight layer was the reason for the poor infiltration rate.

*Figure 8: Basin topsoil profile*

It would appear from the test holes that the initial aeration of the topsoil did not penetrate the whole media layer, leaving a small depth, but significant layer, which water failed to penetrate. A second attempt at aeration was carried out ensuring that the depth of the aerator was set below the tight layer. This ensured that the tight layer was broken up and aerated.

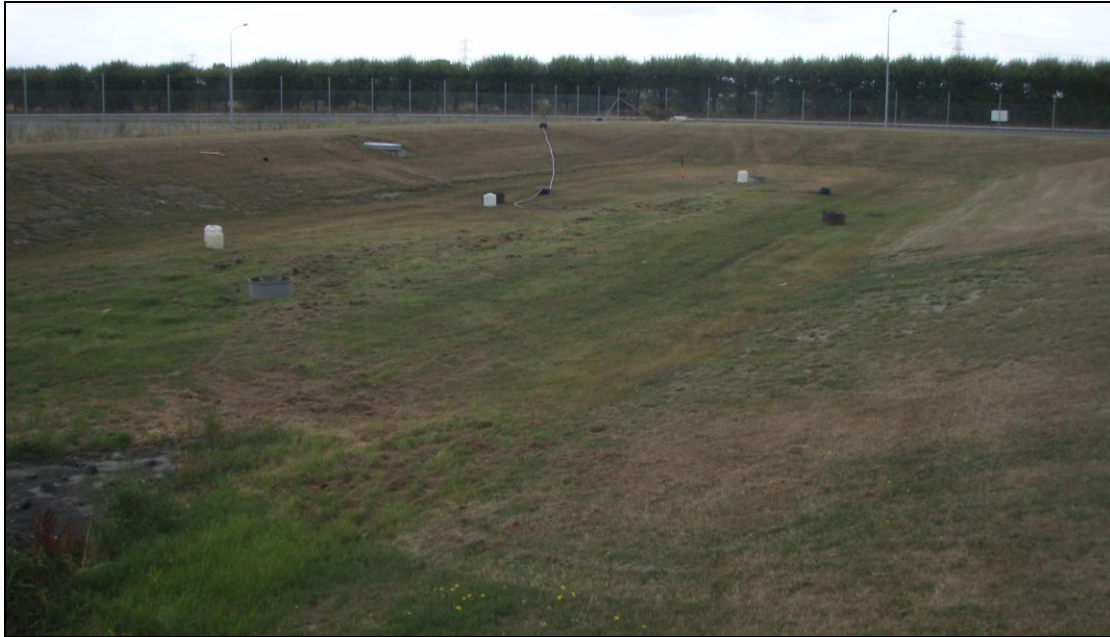
an average these rates were considered acceptable and complaint under the regional council consent. During the infiltration basin test observations were noted that sediment buildup was apparent at the basin inlets. Figure 10 taken in 2008 shows the beginnings of grass die off at the basin inlet due to sediment deposition.

*Figure 10: Double ring basin test after aeration*

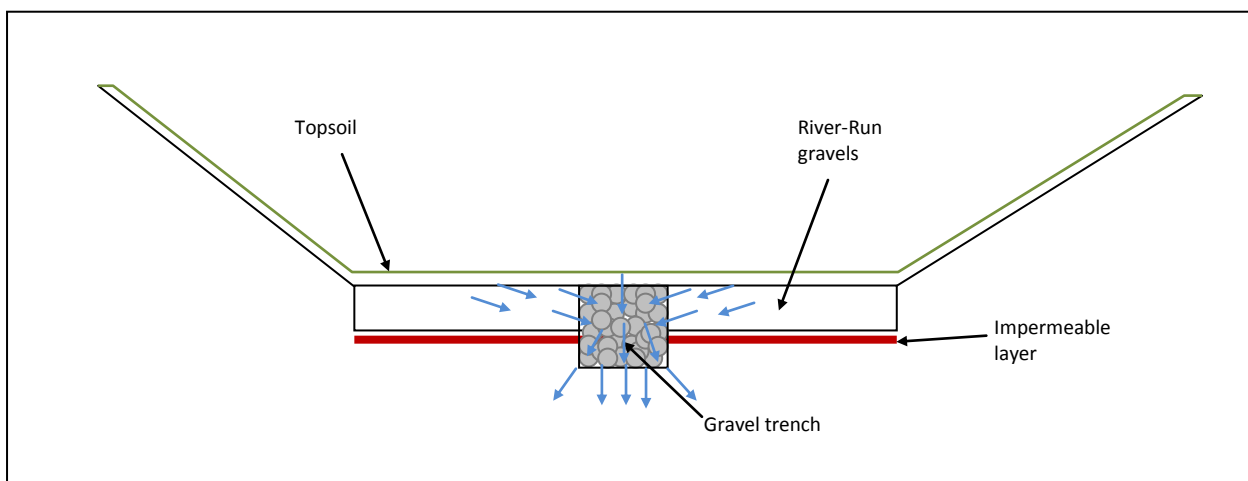
Following the aeration of the topsoil layer the basin condition continued to deteriorate in the form of grass die off and water ponding. During testing, the topsoil rates were shown to be sufficient and therefore it was assumed that water was unable to pass below the topsoil layer during large rainfall events. The mostly likely cause of this blockage is the presence of a low permeability layer immediately below the bottom of the river-run gravel layer.

*Figure 11: Cross section of gravel trench*

In order to get water past this low permeability layer into the more free draining strata a gravel trench was installed in the middle of the basin that extended down further into the natural gravels. Figure 11 shows a conceptual sketch of how the gravel trench would provide a better flow path of treated water into free draining strata.

The installation of the gravel trench alleviated the water ponding issue within the basin.

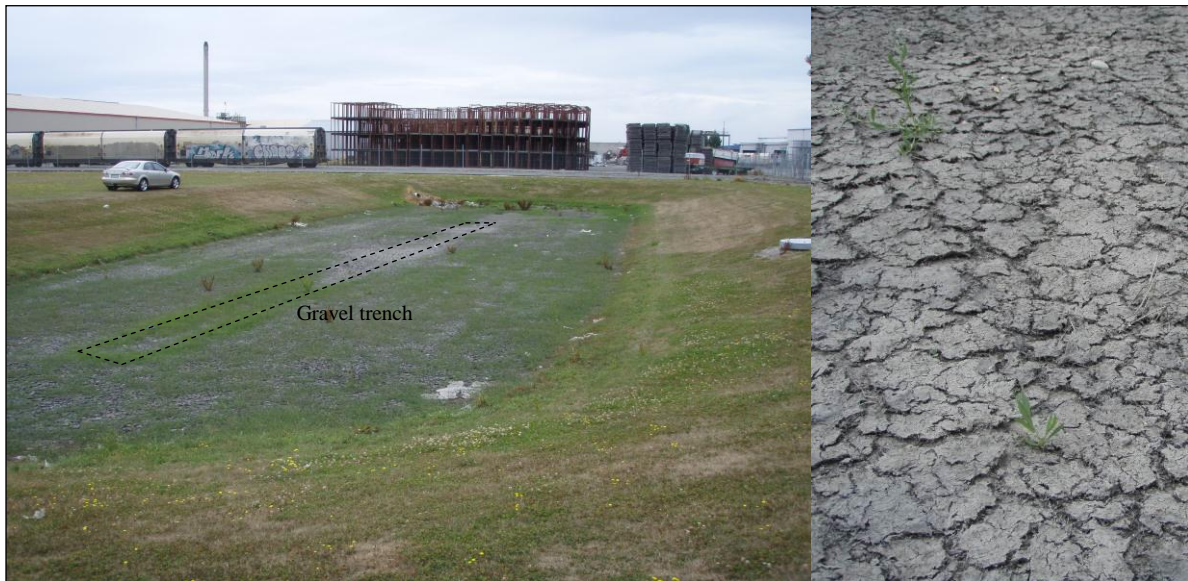
Once the gravel trench was installed grass die off around the basin inlets continued to be an on-going issue. Caking of the grass was also noted as shown in Figure 12. It was determined that this caking was caused by sediments entering the basin from the catchment. These sediments were mainly particles of grains and other organic material from the feed mill processing operation and sediments from trucks and vehicles. To reduce the amount of sediments conveyed into the basin the stormwater sump maintenance frequency was changed to monthly cleaning instead of the previous three monthly. This allowed the sediment containment volume within the stormwater sumps to be cleaned out more frequently and reduce amount of sediment entering the basin.

*Figure 12: Basin after installation of trench*

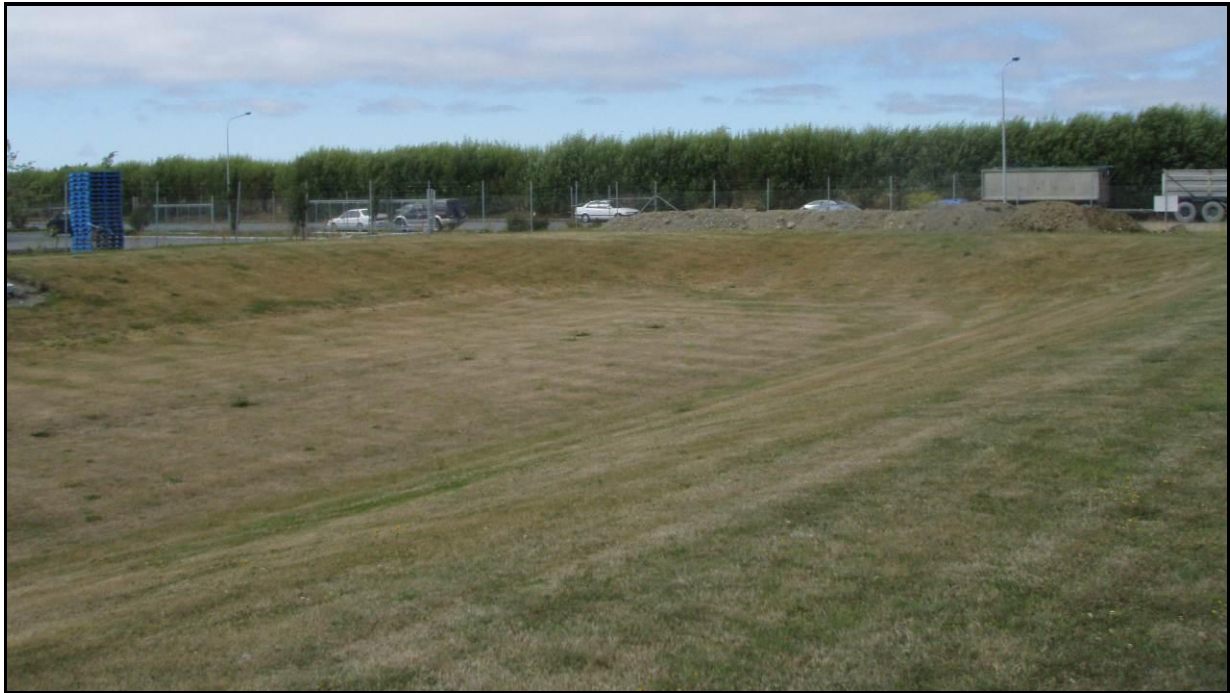
The basin is now performing as expected and adheres to regional council consent requirements. The installation of the gravel trench and increasing the frequency of stormwater sump maintenance has greatly reduced grass die off and caking within the basin. Figure 13 shows the basin condition after remediation works.

*Figure 13: Recent photo of basin*
