# CHRISTCHURCH CITY WASTEWATER INFRASTRUCTURE – RESPONSE ASSESSMENTS AND REPAIR TECHNIQUES

*H.M. Blake-Manson, City Care Limited, Christchurch New Zealand. A. Lindgren, Aurecon Limited Christchurch New Zealand. B. Ewing, Christchurch City Council, Christchurch New Zealand*

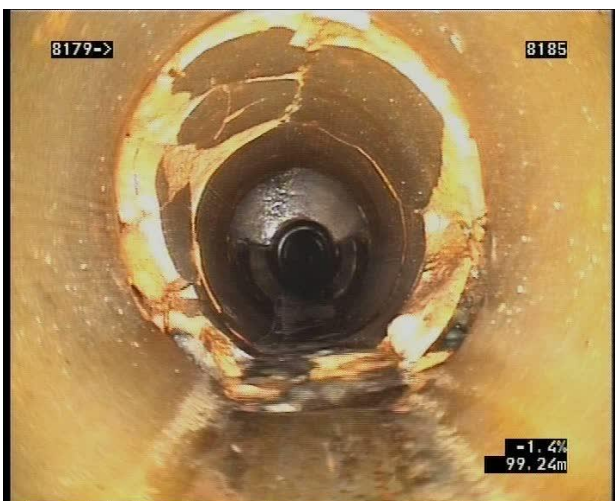
*Photograph 1: Locations where CIPP patches would be applied*

A. Lyttelton St, 150mm EW, depth 1.7 m

CIPP lining (lengths and patches) was generally undertaken on a timeliness-cost effectiveness basis. Patch lining was utilised in wastewater mains at considerable depth e.g. greater than or equal to two metres where dig and lay would require considerable dewatering, shields/sheet piling, and traffic management. Patches were also utilised in locations where breaks have been located in close proximity to buildings. In these circumstances, dig and lay would prove difficult and could result in building damage. Examples of some locations where patches have been utilised are provided in Photograph 1.

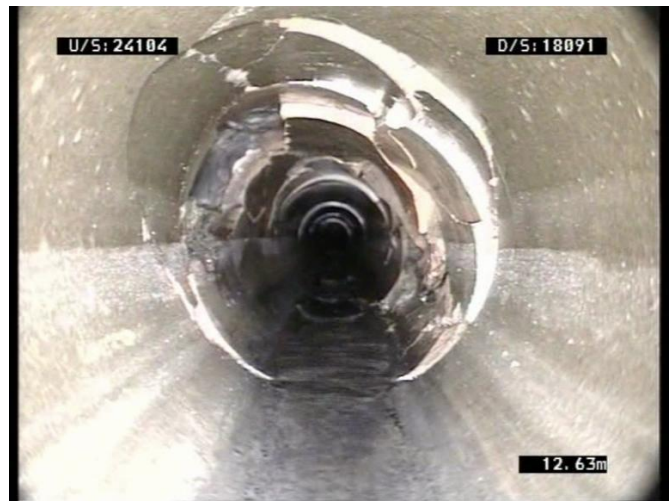
B. Buckleys Rd, 150mm EW, depth 1.8 m

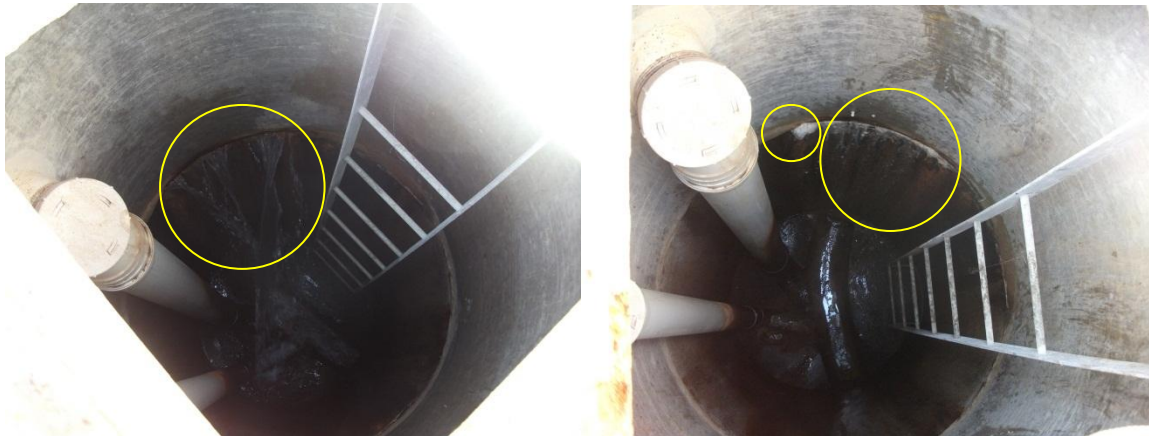
*Photograph 2: Polyurethane Resin Injection In Manholes*

A: Manhole before leak repair (circle)

B: Manhole after leak repair – small circle (further work required – large circle)

The method was quick enough to allow several leak repairs in a day, it also causes minimal disruption to property owners being a trenchless pipe repair technology. A similar methodology was also utilised to seal infiltration between manhole risers – Photograph 2.
