CARTWRIGHT ROAD EMERGENCY STORMWATER WORKS

Dean Watts, Chayne Zinsli, Jayesh Solanki, Matt Hall

ABSTRACT (200 WORDS MAXIMUM)

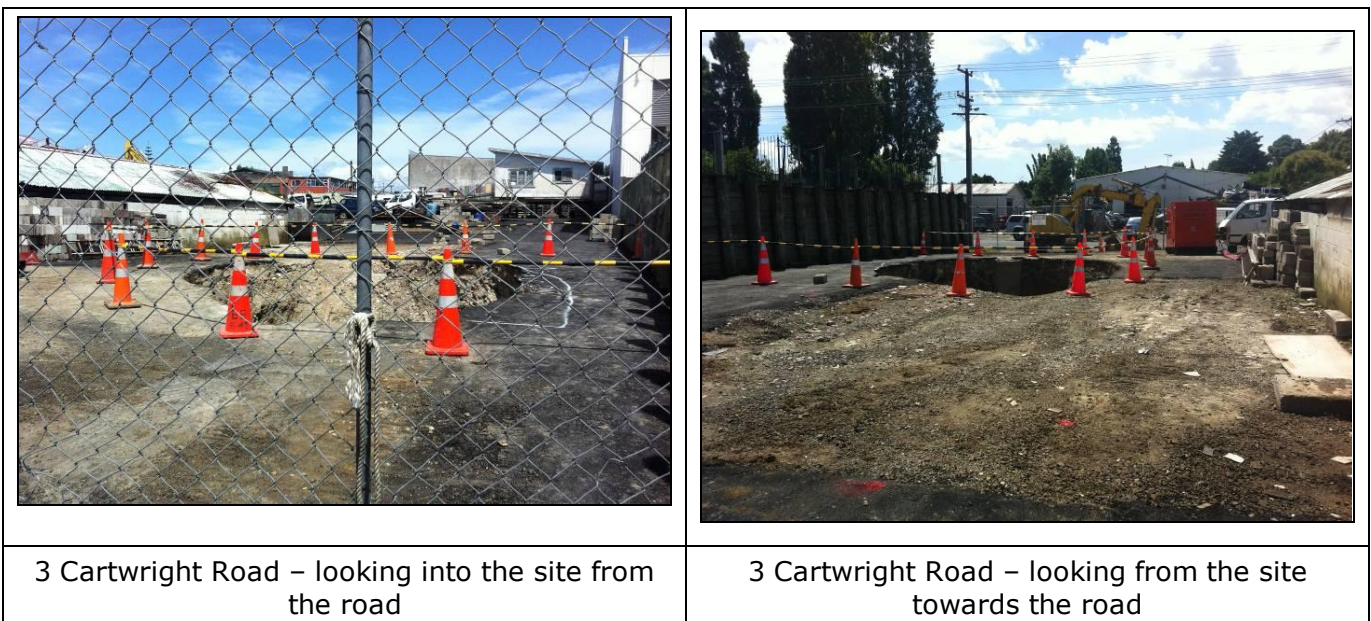
Photograph 1: Sinkhole formed within 3 Cartwright Road

A cordon was set up around the ground void and access to the site was restricted to authorised personnel only. An inspection of the sinkhole revealed that stormwater was flowing out of the "ARMCO" pipe through a section of approximately 6 m of bare ground, where the failed section of pipe had been, and into the concrete pipe downstream. The waters flowing over the section of exposed ground raised the risk of further erosion and the sinkhole being enlarged.

Large trench shields were used to shore the sides and the base of the ground void and to provide a conduit for the stormwater to flow through.

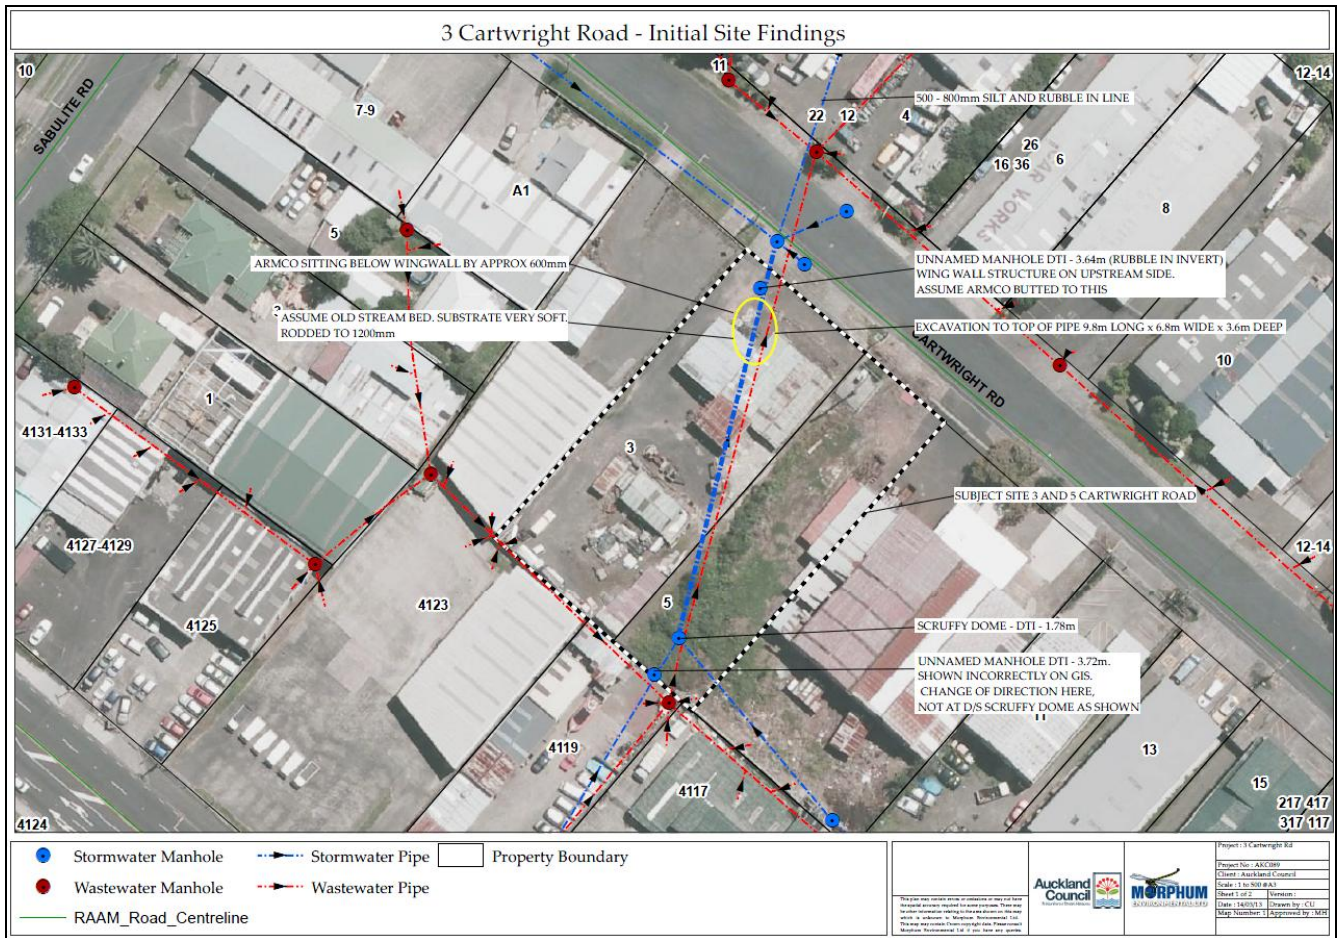
Figure 1: Plan showing initial site findings

The Wairau Creek enters the publicly owned stormwater network through an inlet at 4116 Great North Road. This leads to a 1680 mm diameter concrete pipe that runs beneath Great North Road and through to the subject site. Inside the subject site was a section of "ARMCO" pipe that connected to a manufactured bend within 5 Cartwright Road (upstream) and a manhole in the north eastern corner of 3 Cartwright Road (downstream). It appears that the downstream connection was to a historic inlet structure. From this point the pipe construction reverts to a 1680 mm concrete pipe that flows to the outlet within 4 Cartwright Road. Refer to figure 1.

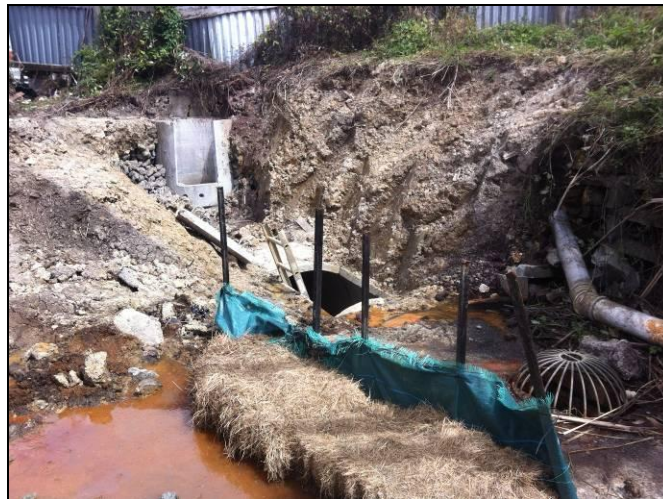
As the stormwater pipe was severally constricted, the upstream line was unearthed and a relief point cut into the pipe to allow any back water to exit the network at this point and follow the newly created overland flow path (Photograph 3).

Photograph 3: Clearance of overland flow path and relief points cut into SW network

Work was undertaken to remove these obstructions; in the case of perimeter fencing care was required to maintain the security of the properties. In some instances wire fences were cut and then tied back in place with low strength wire. This ensured that the fence would give way if pressure from overland flow built up.

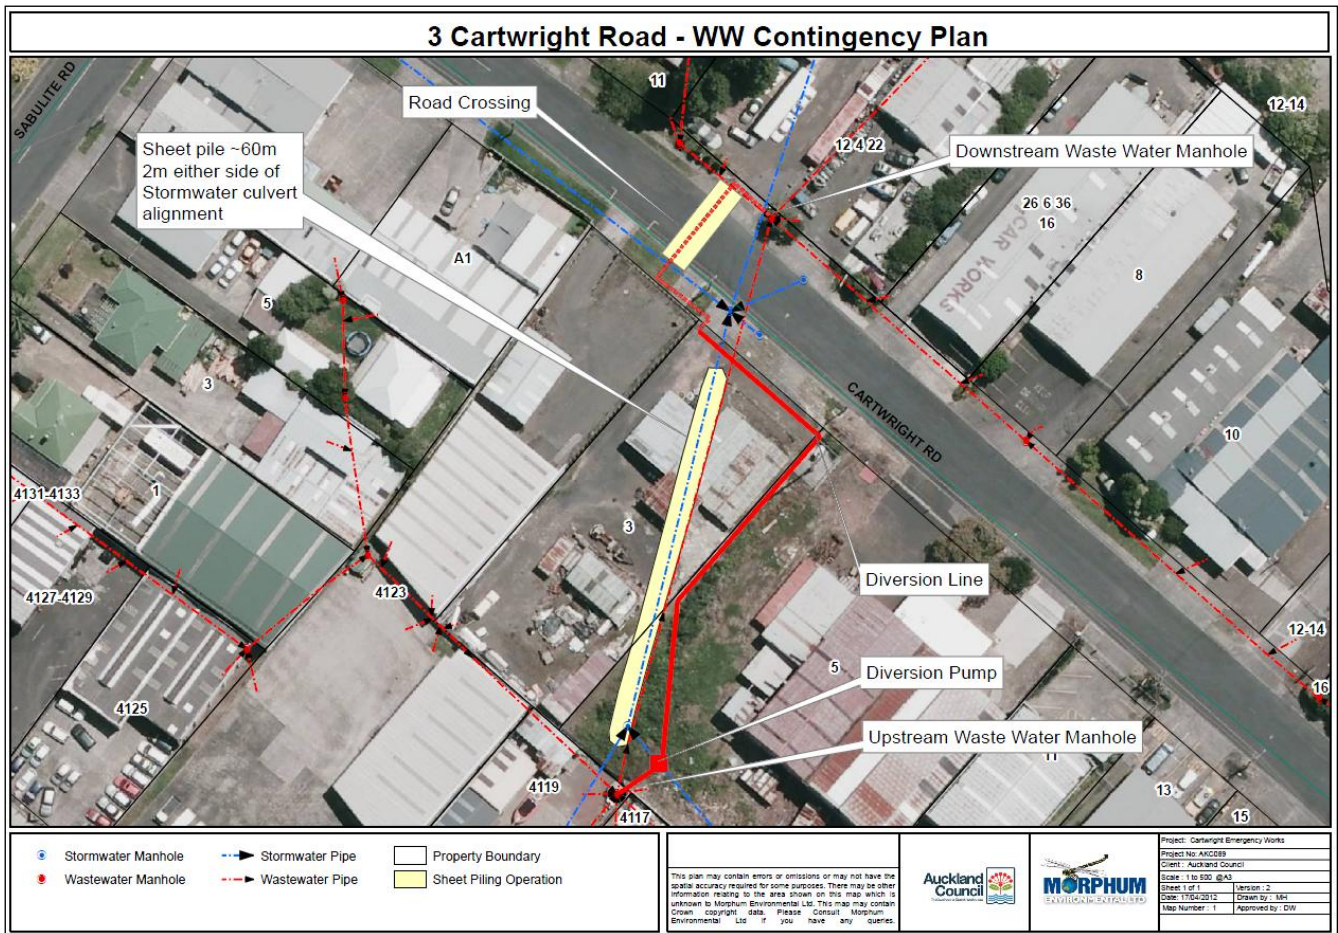
Given the high probability the asbestos cement wastewater line would likely crack or burst when disturbed, the risk of a wastewater overflow was unacceptably high. A number of mitigation measures were developed and options included:

Figure 2: Wastewater diversion plan

Options 3 was considered the most appropriate solution given the time constraints. The contingency plan was developed further and implemented on site so that works to restore stormwater conveyance could continue (Figure 2). Once consent from Watercare Services was granted contractors were engaged to install a Cured In Place Pipe (CIPP) liner through the length of the wastewater line and sheet piling works were started.

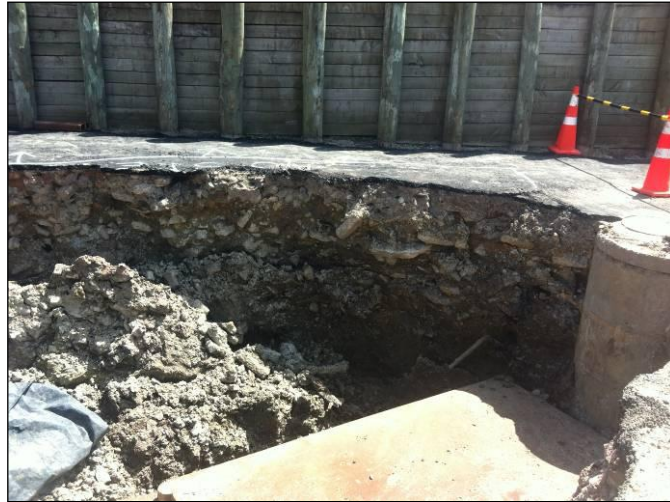
These investigations showed that the pipe was indeed in the existing stream bed and that this was saturated and very weak at the downstream end of the alignment. The upstream end of the alignment was similar however, the stiffer East Coast Bays formation was a lot closer to the surface. The entire alignment of the pipe was overlain with uncontrolled fill comprising soil, clay, bricks, concrete blocks and organic material (Photograph 2). Groundwater was near the surface and standing water in the boreholes had a sheen indicating the possible presence of petrochemicals in the fill material.

Photograph 2: Photo showing uncontrolled fill within 3 Cartwright Road

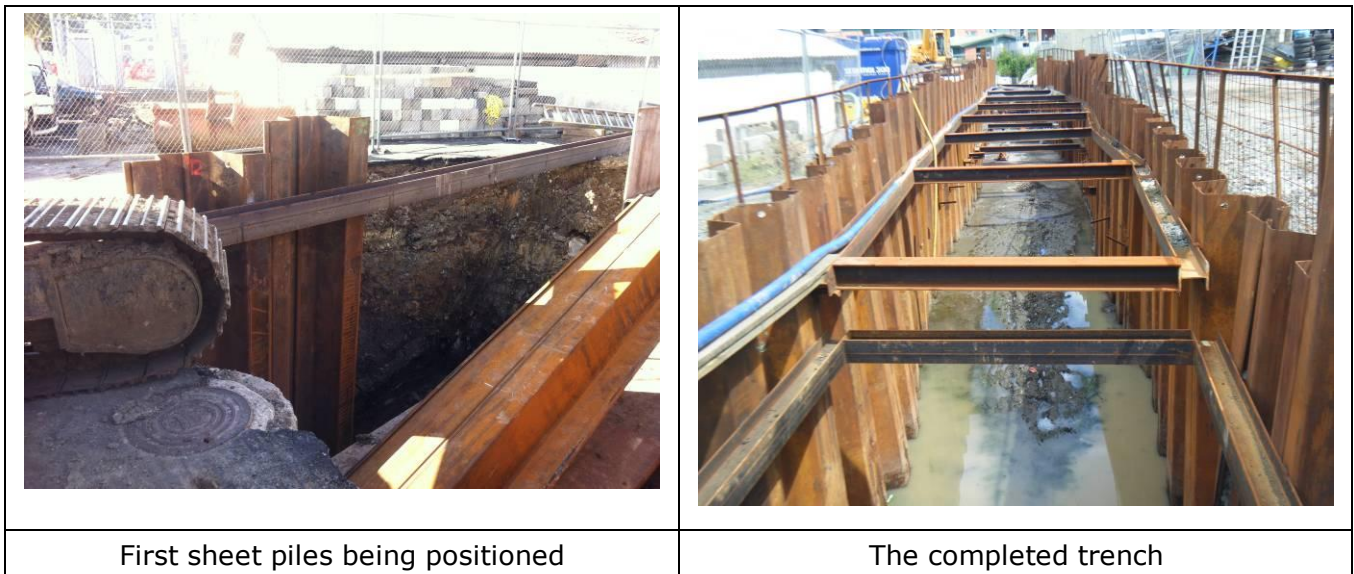
Photograph 4: Excavated trench showing sheet pile shoring

The investigations showed that the removal of the pipe would require the trench to be shored or benched. Given the proximity of the alignment to the retaining wall at the boundary of 1 & 3 Cartwright Road, benching the trench was not a viable option. Sheet piling of the trench was recommended.

An unreinforced concrete base of 150 mm was specified to be poured to form the toe of the sheet piled excavation and provide a surface for stormwater to flow across prior to a new pipe being installed.
