# AN EARTHQUAKE AND RECOVERY OF A STORMWATER SYSTEM

*K D Simpson, Waimakariri District Council*

## ABSTRACT

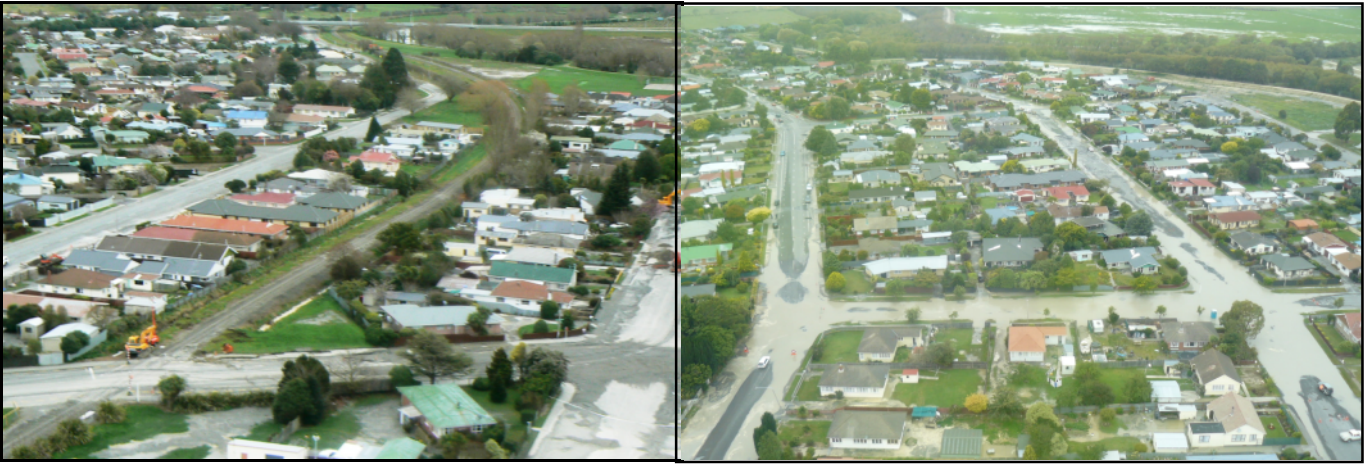
Liquefaction was widespread in some areas (refer Photographs 1 & 2) and resulted in siltation of pipes, open drains and basins. Some sections of pipework were so heavily silted that the material had effectively set in the pipework, with one 300 metre section of 450mm pipe in particular taking approximately 4 days to remove the silt using high pressure jetting.

*Photographs 1 & 2– Liquefaction in Kaiapoi west (left) and Kaiapoi east (right)*

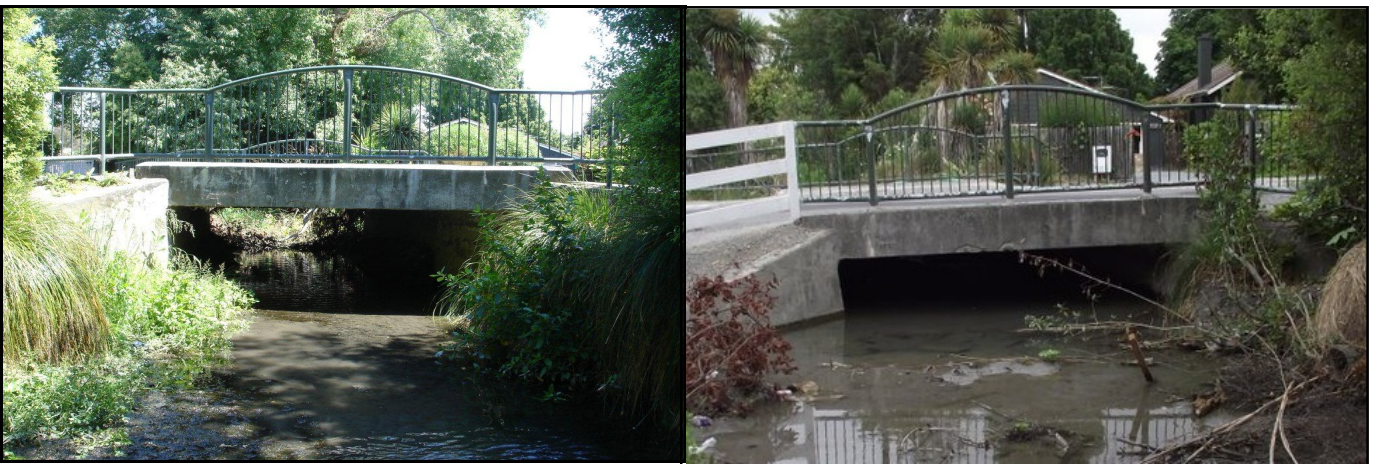
Sections of open drains had to be excavated to remove silt and restore the flow capacity. Some sections required excavation on numerous occasions following aftershocks and also weeks or months later once the silt in the upstream system had worked its way into the lower reaches of the system.

*Photographs 2 & 3– Hilton Street Culvert (downstream view), pre-earthquake (left) water level approximately 1100mm below soffit and post-earthquake (right) water level approximately 600mm below soffit*

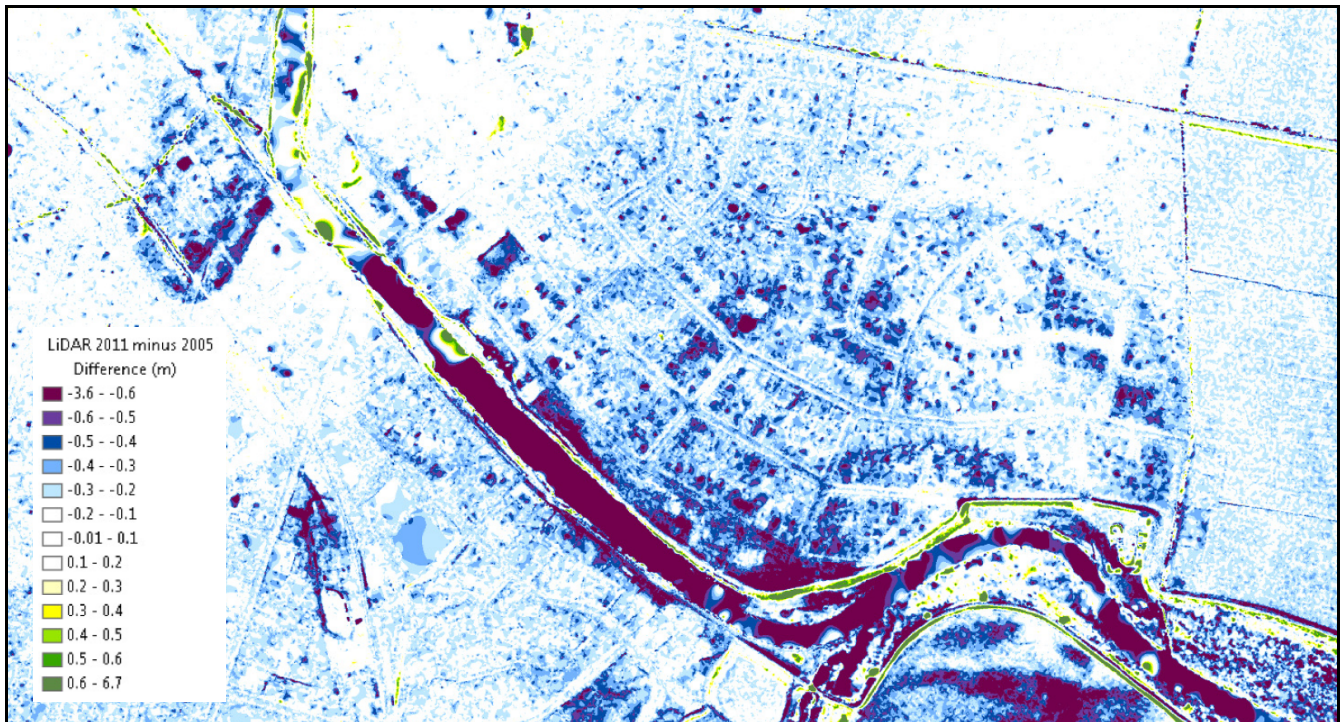
There was a high degree of correlation between the areas of lateral spread and damaged stormwater infrastructure. Figure 1 below shows the area of ground movement, which was derived from comparing pre-earthquake 2005 LiDAR data to post earthquake LiDAR data flown immediately after the September earthquake. In the figure the Kaiapoi River can be seen, the purple corridor through the middle of the figure, and two distinct horse shoe type curves where lateral spread had occurred. These areas may be old alignments of watercourses.

Figure 1: Comparison of pre and post earthquake LiDAR data.

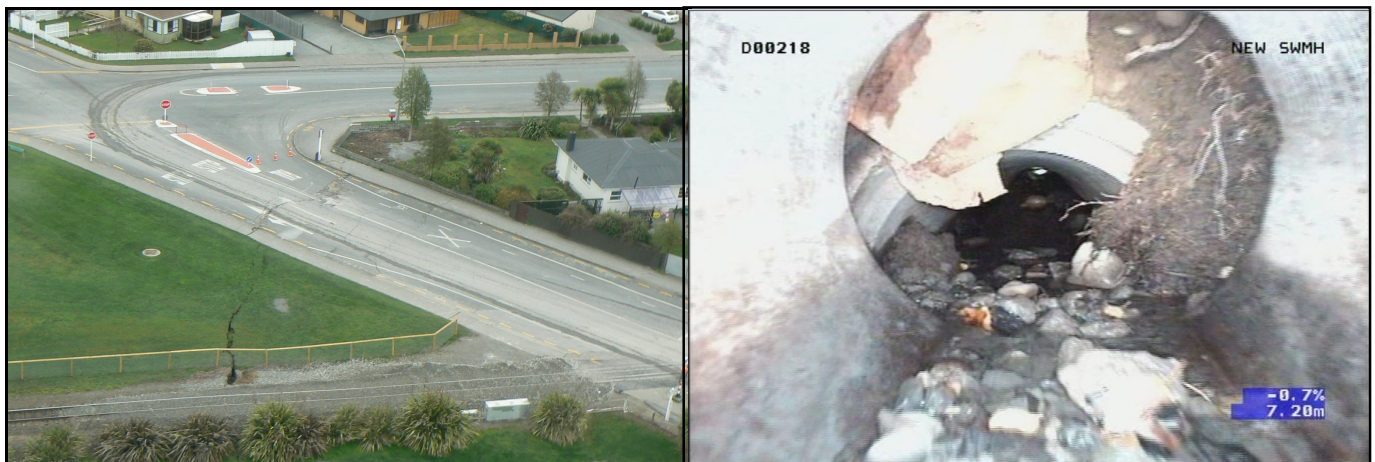
The damage at the interface of land movement was evident in several locations. An example, shown in Photographs 4 & 5 below at the extent of the lateral spread in Kaiapoi west. A section of 450mm diameter pipe had been pulled apart and displaced downwards by approximately 300mm.

Photographs 4 & 5: Damage at extent of lateral spread on Peraki Street. Cracking in road and reserve is evident next to stormwater manhole (left). Damage to 450mm pipe.

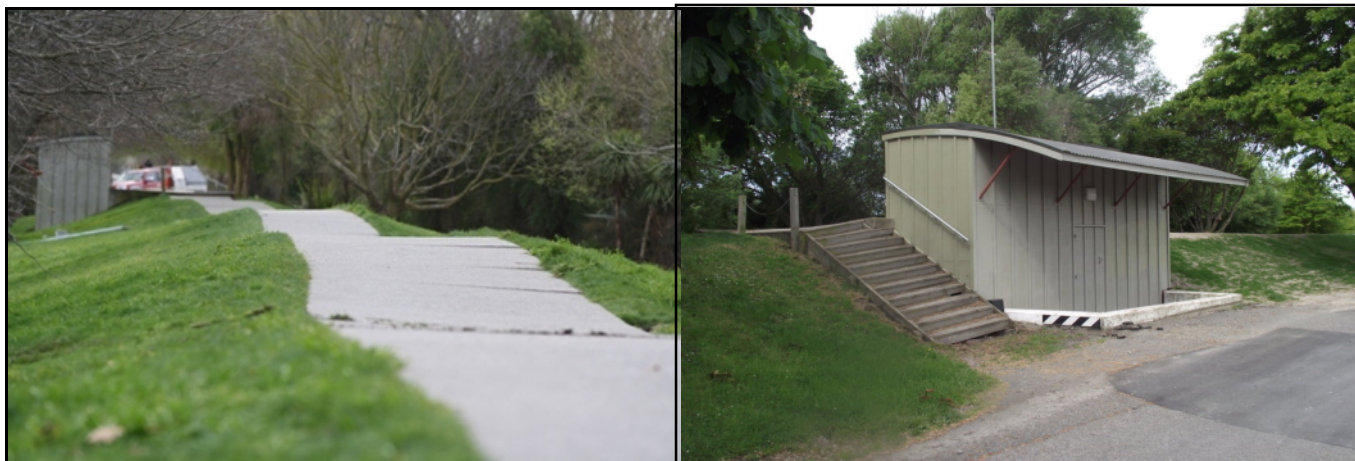
Initial inspection of pump stations located in the stop bank of the Kaiapoi River suggested that the pump stations had popped under buoyancy forces during the earthquake. However further investigation and comparison to pre-earthquake levels indicated that most of the movement was due to lateral spread and settlement of the surrounding land.

*Photographs 6 & 7: Laterals spread of stop bank adjacent Dudley Pump Station.*
