CHRISTCHURCH BRICK BARRELS SEWER REHABILITATION

Maurice Lubbock Principal Engineer, AECOM New Zealand Ltd
Philip McFarlane Principal Engineer, Opus International Consultants Ltd

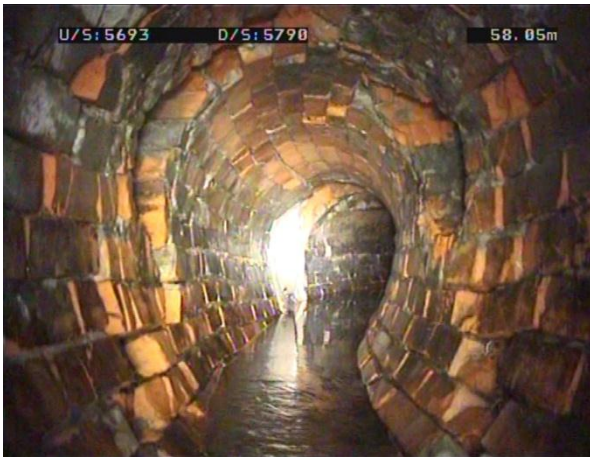
When the brick barrel sewers were exposed to seismic effects, they suffered a range of immediate damage from complete structural collapse in areas where ground displacement occurred, to cracking of varying degrees of severity. Figure 6 shows one example of a shear defect, in which the pipe has suffered a complete dislocation, and shattering of the brickwork structure.

Figure 6 - Shear defect

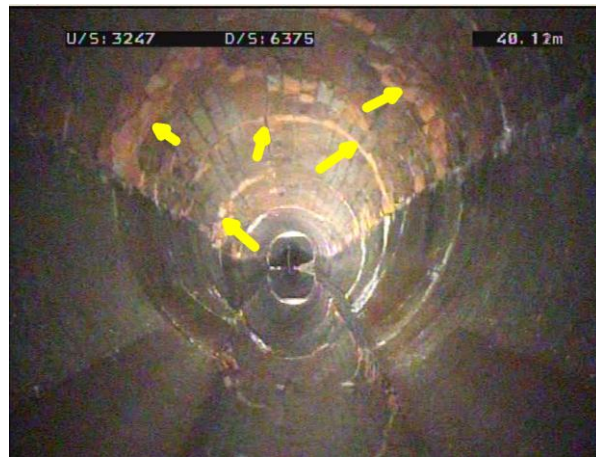
Nearly all of the sewers inspected showed evidence of circumferential cracking as if the ground in which it was built had been exposed to a moving vertical displacement, or ground wave, as shown in Figure 7, where the damage is less severe but more widely distributed.

Figure 7- Circumferential & longitudinal cracking

The defects shown in Figure 6 and Figure 7 were surveyed immediately after the pipeline sections containing them had been cleaned. It is not immediately obvious that the type of defect shown in Figure 7 is the cause of massive silting. The silt in the avenues area is very fine grained, and liquefaction conditions. It is clear that it can enter the sewers in enormous quantities, via defects that would normally be regarded as trivial in a storm water pipe network.

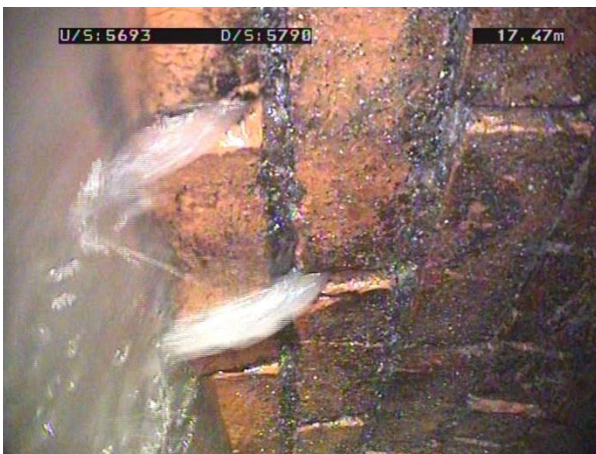
Figure 8 shows such a defect, and Figure 9, which is taken from a survey of the same sewer reach at a different time, shows the result. This is by no means the deepest layer of silt which we found in reviewing the video surveys. Long before the silt reaches such levels, the pipeline sections are impassable to cameras mounted on conventional CCTV survey tractors, because the wheels of such tractors simply sink into the silt, and the tractor chassis becomes stuck in the silt. Heavily silted sections are therefore usually surveyed with cameras mounted on floats, but in some cases, the pipeline sections were impassable even to float mounted cameras, because the remaining open area of pipeline was too small.

Figure 8 - Silt infiltration via defective brickwork

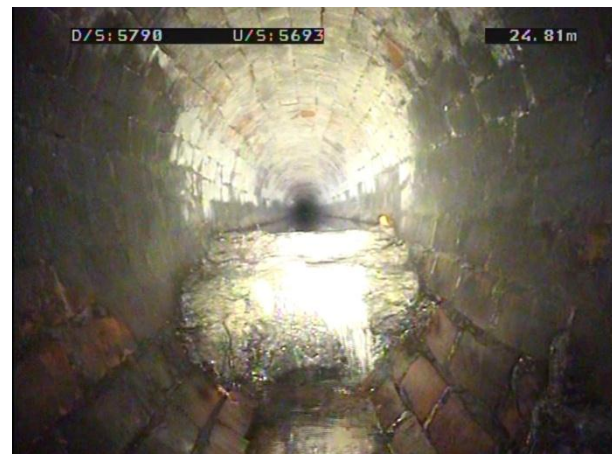
Figure 9 - Silt deposits

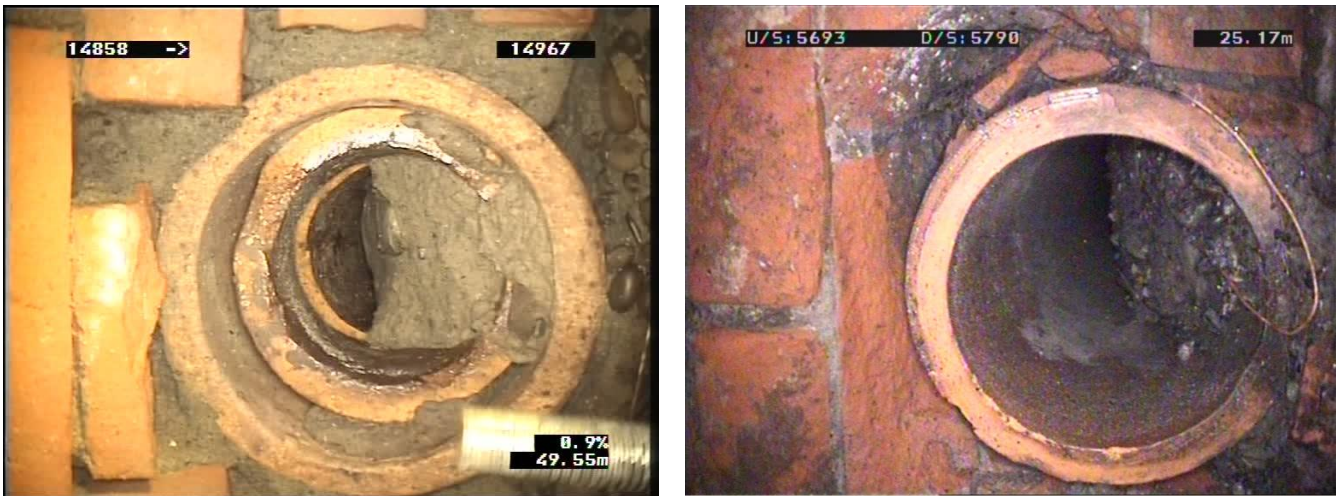
Silt also enters the sewers via lateral connections, most of which show obvious signs of earthquake damage, as in Figure 10

Figure 10 Silt infiltration via laterals

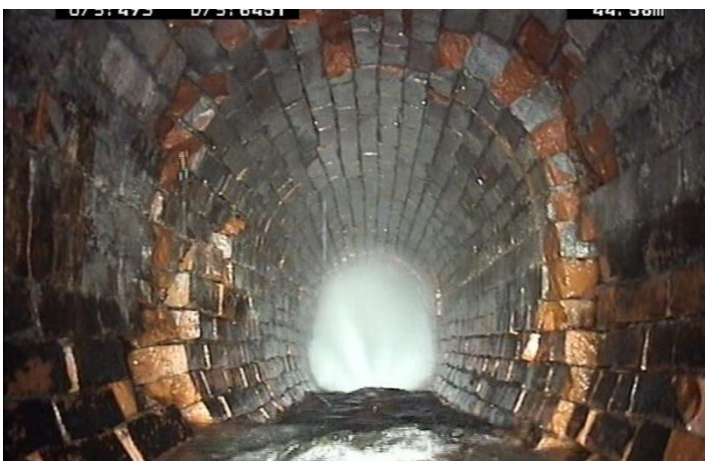
In the immediate aftermath of a significant seismic event, liquefaction occurs, and the volume of silt inflow is greatly increased. Many of the brick barrels require constant flushing, as shown in Figure 11 to maintain their flow capacity as a result.

Figure 11 Flushing to remove silt by water jetting

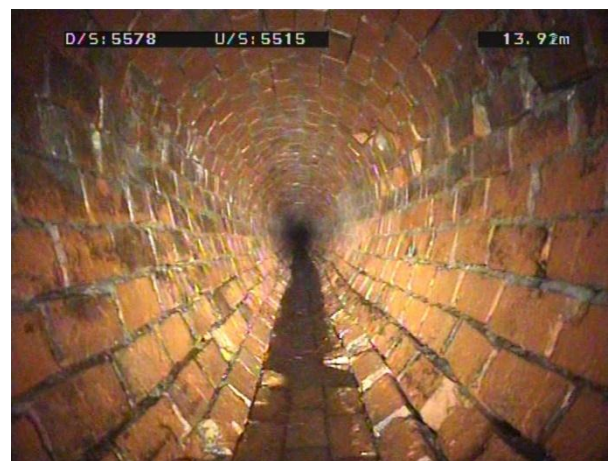
Figure 12 Effects of water blasting

Unfortunately, the silt very quickly turns to a substance with the consistency and strength of weak mortar when it is allowed to settle. The water blasting required to move it when it has reached this state is quite aggressive, and the silt also generally contains fragments of brick and concrete debris, so that the water blasting process has the undesired effect of grit blasting the remaining mortar which holds the brick barrels together.

The effect of this can be seen in Figure 12. Many of the wastewater sewers were constructed using trapezoidal shaped bricks. These sewers are relatively stable even when the mortar between the bricks is damaged or absent. However many of the storm water sewers were constructed using rectangular profile bricks and these are much less stable when damaged. It is common to see that the circular storm water sewers have deformed profiles as a result. These deformations often exceed the eccentricity values commonly used in conventional sewer lining designs, and impose practical difficulties for the designer and rehabilitation contractor.

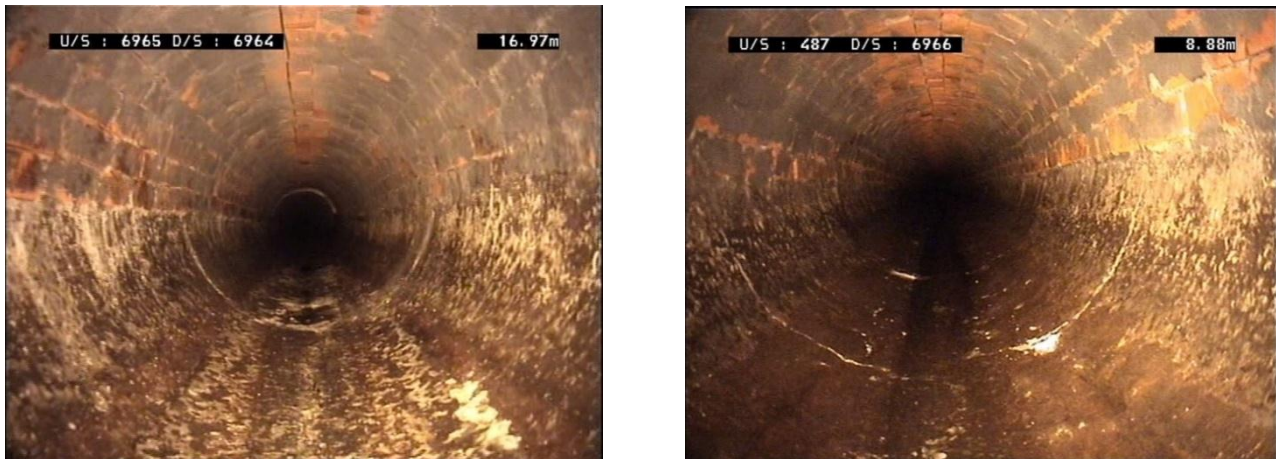
Figure 13 Deformed profiles in storm water brick barrels

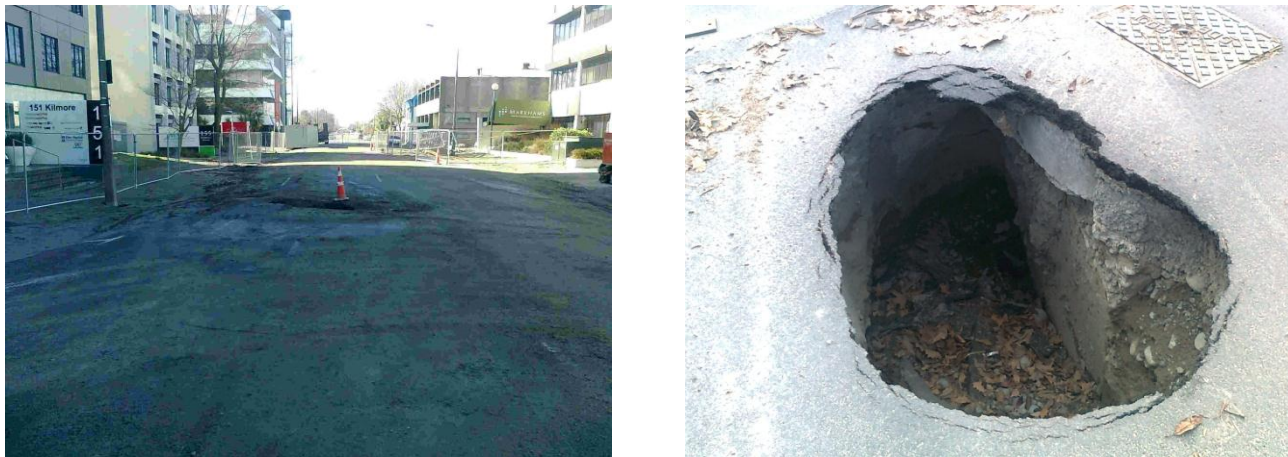
In addition to the visible effects of the silt infiltration as viewed from inside the sewer, there are also serious effects on the surroundings. The silt which enters the sewers has to come from somewhere else, and in the most obvious cases, this creates voids in the surrounding soil. In some cases these become sinkholes, but in all cases, there is an inevitable loss of strength in the side support to the sewer barrel. Over the long term there will also be changes in ground level. Many of these sewers lie under roads so the sinkholes create major traffic issues. They also lie close to other structures such as buildings, bridge abutments, retaining walls, and other underground pipelines, all of which are vulnerable to the effects of this soil movement by liquefaction. Figure 14 shows one example of this. The road surfaces along Christchurch's main roads show the effects on a larger scale, as many of them have obvious channels in the corridor immediately above these sewers, caused by the silt loss to the sewer system. The Burwood silt mountain shows the scale of this phenomenon, with thousands of tonnes added to it every day.

Figure 14 Kilmore St sinkhole (photo- Christchurch CC)
